# **JUNO**

## **Pre-Purchase Survey**

Completed for  
John Smith,  
5, South Road,  
London,  
E22 1QQ  
On 29/10/2011

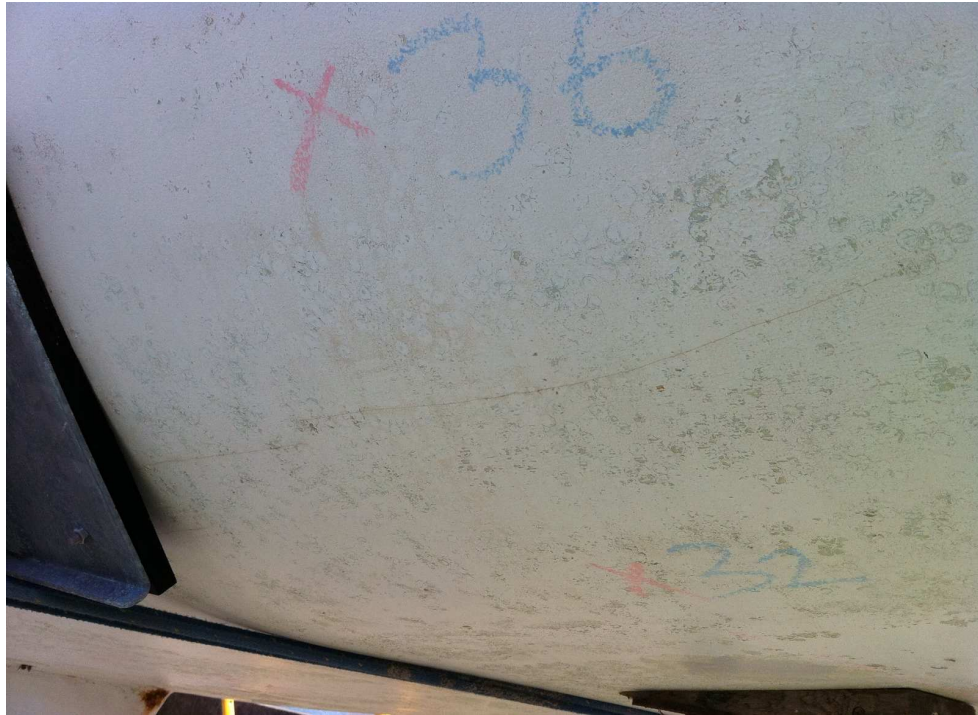
- 5.1.4.4 A crack in the gel-coat was found on the forward quarter, starboard side, and just forward of the main supporting shore, as shown in Figure 1. There is no evidence to suggest that this was caused by impact damage. It is likely that this crack has developed due to flexing of the hull in this area whilst the vessel has been under sail. Moisture readings were taken in this area and were found to be similar to adjacent laminate. It is **RECOMMENDED** (type C recommendation with an implementation time of one year) that the hull around these cracks is cut back to sound material. Any removed laminate shall be replaced and the repair finished with epoxy gel-coat. Additional laminate should be applied to the hull in this area (internal face) in order to stiffen the hull and to decrease the likelihood of this problem recurring.

**Figure 1: Cracks to gel-coat, starboard side, forward quarter**

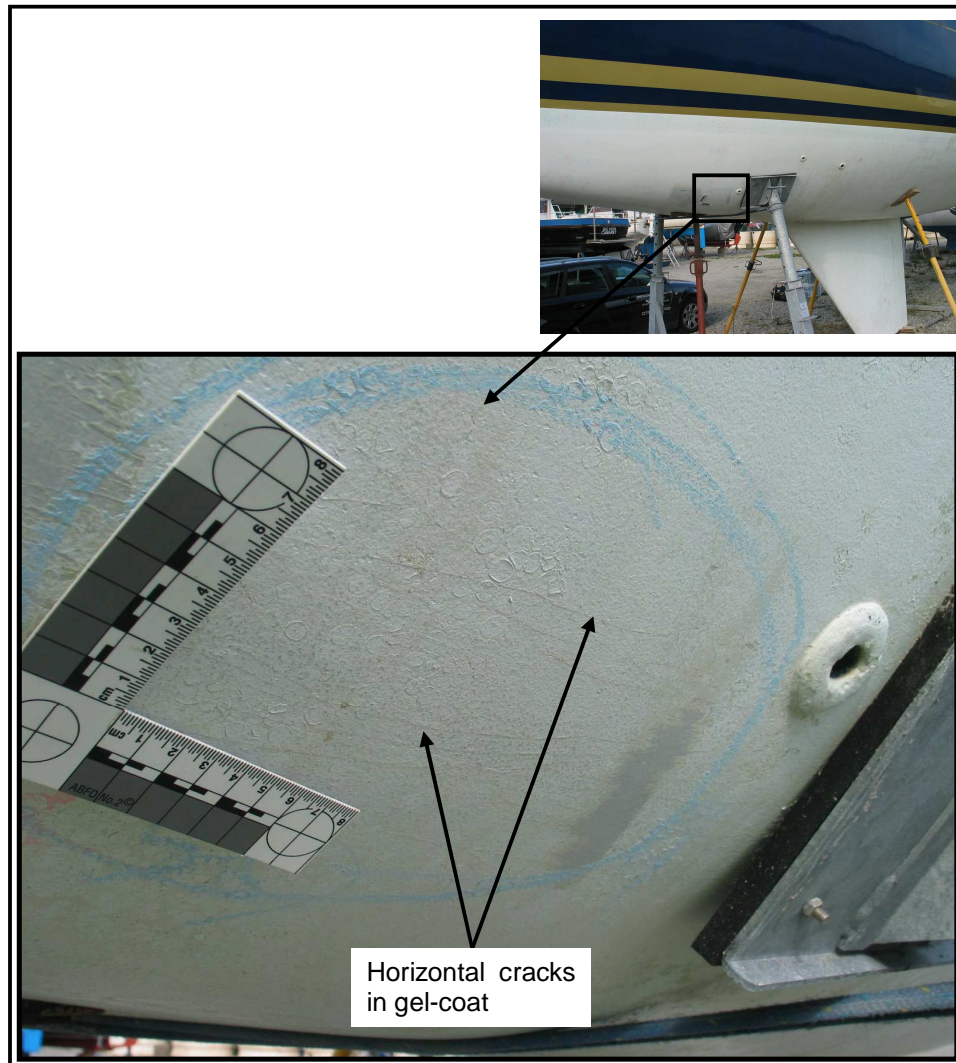
- 5.1.4.5 Multiple horizontal and parallel cracks were found in the gel-coat on the forward quarter, port side, and just forward of the forward heads sink outlet, as shown in Figure 2. These are similar to the crack described in 5.1.4.4 and there is no evidence to suggest that these were caused by impact damage. It is likely that these cracks have developed due to flexing of the hull in this area whilst the vessel has been under sail. Moisture readings were taken in this area and were found to be very high, indicating that moisture has been absorbed to a higher degree than surrounding, un-damaged gel-coat. It is **RECOMMENDED** (type C recommendation with an implementation time of one year) that the hull around these cracks is cut back to sound material. The laminate should then be thoroughly cleaned and dried. Any removed laminate shall be replaced and the repair finished with epoxy gel-coat. Additional laminate should be applied to the hull in this area (internal face) in order to stiffen the hull and to decrease the likelihood of this problem recurring.

**Figure 2: Cracks to gel-coat, port side, forward quarter, just forward of heads sink outlet**

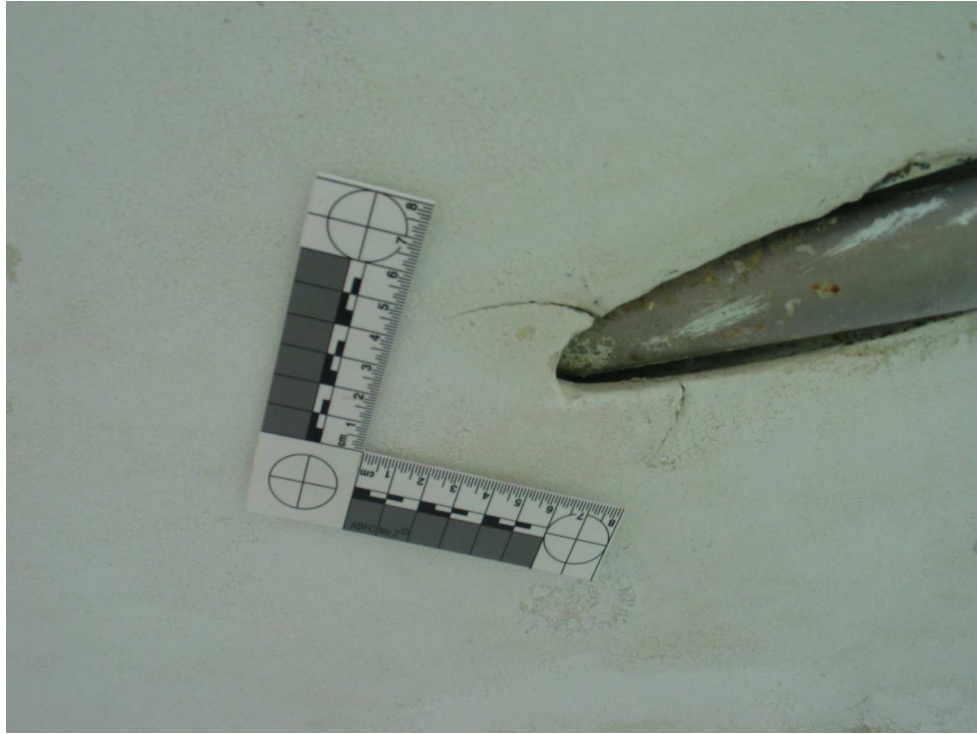
- 5.1.4.6 Figure 3 shows an area of laminate damage where the propeller shaft enters the hull. This damage is not detrimental to the strength of the hull but repair should be carried out in order to prevent water ingress into the adjacent laminate. It is **RECOMMENDED** (type C recommendation with an implementation time of one year) that the broken material is cut out. The gel-coat around the damage should be cut back to allow new laminate to be applied in this area. The repair should then be finished with epoxy gel-coat.

**Figure 3: Fracture of gel-coat and laminate, adjacent to prop-shaft hull entry point**

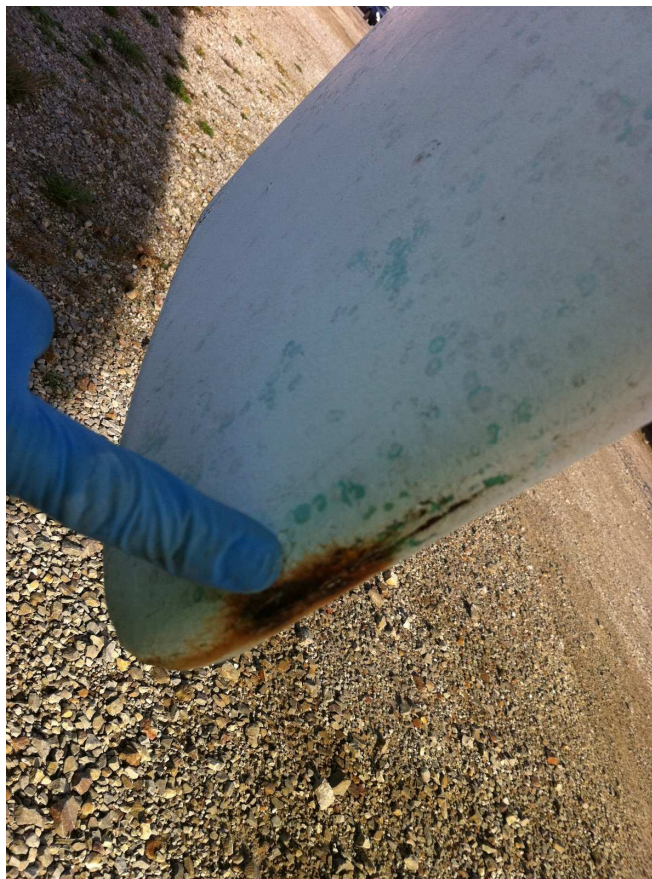
- 5.1.8.1 JUNO had a balanced spade rudder constructed from a stainless steel stock encapsulated in a hollow GRP moulding. It was inspected visually and found to be in serviceable condition. There was a small crack along the lower corner of the leading edge of the rudder moulding, as shown in Figure 4. This crack shows evidence that the internal steel framework has corroded, although the degree to which it has corroded cannot be ascertained without splitting the rudder moulding. Moisture readings taken on the rudder were high, although these readings can be attributed to residual moisture in the air space inside the moulding. It is **RECOMMENDED** (type C recommendation with an implementation time of one year) that this crack is inspected on an annual basis or whenever the vessel is hauled. If the crack extends in length, or additional cracks appear around the rudder edges, the rudder moulding should be split along its join and the internal steel framework repaired or replaced.

**Figure 4: Weeping from crack in leading edge of rudder**

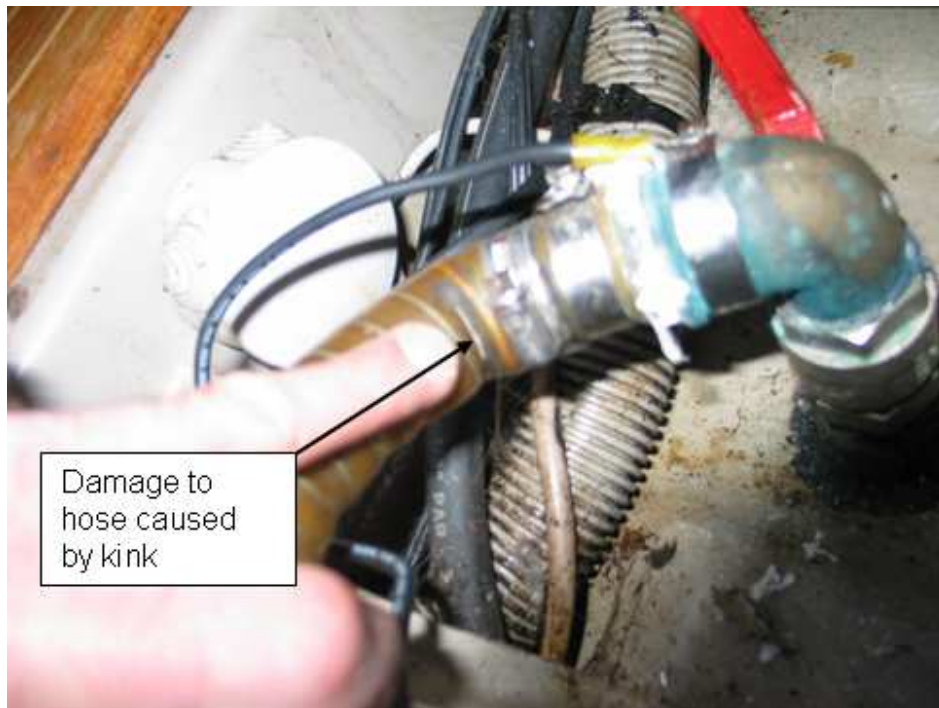
- 2.5.8 The hose that supplies sea water to the engine cooling system (item 20 in Table 3) was found to be severely kinked where it was attached to the valve. Closer inspection revealed that the hose had been damaged by the heavy strain imposed by the kink. Figure 6 shows where the hose has been weakened. It is **RECOMMENDED** (type A1) that the hose is replaced and routed so that there are no such kinks in the new installation. See paragraph 5.1.9.11 for full details.

- 5.1.9.11 The hose that supplies sea water to the engine cooling system (item 20 in Table 3) was found to be severely kinked where it was attached to the valve. Closer inspection revealed that the hose had been damaged by the heavy strain imposed by the kink. Figure 6 shows where the hose has been weakened. It is **RECOMMENDED** (type A1) that the hose is replaced and routed so that there are no such kinks in the new installation.

**Figure 6: Damage to engine cooling supply hose**

- 5.1.9.12 There was clear access inside the vessel to all valves and seacocks. The engine cooling inlet valve should be adjusted (rotated) to remove the sharp kink in the hose.

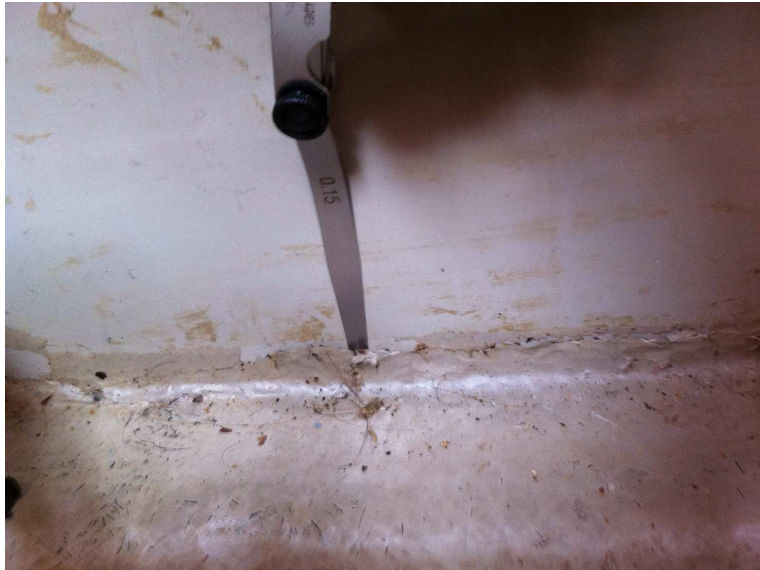
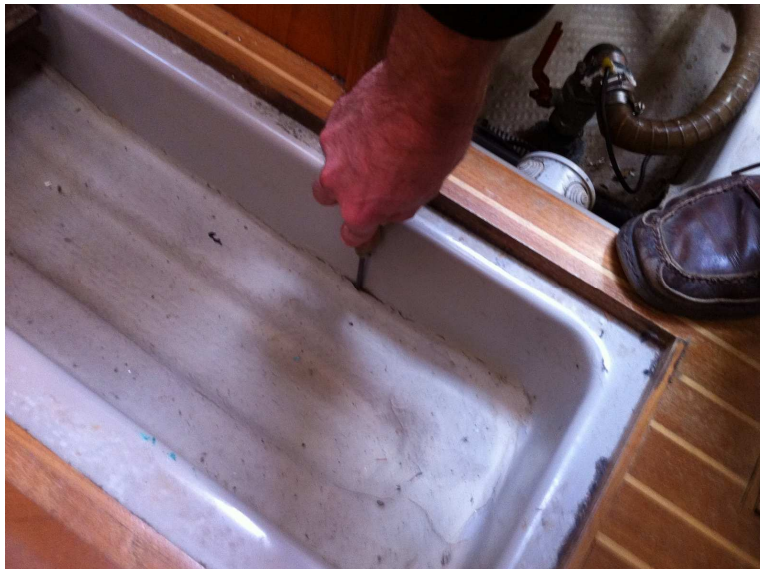
- 5.2.2.4 Close examination of the join between the tabbing and a number of sections of the Internal Moulding revealed that the bond had failed. Figure 7 and Figure 8 show two typical areas where this has occurred in the saloon area.

**Figure 7: Debonding of tabbing to Internal Moulding laminate**

**Figure 8: Debonding of tabbing to Internal Moulding laminate**

- 5.2.2.6 It is **RECOMMENDED** (type A2) that for ALL de-bonded areas of the Internal Moulding, the de-bonded tabbing is cut back entirely until the bonded interface is found. Surfaces of the Internal Moulding that are to receive over-laminating shall be cut back to remove the gel-coat surface. This is to ensure that the new laminate is bonded to existing laminate rather than gel-coat, which is a very poor substrate for bonding. All prepared areas shall then be thoroughly cleaned and dried. Multiple layers of fibreglass cloth and epoxy resin should then be applied, with the edges of the cloth layered so as to give a gradual tapering to the existing structure. The thickness of the layup should be in excess of the laminate removed during the repair. This will ensure that strength of the repair is similar or greater than the original layup.

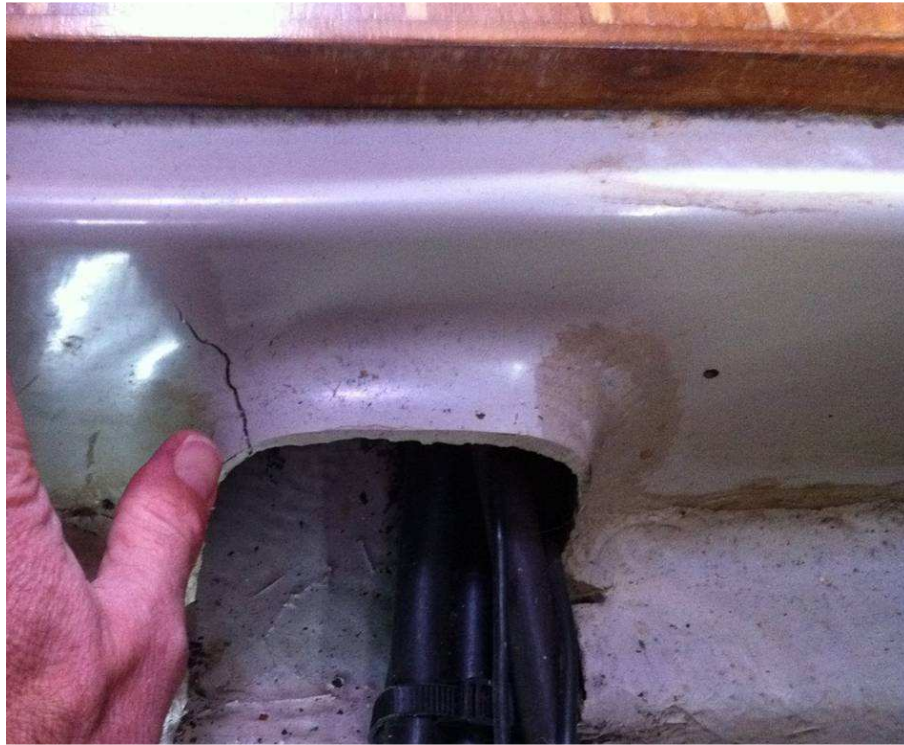
- 2.6.3 There is a large (greater than 50mm) crack in the GRP transverse floor (see Figure 10) that is directly in front of the mast compression post. The forward end of the stainless steel fabrication that provides a base for the mast compression post is connected to this floor. It is **RECOMMENDED** (type A2) that the area around the crack shown in Figure 10 should be stiffened. The tip of the crack should be located and a 6mm diameter hole drilled through the stiffener at this point. This will help to reduce the rate of propagation of the crack. Following this, all surfaces of the damaged area that are to receive over-laminating (at least 200mm either side of the 'arch' of the limber hole) shall be cut back to remove the gel-coat surface. This is to ensure that the new laminate is bonded to existing laminate rather than gel-coat, which is a very poor

5.2.2.7 Figure 10 shows a large crack (greater than 50mm) crack in the GRP transverse floor that is directly in front of the mast compression post. The forward end of the stainless steel fabrication that provides a base for the mast compression post is connected to this floor (section 5.2.3). The location of this crack strongly indicates that the crack has been caused by high loading in this area, combined with the reduced section of the transverse floor: The size and location of the limber hole where the cabling and tubing pass through has significantly reduced the section and hence the strength and stiffness of the transverse floor.

Figure 10: Crack in transverse floor

5.2.2.8 It is **RECOMMENDED** (type A2) that, in addition to the recommendation made in paragraph 5.2.2.6 being applied to this transverse floor, the area around the crack should be stiffened. The tip of the crack should be located and a 6mm diameter hole drilled through the stiffener at this point. This will help to reduce the rate of propagation of the crack. Following this, all surfaces of the damaged area that are to receive over-laminating (at least 200mm either side of the 'arch' of the limber hole) shall be cut back to remove the gel-coat surface. This is to ensure that the new laminate is bonded to existing laminate rather than gel-coat, which is a very poor substrate for bonding. All prepared areas shall then be thoroughly cleaned and dried. Multiple layers of fibreglass cloth and epoxy resin should then be applied, with the edges of the cloth layered so as to give a gradual tapering to the existing structure. The thickness of the layup should be significantly in excess of the laminate thickness of the transverse floor. This will ensure that strength of the repair is similar or greater than the original layup. Note that this over-laminating should cover both port and starboard sides of the 'arch'. The accessible surfaces inside the 'arch' should also be strengthened in a similar manner.

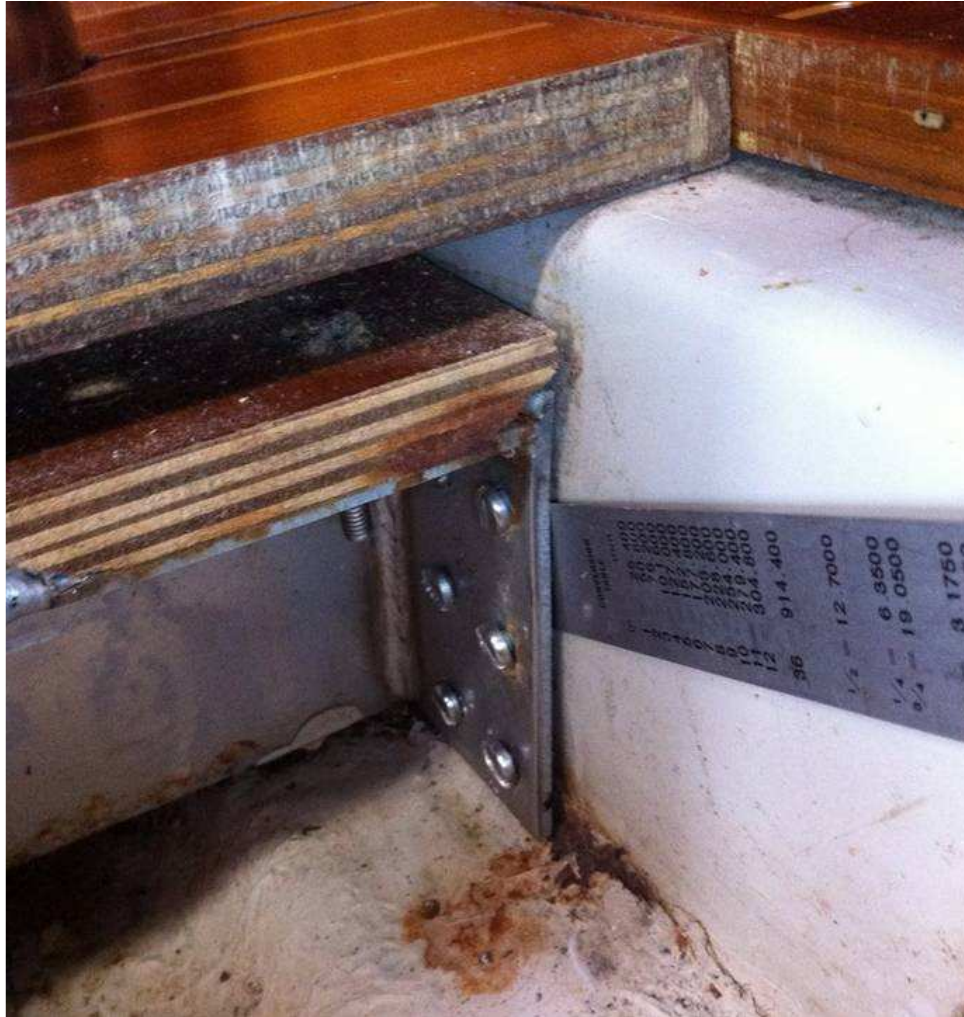
- 5.2.3.3 The stainless steel fabrication is also designed to transfer some load to the hull inner surface by means of a contact surface that is half-way along the underside of the fabrication. Once the repair discussed in paragraph 5.2.3.2 has been completed, it is likely that there will be a gap between the fabrication and the hull inner surface. This must be completely filled by a hard setting epoxy / filler mix.

**Figure 11: Downward deflection of support for mast compression post**

5.2.3.2 It is **RECOMMENDED** (type A2) that this misalignment is rectified and the following repair carried out at both ends of the stainless steel fabrication. In order to perform this task, it will be necessary to remove the tension in the mast rigging (or lift the entire mast off the coachroof) so that the fabrication can be raised into its correct position. Once the fabrication has been lifted up and realigned, a hard setting epoxy / filler mix should then be used to fill the gap between the steel end plates and the transverse floors. Once this has set, the steel plates should be re-attached to the floors. Instead of self-tapping screws, suitably sized stainless steel bolts, washers and nuts should be used. Access to the inside of the top hat sections of the floors can be gained by cutting a single hole in the mid-height of the opposite face of each of the transverse floors. The size of each hole should be the minimum necessary to allow the insertion of a bolt & penny washer. Once all of the bolts are inserted, the penny washers should not overlap adjacent washers. After satisfactory assembly of the bolted joints, the gel-coat around the repair areas should be cut back and cleaned thoroughly. The access holes should then be over-laminated to a thickness equal to or greater than the transverse floor thickness.

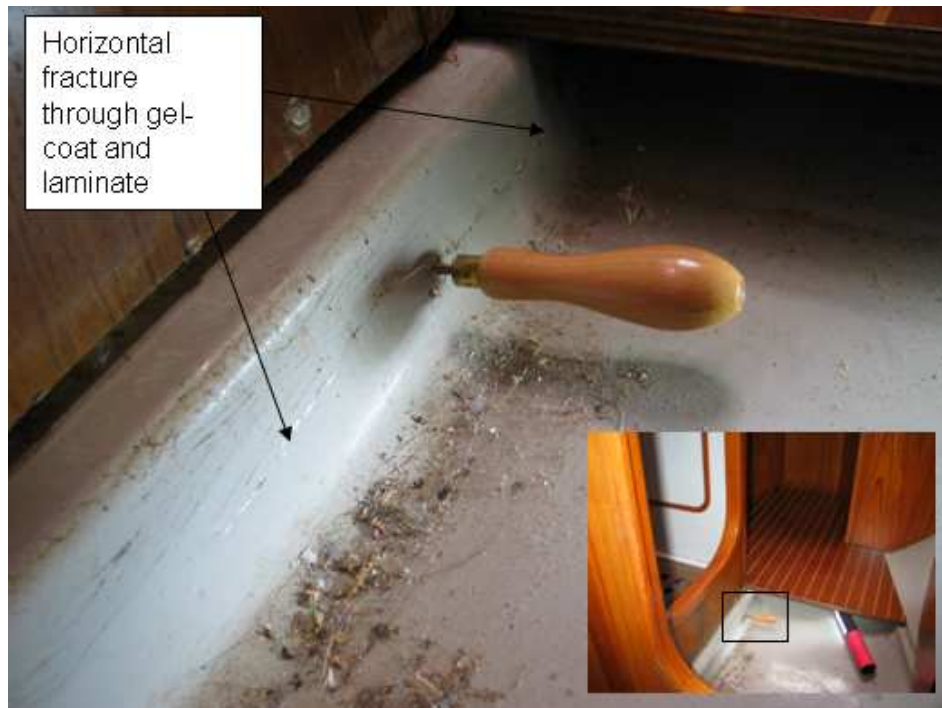
- 2.6.5 The Internal Moulding under the forepeak sole was also inspected and found to have a fracture approximately 300mm in length along the vertical face of the moulding that adjoins the forward heads door bulkhead, as shown in Figure 12. It is **RECOMMENDED** (type A2) that this damage is cut out and repaired. The damaged laminate should be cut back to sound material. Surfaces of the Internal Moulding that are to receive over-laminating shall be cut back to remove the gel-coat surface. Multiple layers of fibreglass cloth and epoxy resin should then be applied, with the edges of the cloth layered so as to give a gradual tapering to the existing structure. The thickness of the layup should be in excess of the laminate removed during the repair. This will ensure that strength of the repair is similar or greater than the original layup. See paragraph 5.2.3.4 for full details.

- 5.2.3.4 The Internal Moulding under the forepeak sole was also inspected and found to have a fracture approximately 300mm in length along the vertical face of the moulding that adjoins the forward heads door bulkhead, as shown in Figure 12. The cause of this damage cannot be verified but it may possibly be due to flexing of the portion of hull & deck that is forward of the mast. It is **RECOMMENDED** (type A2) that this damage is cut out and repaired. The damaged laminate should be cut back to sound material. Surfaces of the Internal Moulding that are to receive over-laminating shall be cut back to remove the gel-coat surface. This is to ensure that the new laminate is bonded to existing laminate rather than gel-coat, which is a very poor substrate for bonding. All prepared areas shall then be thoroughly cleaned and dried. Multiple layers of fibreglass cloth and epoxy resin should then be applied, with the edges of the cloth layered so as to give a gradual tapering to the existing structure. The thickness of the layup should be in excess of the laminate removed during the repair. This will ensure that strength of the repair is similar or greater than the original layup.

**Figure 12: Fracture of Internal Moulding in forepeak**

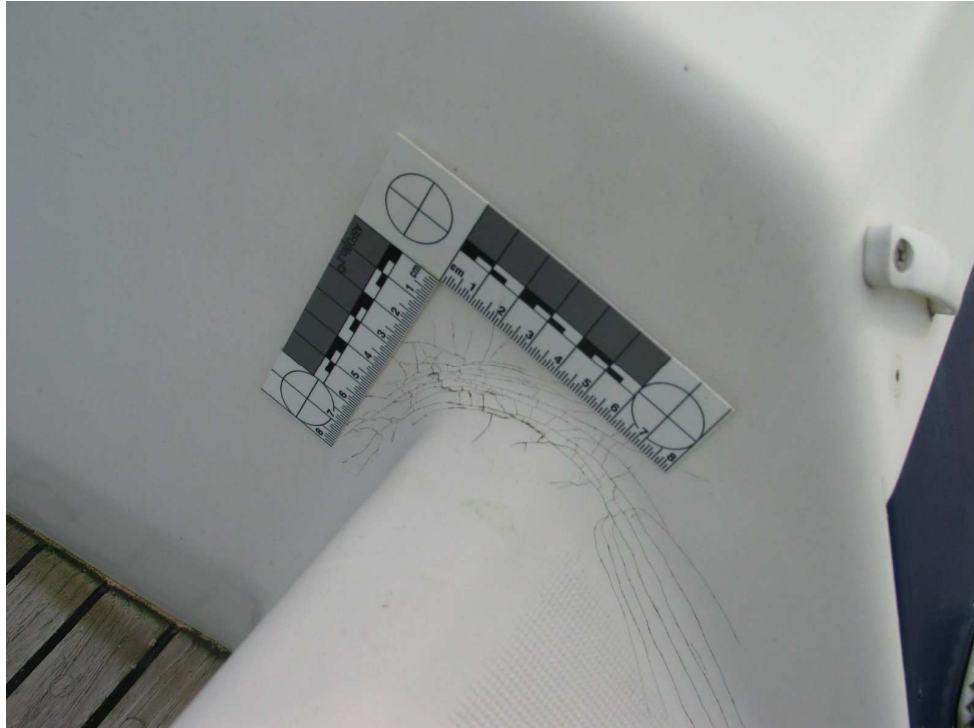
- 2.6.6 There were two areas of the cockpit moulding where significant gel-coat cracking had occurred. These were located on the port and starboard sides of the cockpit coaming, where the horizontal section of the coaming meets the vertical face of the coachroof aft bulkhead. Figure 14 shows that the surface of the gel-coat has been distorted and roughened by this cracking. The gel-coat has been permanently distorted, which suggests that the damage extends into the laminate, although this cannot be guaranteed without destructive testing of the gel-coat and laminate. It is **RECOMMENDED** (type A2) that the damaged gel-coat is cut back to sound laminate and repaired. Additional laminate should be applied to the internal surface of the cockpit and bulkhead in these areas in order to stiffen the coaming to bulkhead join and to decrease the likelihood of this problem recurring. See paragraph 5.3.3.1 for full details.

- 5.3.3.1 There were two areas of the cockpit moulding where significant gel-coat cracking had occurred. These were located on the port and starboard sides of the cockpit coaming, where the horizontal section of the coaming meets the vertical face of the coachroof aft bulkhead, as shown in Figure 13.

**Figure 13: Cracks in gel-coat of cockpit coaming**

- 5.3.3.3 It is **RECOMMENDED** (type A2) that the damaged gel-coat is cut back to sound laminate. The laminate should then be thoroughly cleaned and dried. Any removed laminate shall be replaced and the repairs finished with epoxy gel-coat. Additional laminate should be applied to the internal surface of the cockpit and bulkhead in these areas in order to stiffen the coaming to bulkhead join and to decrease the likelihood of this problem recurring.

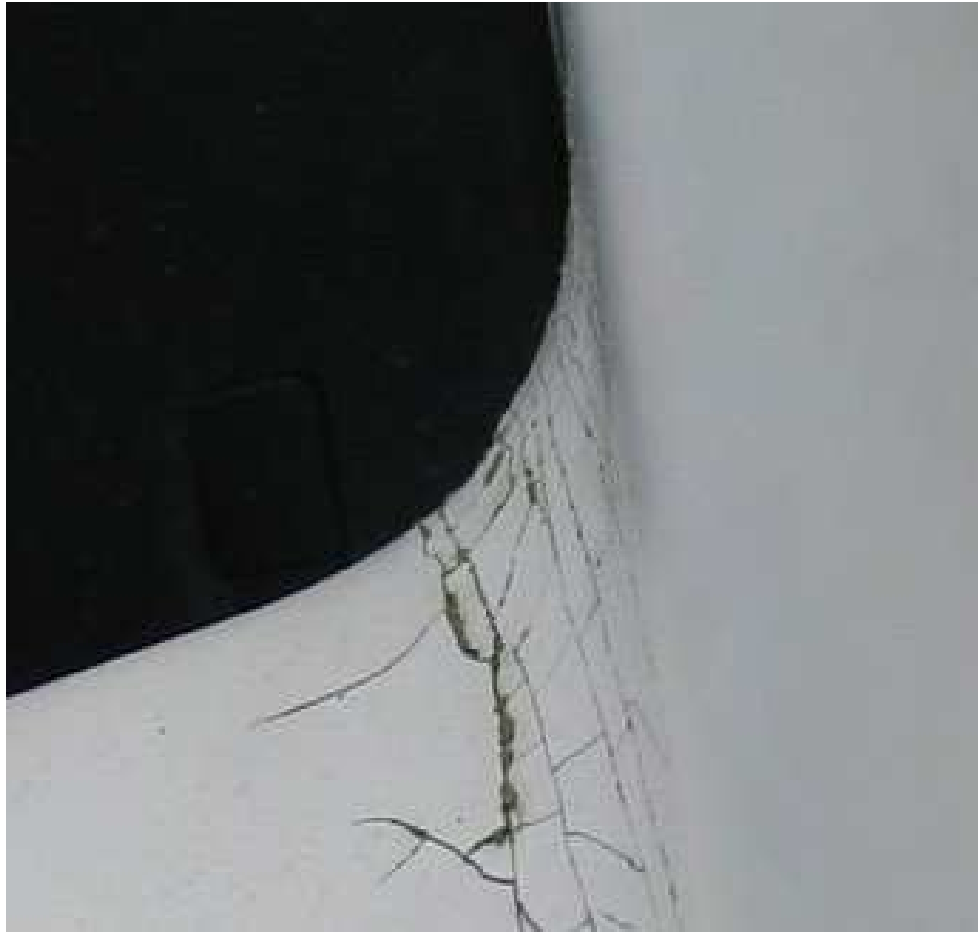
- 5.3.3.2 Figure 14 shows that the surface of the gel-coat has been distorted and roughened by this cracking. The gel-coat has been permanently distorted, which suggests that the damage extends into the laminate, although this cannot be guaranteed without destructive testing of the gel-coat and laminate.

**Figure 14 Detail of cracks showing uneven surface**

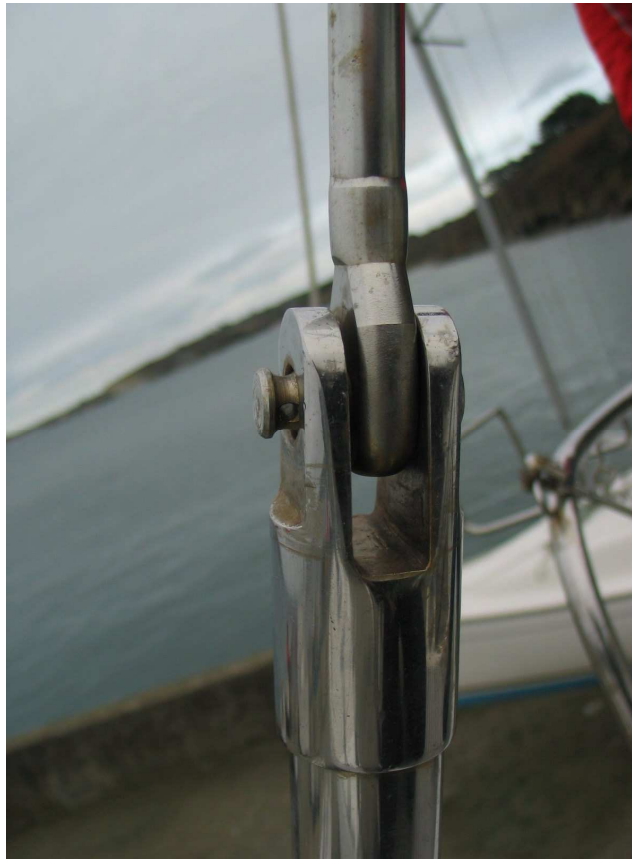
- 2.5.9 Where the backstay was connected to the backstay tension adjuster, the split pin was found to be missing, as shown in Figure 15. It is **RECOMMENDED** (type A1 recommendation) that a new split pin is inserted. See paragraph 5.4.7.2 for full details.

- 5.4.7.1 The standing rigging comprised single lower shrouds, intermediate shrouds and cap shrouds passing over triple spreaders. There was a single backstay terminating at a plate on the transom. The forestay was formed by the headsail reefing foil.
- 5.4.7.2 Where the backstay was connected to the backstay tension adjuster, the split pin was

found to be missing, as shown in Figure 15. It is **RECOMMENDED** (type A1 recommendation) that a new split pin is inserted.

**Figure 15: Missing split pin in backstay**
