REGAL COMMODORE 272

Pre Purchase Survey

Completed for
James Wilson,
6 Hill Lane,
Hinton,
Wiltshire,
DE55 5PJ
On 17/03/2012

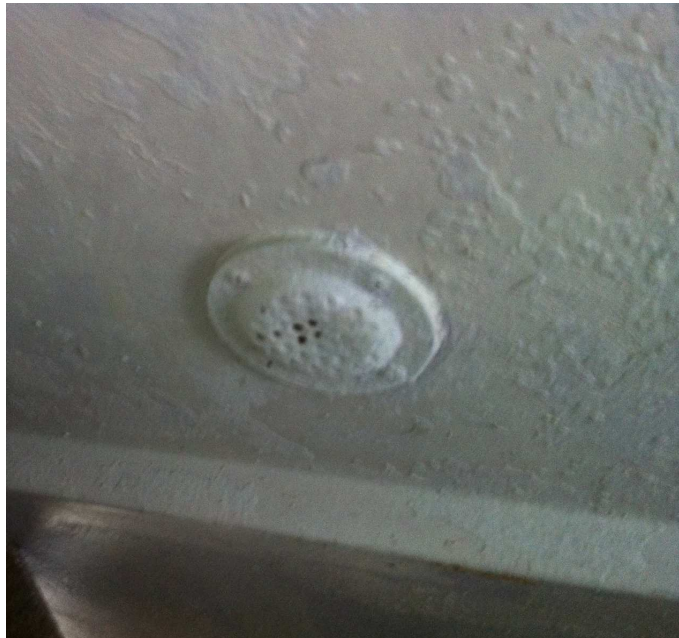
- 2.6.1 The skin fitting for the toilet intake was found to be partially blocked by excessive application of antifouling. It is **RECOMMENDED** (type A1 recommendation) that the paint is removed from these holes to maximise the flow of water through to the toilet (see paragraph 5.1.5.5).

- 5.1.5.2 There was clear access inside the vessel to all valves and seacocks.
- 5.1.5.3 All fittings below the waterline were bronze, were in serviceable condition and showed no signs of dezincification.
- 5.1.5.4 It was not possible to survey all the associated spigots and pipe work in detail. All that we were able to survey appeared in satisfactory condition with the connections in good order, secure and no evidence of water ingress or leakage.
- 5.1.5.5 The skin fitting for the toilet intake was found to be partially blocked by excessive application of antifouling. Figure 1 shows that the majority of the holes in the grille are covered by paint. It is **RECOMMENDED** (type A1 recommendation) that the paint is removed from these holes to maximise the flow of water through to the toilet.

Figure 1: Partially blocked skin fitting grille

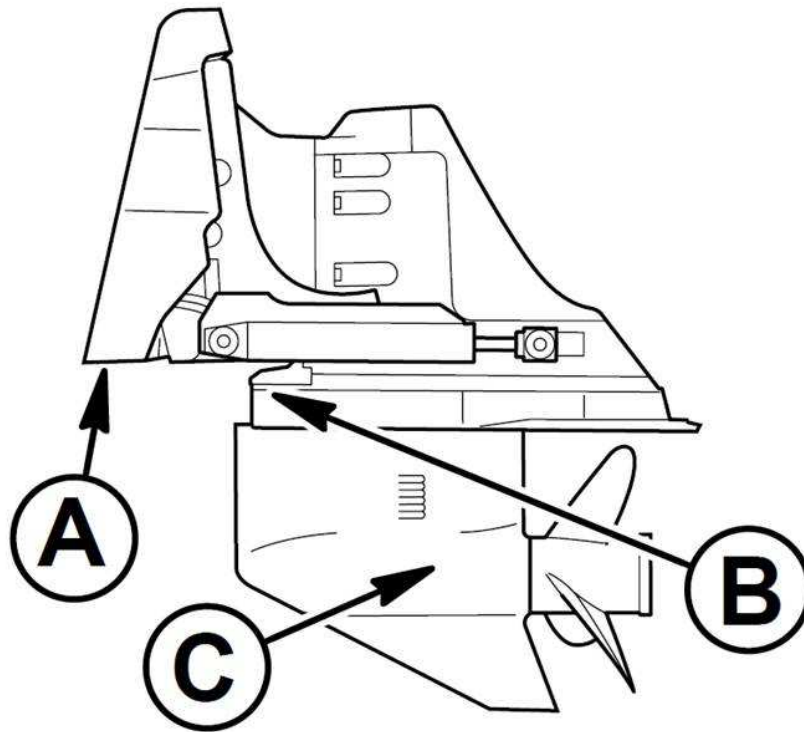
- 5.1.6.1 One zinc anode was found on the starboard stern drive, located on the front of the gearcase, above the anti-ventilation plate (location B in Figure 2). This anode was 50% consumed. The equivalent anode on the port stern drive was completely wasted.
- 5.1.6.2 Referring to Figure 2, there were no anodes found at location A, indicating that these had completely wasted.
- 5.1.6.3 It is **RECOMMENDED** (type A1 recommendation) that for both stern drives, new anodes are installed at locations A (bottom of gimbal housing), front of gearcase, above anti-ventilation plate) and C (in exhaust passage).

Figure 2: Locations of anodes on SX Cobra stern drives

- 2.6.2 It is **RECOMMENDED** (type A1 recommendation) that for both stern drives, new anodes are installed at locations the bottom of the gimbal housing, front of gearcase (above anti-ventilation plate) and in the exhaust passage (see paragraph 5.1.6.3).

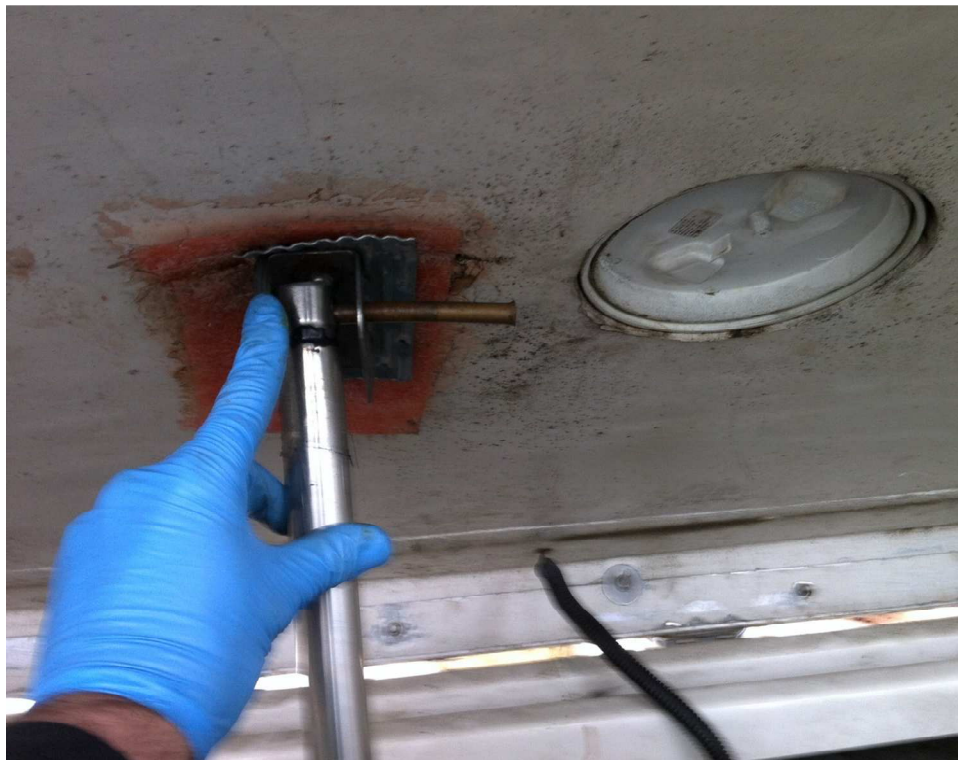
- 5.3.3.9 Access to the engine bay was provided by the upward & rearward hinging of the cockpit sole. The lifting force was by means of a hydraulically powered strut. The method of attachment of the strut to the cockpit sole was very poor and the concentrated load had damaged the sole, resulting in a deformed laminate. Figure 3 shows the location of the damage. Additionally, the brass pivot pin was deformed and inadequately secured. It is **RECOMMENDED** (type A2 recommendation) that the strut connection to the sole is stiffened by a large aluminium backing plate which is bonded, screwed and laminated in place. The brass pin must also be replaced by a stainless steel shoulder bolt, secured by a nyloc nut.

Figure 3: Damage to cockpit sole from engine access lifting strut.

- 2.7.3 Access to the engine bay was provided by the upward & rearward hinging of the cockpit sole, which was lifted by a hydraulic strut. The method of attachment of the strut to the cockpit sole was very poor and the concentrated load had damaged the sole. Additionally, the brass pivot pin was deformed and inadequately secured. It is **RECOMMENDED** (type A2 recommendation) that the strut connection to the sole is stiffened by a large aluminium backing plate which is bonded, screwed and laminated in place. The brass pin must also be replaced by a stainless steel shoulder bolt, secured by a nyloc nut (see paragraph 5.3.3.9).

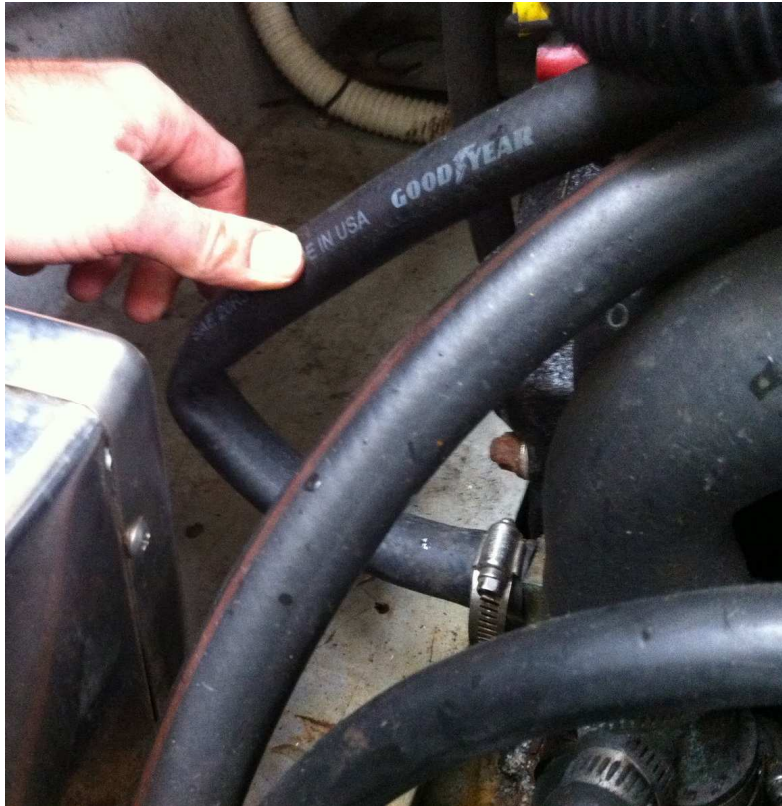
- 5.4.3.7 One of the coolant hoses that fed into the exhaust manifold was found to be heavily kinked and was severely restricting the flow of water around the engine. Figure 4 shows the hose. It is **RECOMMENDED** (type A1 recommendation) that this hose is replaced with a custom moulded hose that provides the correct shape and curvature.

Figure 4: Restriction in starboard engine cooling hose

- 2.6.6 On the starboard engine one of the coolant hoses that fed into the exhaust manifold was found to be heavily kinked and was severely restricting the flow of water around the engine. It is **RECOMMENDED** (type A1 recommendation) that this hose is replaced with a custom moulded hose that provides the correct shape and curvature (see paragraph 5.4.3.7).
