FAR HORIZON

Pre-Purchase Survey

Completed for
Tom Smith,
99 Taunton Road,
Bridgwater,
Somerset,
TA65 1AB
On 16th February 2013

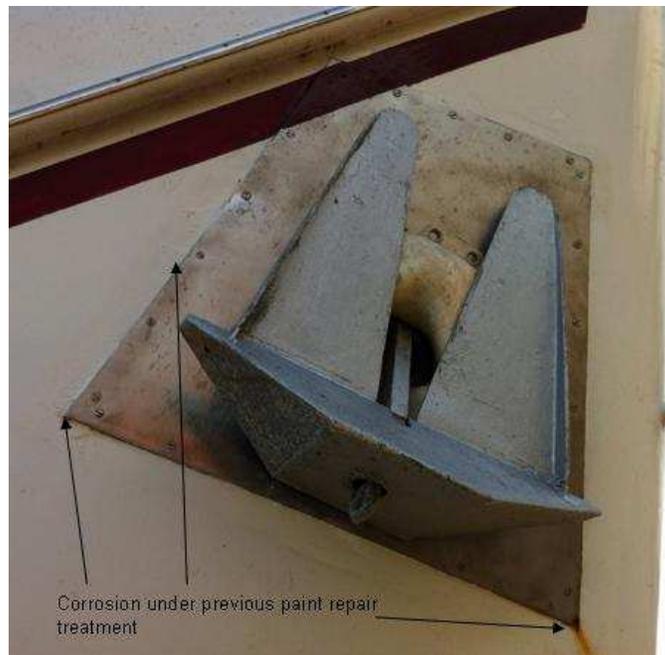
5.1.3.2 The hull plating was found to be corroding around the perimeter of the stainless steel anchor rubbing plate, located on the starboard bow, as shown in Figure 1. Previous treatment of this area to prevent rusting has been partially successful, but the paint coating was seen to be bubbling, suggesting that corrosion is continuing under the paint. At present this defect is only cosmetic with minor rust streaks showing on the topside coating. It is **RECOMMENDED** (type C recommendation) that the stainless steel plate is removed, the corrosion treated and the affected area protected by a suitable paint system. The stainless steel plate should then be re-fastened, using a suitable mastic sealant to prevent water from penetrating the gap between the stainless steel plate and the hull. This should be performed within a 2 year period, to prevent the corrosion from progressing too far.

Figure 1: Corrosion around edge of anchor rubbing plate

- 2.9 There are four **type C recommendations** that do NOT require immediate attention but are to be dealt with in a specified time period:
- 2.9.1 The hull plating was found to be corroding around the perimeter of the stainless steel anchor rubbing plate, located on the starboard bow. At present this defect is only cosmetic with minor rust streaks showing on the topside coating. It is **RECOMMENDED** (type C recommendation with an implementation time of two years)

that the stainless steel plate is removed, the corrosion treated and the affected area protected by a suitable paint system (see paragraph 5.1.3.2).

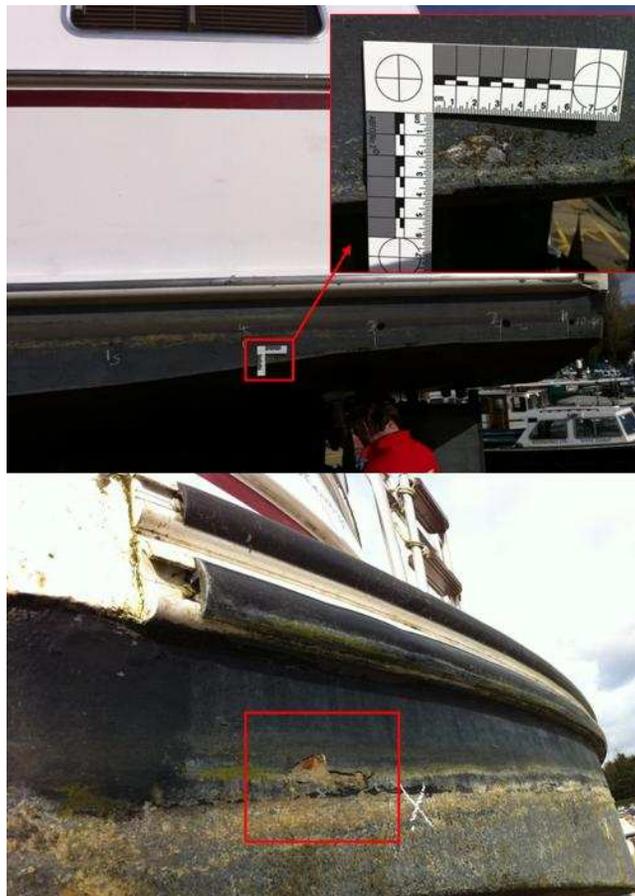
- 5.1.4.1 The hull below the waterline and the hull bottom was coated with an epoxy paint. This was examined and found to be in generally firm condition, carried out to a high standard and adhering well to the shell and with no sign of exfoliation. There was minor evidence of flaking in some areas under the waterline, but this was between the top coat of epoxy and the layer underneath.
- 5.1.4.2 There were two locations on the hull where the paint coating had been damaged, revealing the hull plating. These are shown in Figure 2. It is **RECOMMENDED** (type C recommendation) that the corrosion is treated and the affected area protected by a suitable paint system. This should be performed within a 2 year period or within 1 year if the vessel is to be kept in a salt water environment.

Figure 2: Two locations of hull coating penetration

- 2.9.2 There were two locations on the hull where the paint coating had been damaged at the waterline, revealing the hull plating. It is **RECOMMENDED** (type C recommendation) that the corrosion is treated and the affected area protected by a suitable paint system. This should be performed within a 2 year period or within 1 year if the vessel is to be kept in a salt water environment (see paragraph 5.1.4.1).

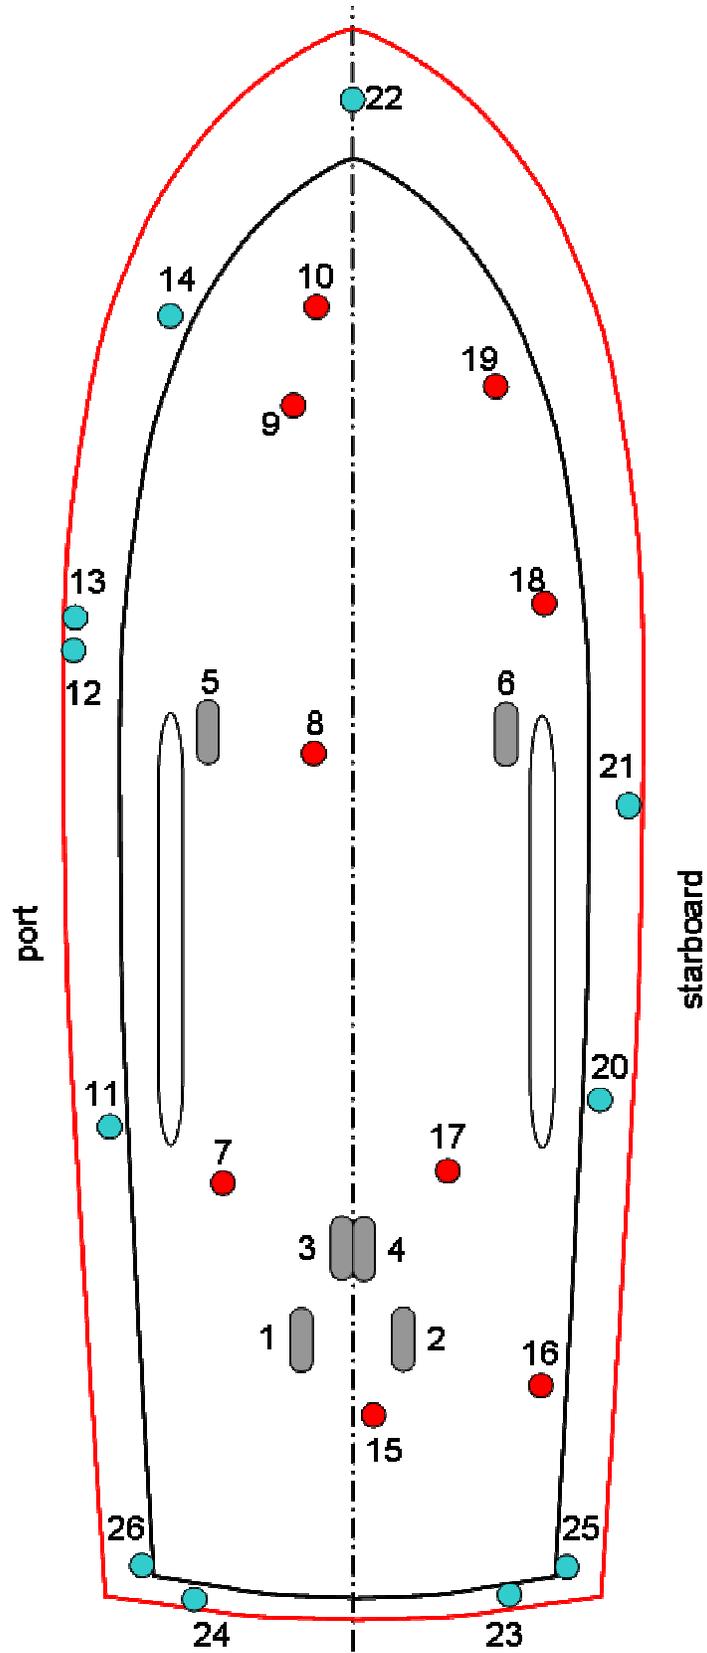
Figure 3: Location of skin fittings (plan view looking from above)

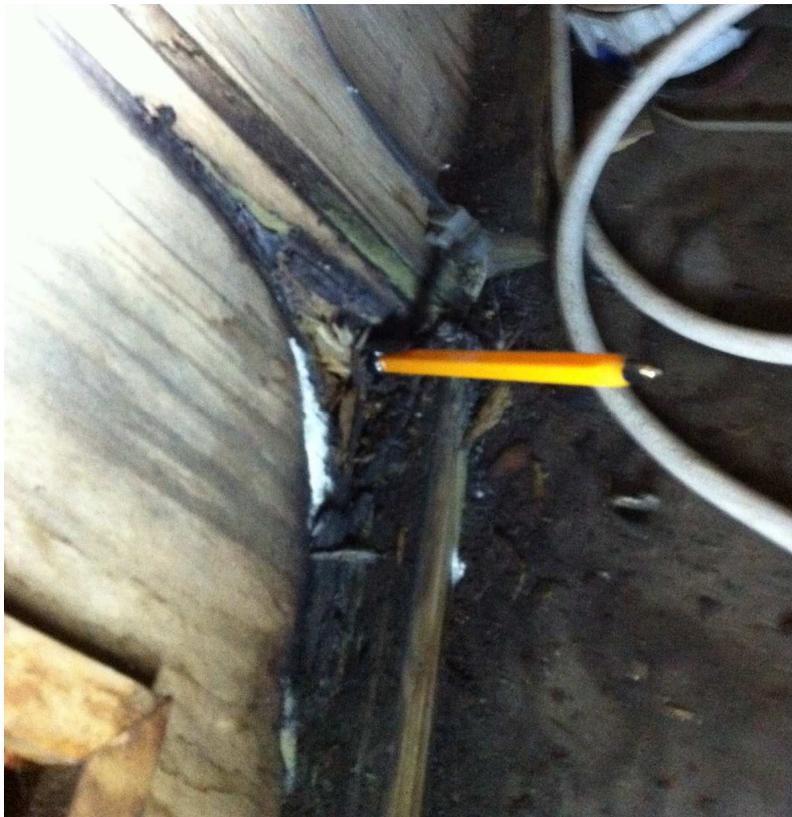
- 5.6.1.6 The saloon contained a television with integral VHS video cassette player, located in one of the corner units.
- 5.6.1.7 The two sliding doors that gave access to the interior accommodation were at the aft end of the saloon and on either side of the vessel. The steps that lead up to each of these were removed in order to provide access into the spaces under the side decks. Inspection of these spaces found that there were two areas where moisture ingress had caused the wood panelling of the saloon to rot. Figure 4 shows one such area, located beneath the door from the saloon to the port side deck. A similar defect was found on the starboard side. The source of the water ingress that has lead to this rot was not ascertained, but it is likely that it has been caused by rainwater seeping around the door frames and sill. To prevent further deterioration of the interior panelling, the cause of the water ingress should be determined and appropriate steps taken to seal against further ingress.

Figure 4: Wet rot – port side, beneath exterior access door in saloon
