# QUICKSILVER

## Pre-purchase Survey

Completed for  
Dave Wakelin,  
Hill View,  
Dorking,  
Surrey,  
DK14 0PQ  
On 24/08/2013

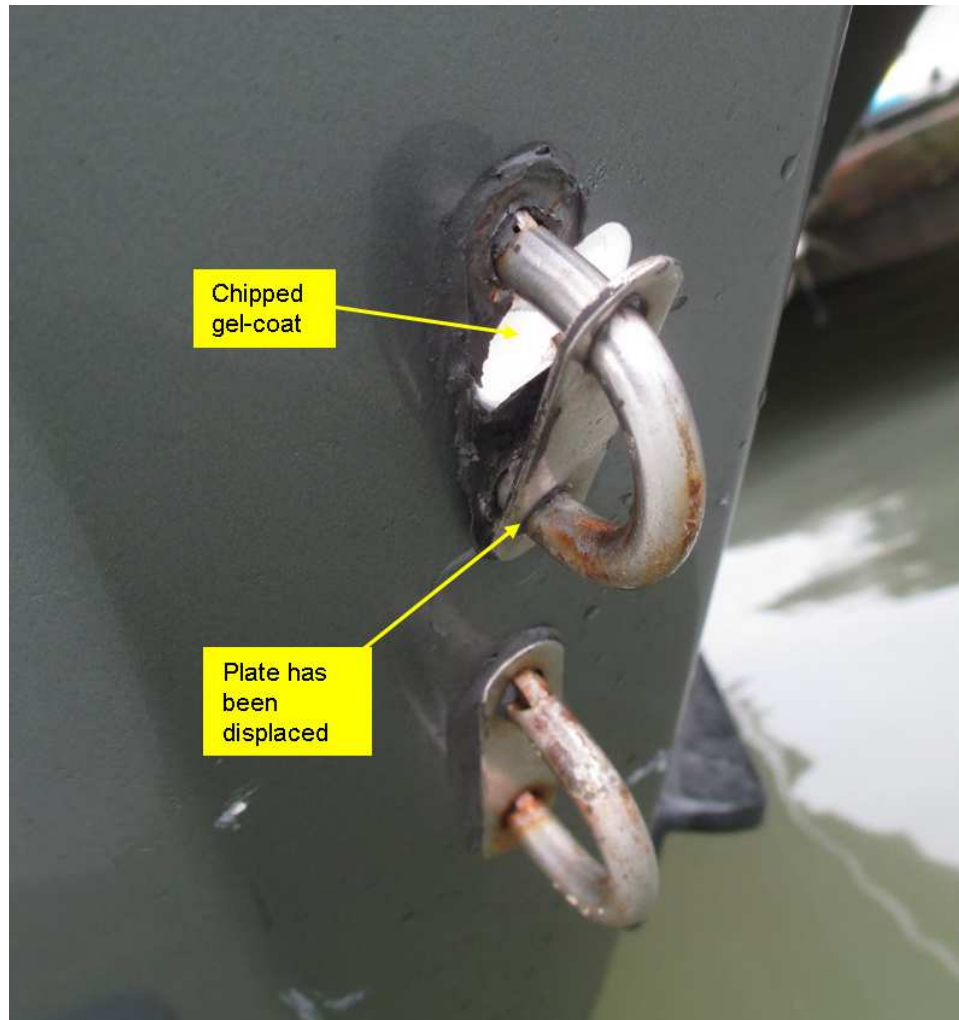
- 2.4 There were sixteen **type A2 recommendations** that must be implemented before the vessel is taken cruising:
- 2.4.1 There was a chip in the gel-coat on the stem of the vessel, as shown in Figure 1. It is likely that this was caused by the upper U-bolt on the stem being struck in the fore-aft direction. The stainless steel plate that normally bridges the two sides of the U-bolt has also been displaced. This probably occurred when the U-bolt was struck. The U-bolt was inspected from inside the vessel and it was noted that the fastenings and backing pad were in good order. It is likely that any watertight seal around the U-bolt has been broken. It is **RECOMMENDED** (type A2) that the U-bolt is replaced with a new item and the gel-coat is repaired. During installation, a semi-hardening sealing compound should be used prevent water ingress (see paragraph 5.1.2.3).

- 5.1.2.3 There was a chip in the gel-coat on the stem of the vessel, as shown in Figure 1. It is likely that this was caused by the upper U-bolt on the stem being struck in the fore-aft direction. The stainless steel plate that normally bridges the two sides of the U-bolt has also been displaced. This probably occurred when the U-bolt was struck. The U-bolt was inspected from inside the vessel and it was noted that the fastenings and backing pad were in good order. It is likely that any watertight seal around the U-bolt has been broken. It is **RECOMMENDED** (type A2) that the U-bolt is replaced with a new item and the gel-coat is repaired. During installation, a semi-hardening sealing compound should be used prevent water ingress.

Figure 1: Damage to upper U-bolt on stem

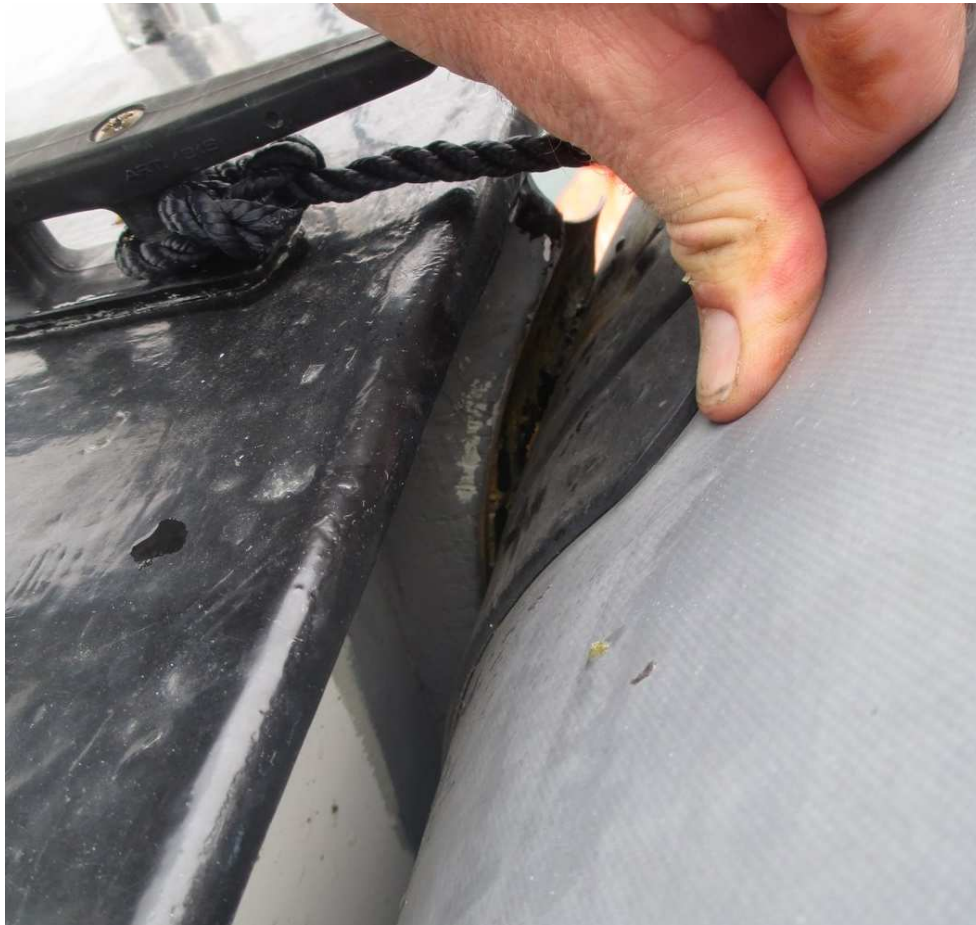
5.2.3 Where access allowed, the sponsons were inspected and found to be in serviceable condition, with no evidence of significant UV degradation. No repair patches were found. There were minor scuff and scratch marks in some areas. The outboard surfaces of the sponsons were dirty and in need of a clean. The only evidence of debonding of the sponson material was on the port & starboard joins to the transom. Figure 2 shows the debonding of the join between the port sponson and the transom.

**Figure 2: debonding of port sponson to transom join.**

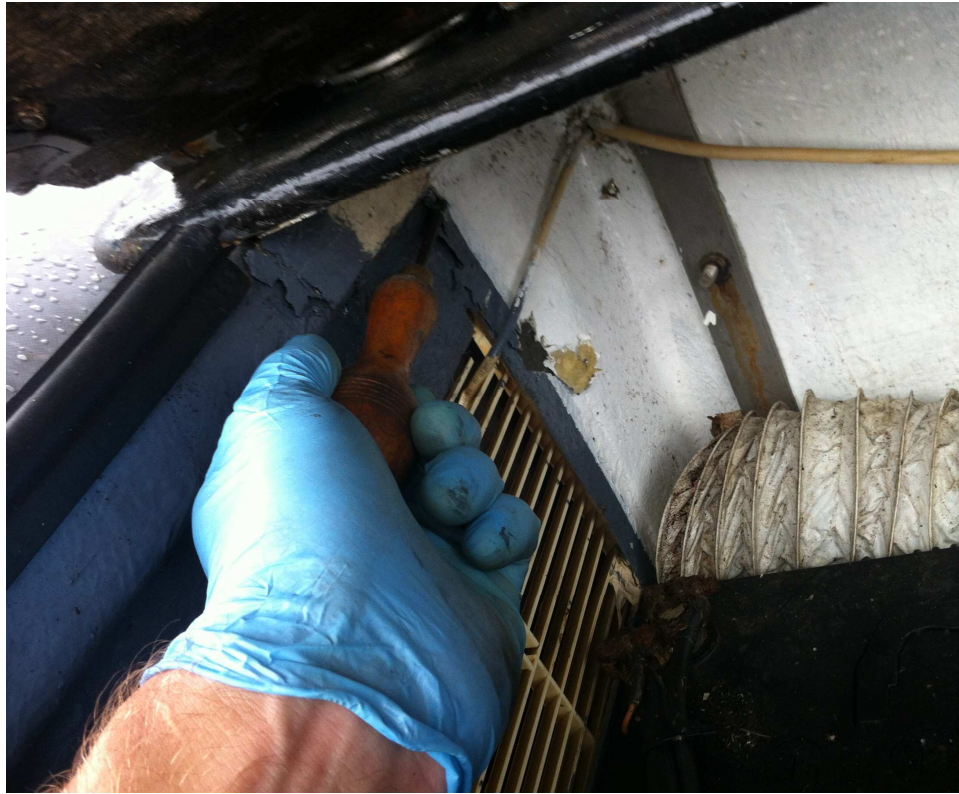
the transom by GRP tabbing, which was showing evidence of debonding on both port and starboard sides. Figure 4 shows the debonding on the starboard side. These should be repaired using a suitable adhesive, followed by the addition of a number of through bolts to prevent the damage from recurring.

**Figure 4: Debonding of engine compartment to transom join**

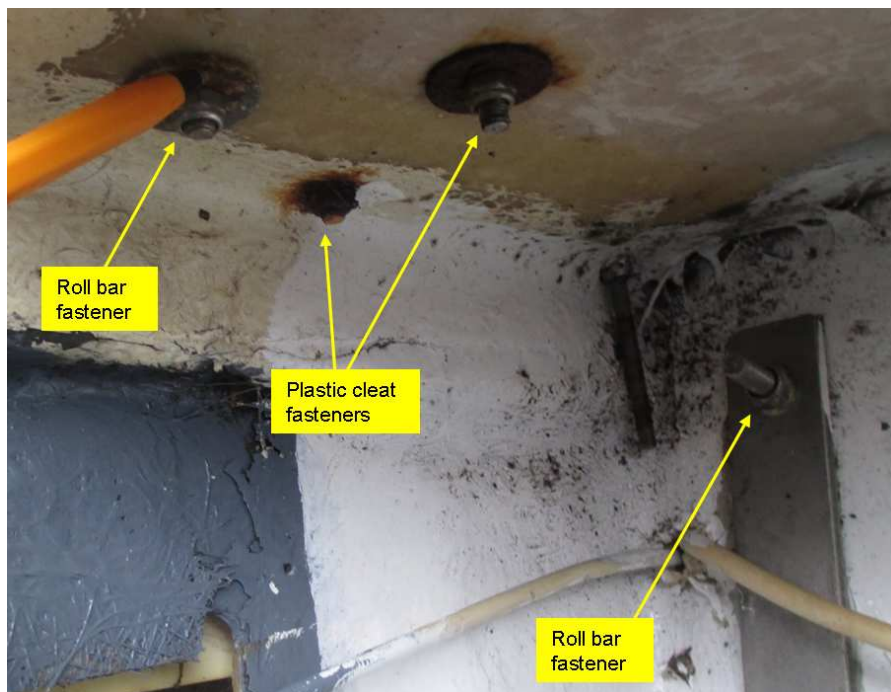
- 2.5 In addition to the one type A1 recommendations and sixteen type A2 recommendations, there were two **type C recommendations**:
- 2.5.1 There were two plastic mooring cleats, one on each corner of the aft deck. It was found that the fasteners that secure the plastic cleats to the horizontal surface of the aft deck were heavily corroded, as shown in Figure 5. It is **RECOMMENDED** (type C recommendation with an implementation time of six months) that the corroded fasteners are replaced, using large penny washers and ideally with a large plywood backing pad for additional support (see paragraph 5.4.8.2).

- 5.4.8.1 There were three aluminium mooring cleats: One on the foredeck and one on each of the port & starboard sides of the roll bar. All were inspected and found to be adequately secured to the adjacent structure.
- 5.4.8.2 There were two plastic mooring cleats, one on each corner of the aft deck. It was found that the fasteners that secure the plastic cleats to the horizontal surface of the aft deck were heavily corroded, as shown in Figure 5. It is **RECOMMENDED** (type C recommendation with an implementation time of six months) that the corroded fasteners are replaced, using large penny washers and ideally with a large plywood backing pad for additional support.

Figure 5: Corroded fasteners on plastic cleat mountings

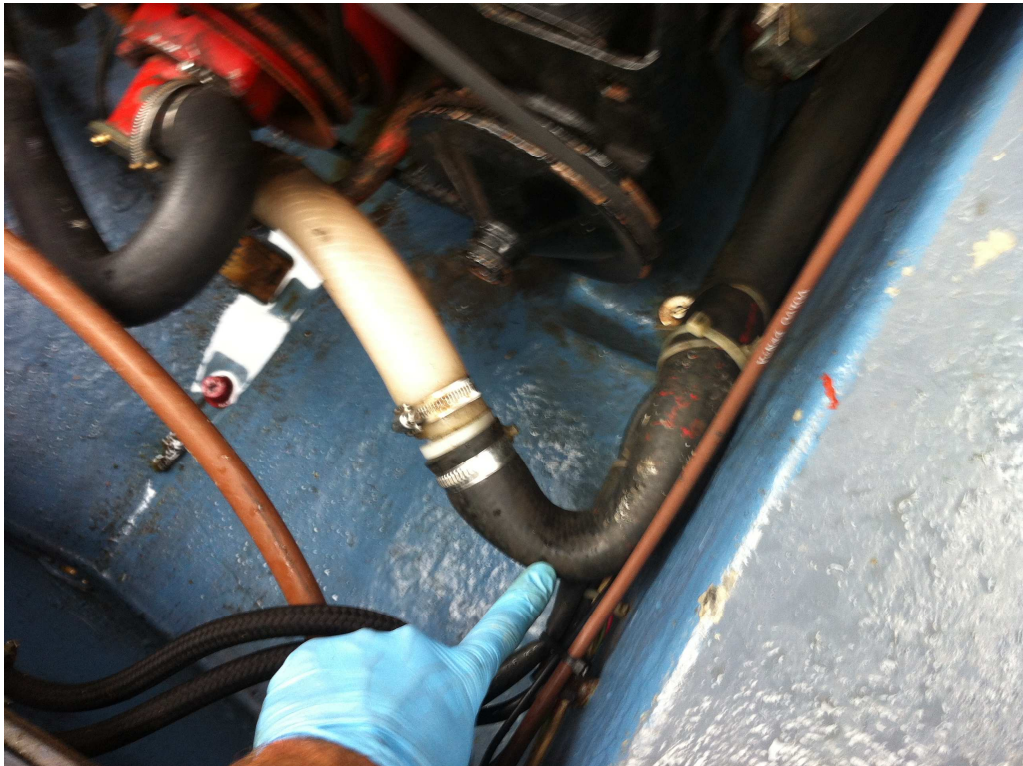
- 2.4.4 One of the coolant hoses was found to be heavily kinked and was restricting the flow of water to the engine. Figure 6 shows the hose. It is **RECOMMENDED** (type A2 recommendation) that this hose is replaced with a custom moulded hose that provides the correct shape and curvature, or a longer length that would be less liable to kink (see paragraph 5.5.1.14).

- 5.5.1.14 One of the coolant hoses was found to be heavily kinked and was restricting the flow of water to the engine. Figure 6 shows the hose. It is **RECOMMENDED** (type A2 recommendation) that this hose is replaced with a custom moulded hose that provides the correct shape and curvature, or a longer length that would be less liable to kink.

**Figure 6: Restriction in engine cooling hose**
