## JUNO

### Pre- purchase Survey

Completed for  
Client Name,  
House Name,  
Town,  
Country

On 15/09/2014

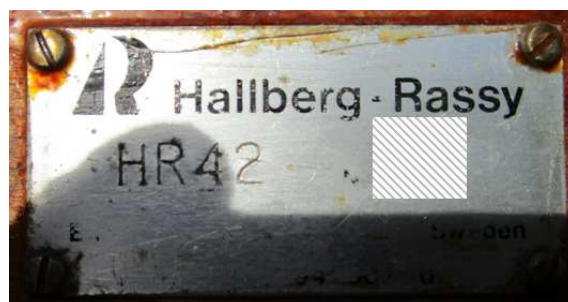
The hull number plate was secured to the coaming of the companionway hatch. The number was 37, as shown in Figure 1.

Figure 1: Craft Identification Number of JUNO

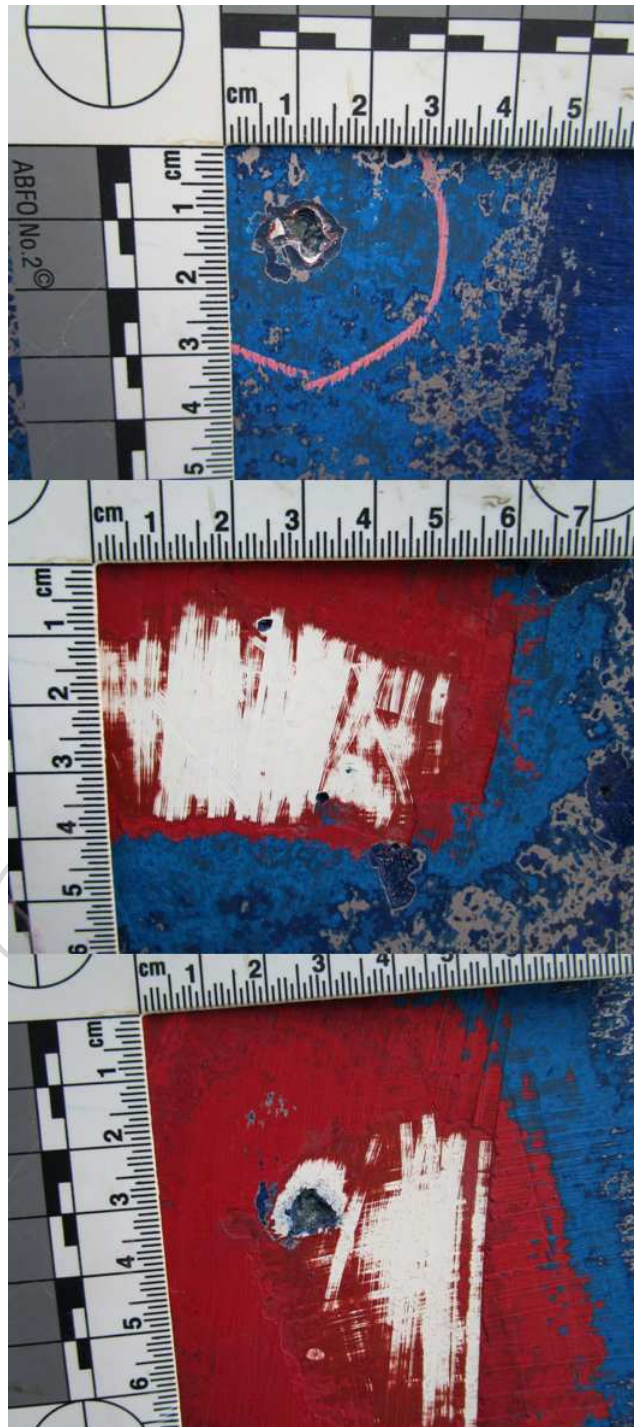
than approximately 1 mm into the laminate. These broken blisters were found all over the hull and keel, with an estimated concentration of 20 to 30 blisters per 300x300 mm, although there were some areas where there were lower concentrations of exposed cavities than this.

**Figure 2: Examples of broken blisters in hull gel-coat**

- 5.1.4.4 As there was no evidence of existing blistering and all of the old cavities had been overpainted by previous coats of antifouling, it is likely that the blistering process in the hull is no longer in progress. In view of this and also the observation that most of the cavities were shallow, it is considered un-necessary to fully strip the gel-coat in order to repair the cavities. It is **RECOMMENDED** (type C recommendation with an implementation time of one year) that all of the antifouling is stripped from the hull & keel. All exposed cavities should be thoroughly cleaned and antifouling debris removed. The hull should then be cleaned by water pressure washing. When fully dry, the cavities should be filled with a suitable filler compound.

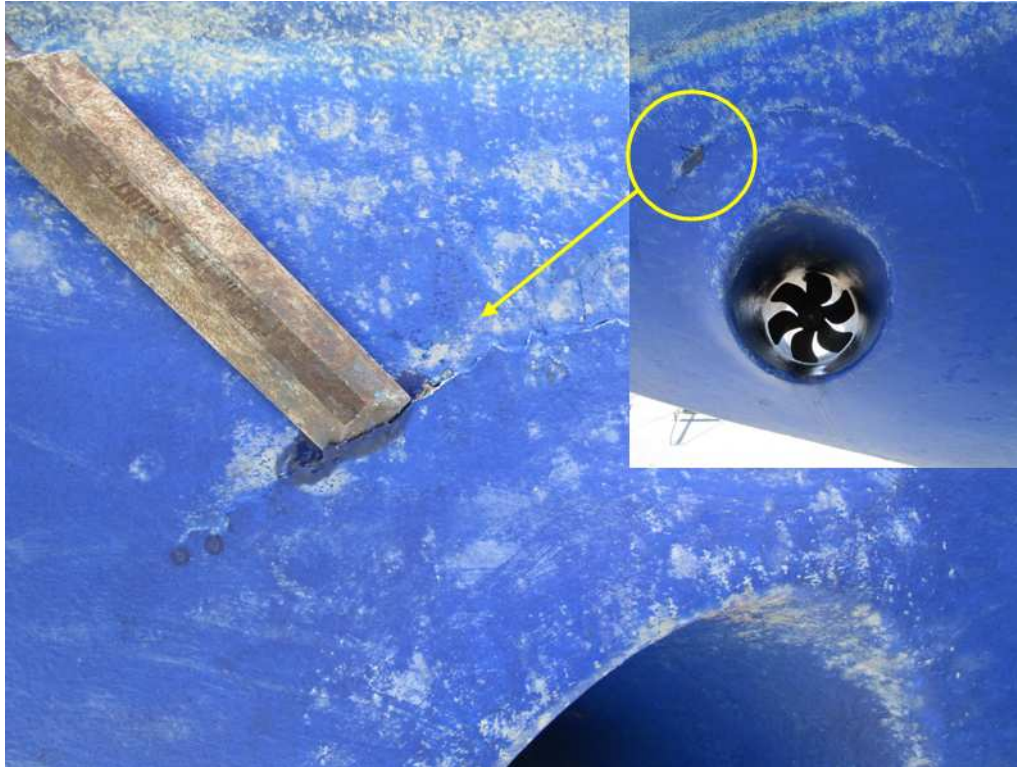
- 5.1.4.5 No evidence of scratching or chipping of the hull was found.
- 5.1.4.6 The installation of the bow thruster tube was inspected and it was found that the filling compound that was used to fair the tube into the hull had not been adequately finished off. Figure 3 shows that the filler compound on the port side has not been fully faired into the hull profile. It is **RECOMMENDED** (type D recommendation) that the loose filler is cut out. New filler (and laminate if required) should be applied, ensuring that the substrate is clean, dry and adequately prepared so that the material bond is as strong as possible.

**Figure 3: Poor finish of fairing around bow thruster**

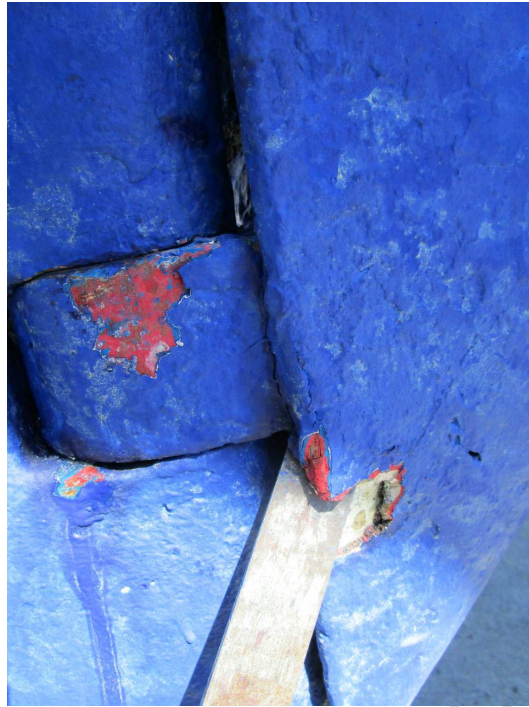
- 5.1.8.1 JUNO had an un-balanced skeg-mounted rudder constructed from a bronze stock encapsulated in a GRP or timber blade. It was inspected visually and by hammer testing and found to be in serviceable condition, but with evidence of a previous repair: The forward edge of the blade and the adjacent area of the skeg on the starboard side had been repaired or stiffened by a number of layers of GRP and filler material. Figure 4 shows the cracked filler material next to the lower bearing. The filler material was cracked and falling away in the area next to the lower rudder bearing. It is **RECOMMENDED** (type C recommendation with an implementation time of six months or before an ocean voyage) that the antifouling and loose filler material is removed from the rudder blade & skeg and the repaired area carefully inspected. The blade and skeg should then be suitably repaired.

**Figure 4: Loose filler next to lower bearing of rudder**

- 2.5.3 JUBA III had an un-balanced skeg-mounted rudder constructed from a bronze stock encapsulated in a GRP or timber blade. It was inspected visually and by hammer testing and found to be in serviceable condition, but with evidence of a previous repair: The forward edge of the blade and the adjacent area of the skeg on the starboard side had been repaired or stiffened by a number of layers of GRP and filler material. The cracked filler material next to the lower bearing can be seen in Figure 4. The filler material was cracked and falling away in the area next to the lower rudder bearing. It is **RECOMMENDED** (type C recommendation with an implementation time of six months or before an ocean voyage) that the antifouling and loose filler material is removed from the rudder blade & skeg and the repaired area carefully inspected. The blade and skeg should then be suitably repaired (see paragraph 5.1.8.1).

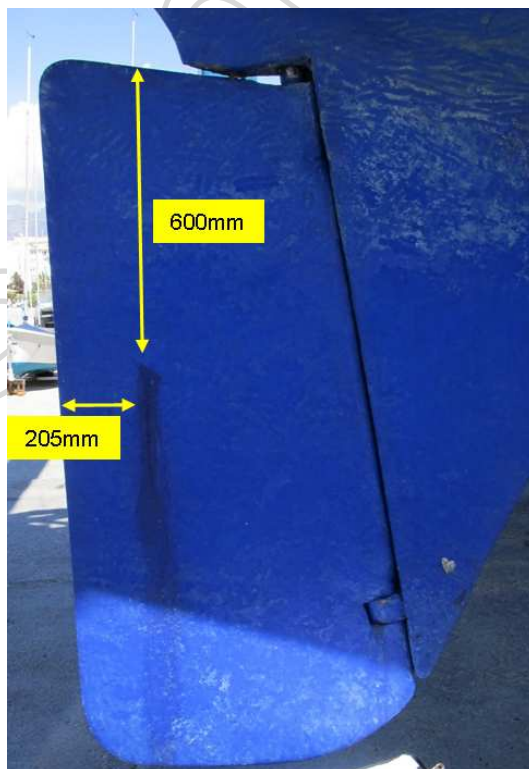
It was also noted that there was one small area of weeping on the starboard side of the blade, as shown in Figure 5. This area was inspected closely and it was found that the moisture was leaking out from beneath a piece of copper plate. The size of the piece of copper was not determined as this would have inflicted further damage to the blade. It is **RECOMMENDED** (type C recommendation with an implementation time of six months or before an ocean voyage) that the cause of the weeping is investigated further.

**Figure 5: Area of weeping of rudder blade, starboard side**

- 2.5.4 It was noted that there was one small area of weeping on the starboard side of the blade, as shown in Figure 5. This area was inspected closely and it was found that the moisture was leaking out from beneath a piece of copper plate. The size of the piece of copper was not determined as this would have inflicted further damage to the blade. It is **RECOMMENDED** (type C recommendation with an implementation time of six months or before an ocean voyage) that the cause of the weeping is investigated further (see paragraph 5.1.8.2).

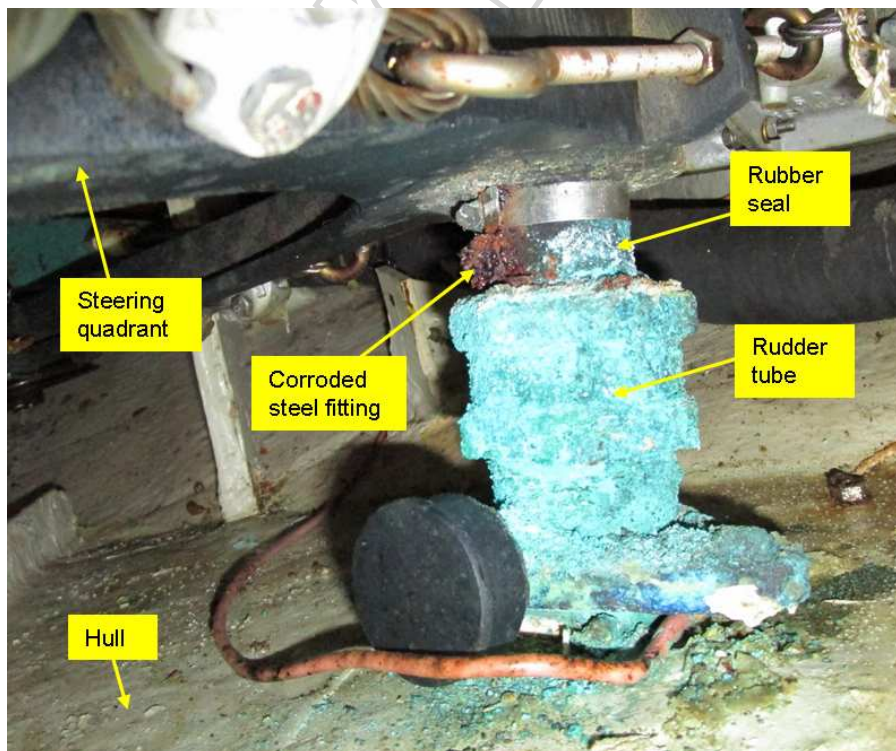
- 5.1.8.9 The part of the rudder tube that was positioned below the steering quadrant was inspected. The rudder tube & upper bearing housing was found to be covered in verdigris (copper chloride), which is normal for bronze when exposed to air or sea water. Above the bronze rudder tube & upper bearing a rubber or neoprene seal was installed to prevent sea water entering through the bearing. Adjacent to this rubber seal was a mild steel fitting or fastener. This steel item was corroding, as shown in Figure 6. It is **RECOMMENDED** (type C recommendation with an implementation time of one year) that the rudder tube and corroded steel fitting are cleaned with a wire brush (bronze wire, not steel). The steel fitting should be replaced by a stainless steel equivalent.

**Figure 6: Corroded steel fitting on upper bearing**

- 2.5.5 The part of the rudder tube that was positioned below the steering quadrant was inspected. The rudder tube & upper bearing housing was found to be covered in verdigris (copper chloride), which is normal for bronze when exposed to air or sea water. Above the bronze rudder tube & upper bearing a rubber or neoprene seal was installed to prevent sea water entering through the bearing. Adjacent to this rubber seal was a mild steel fitting or fastener. This steel item was corroding, as shown in Figure 6. It is **RECOMMENDED** (type C recommendation with an implementation time of one year) that the rudder tube and corroded steel fitting are cleaned with a wire brush (bronze wire, not steel). The steel fitting should be replaced by a stainless steel equivalent (see paragraph 5.1.8.9).

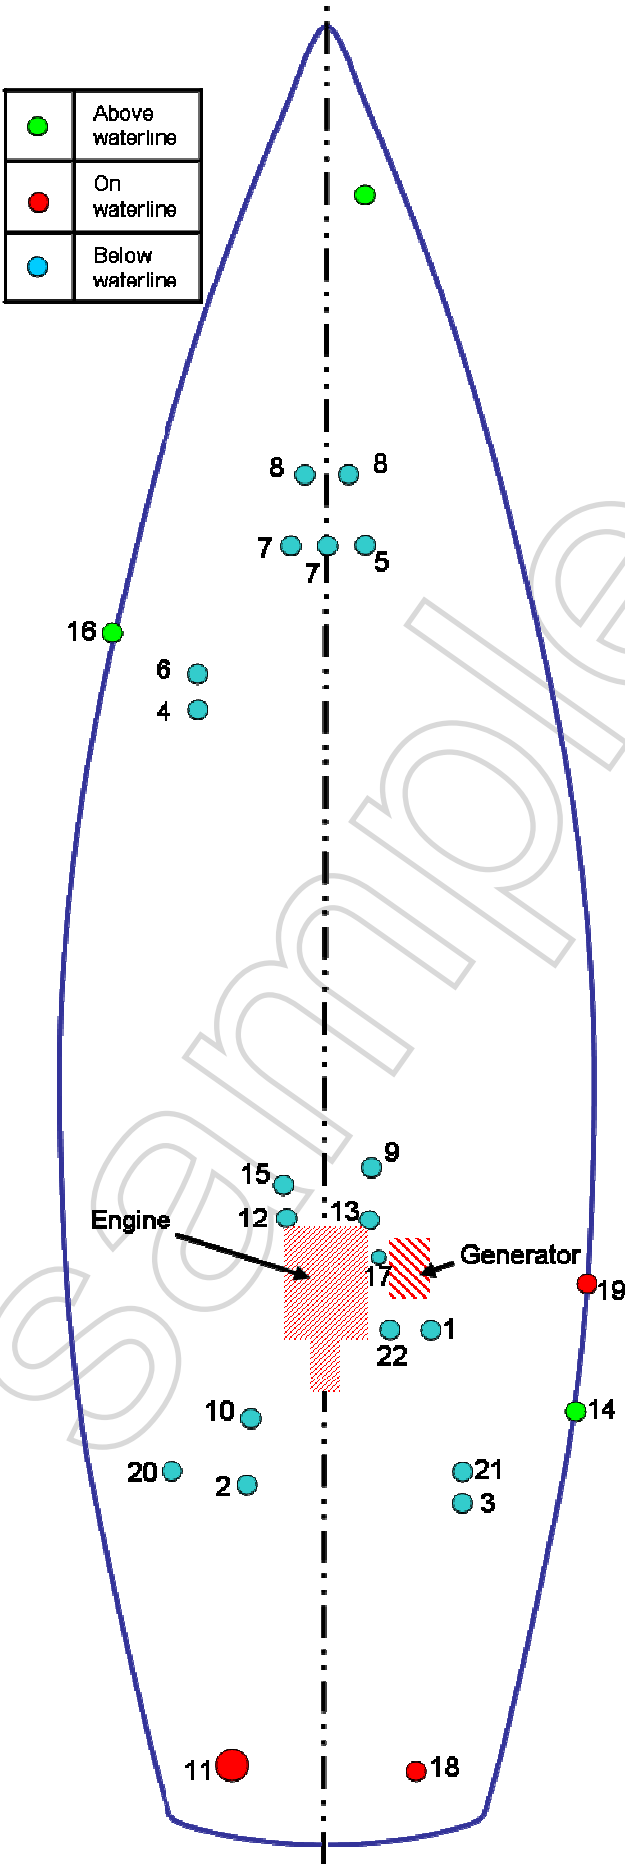
- 5.1.9.3 Figure 7 and Table 3 below show the location and function of the skin fittings, together with the condition of the valves, hoses and clips. The items in red text in Table 3 indicate a defect or poor condition of the items and are addressed in the recommendations below.

Figure 7: Location of skin fittings (plan view looking from above)

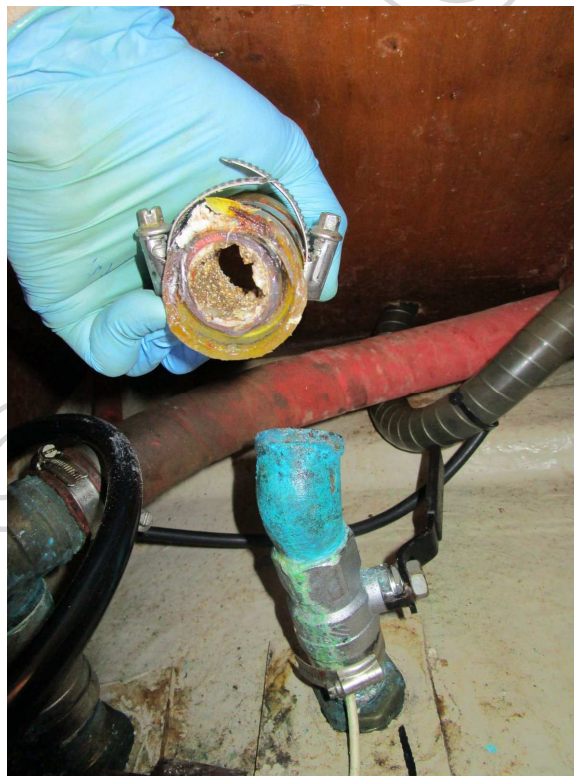
- 5.1.9.11 The valve and spigot of the forward heads sink outlet was found to be heavily corroded. These were tested with light blows from a hammer and the spigot broke where it enters the drain hose. It is **RECOMMENDED** (type A2 recommendation) that the valve & spigot are replaced.

**Figure 8: Fractured spigot of forward heads sink outlet**

- 2.4.6 The valve and spigot of the forward heads sink outlet was found to be heavily corroded. These were tested with light blows from a hammer and the spigot broke where it enters the drain hose. It is **RECOMMENDED** (type A2 recommendation) that the valve & spigot are replaced (see paragraph 5.1.9.11).

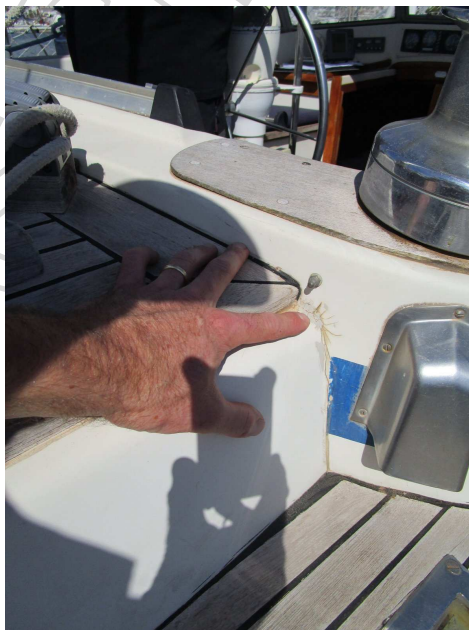
- 5.3.2.3 Stress cracks were found in the deck moulding, where the cockpit coaming sides meet the side of the aft cabin coachroof. This was found to occur on both port and starboard sides of the moulding. Figure 9 shows the cracks on the starboard side of the moulding. There was evidence that the gel-coat around the cracks had been repaired in the past. In order to prevent these cracks from re-occurring, it would be necessary to stiffen the corner by adding additional layers of laminate on the inner surface of the deck moulding.

**Figure 9: Stress cracks in deck moulding**

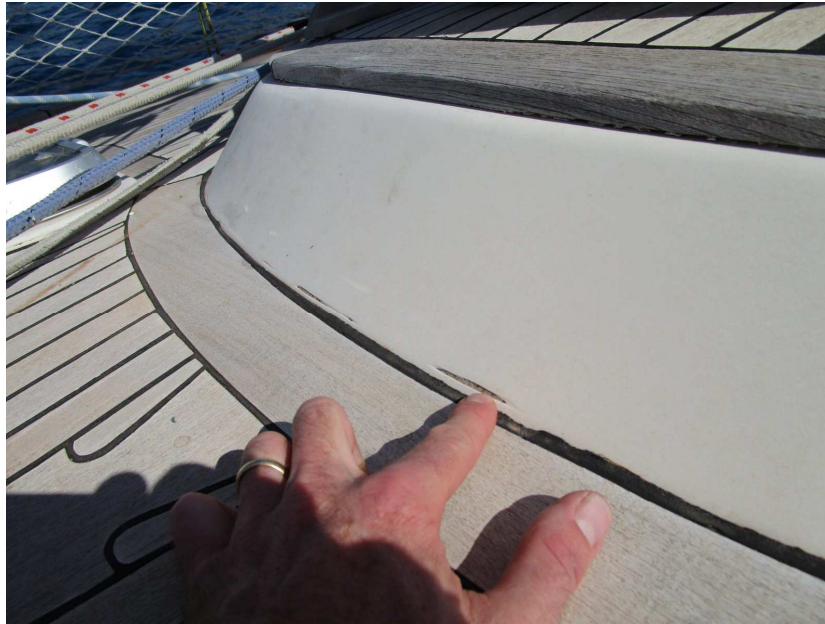
- 5.3.2.4 Where the sides of the deck meet the enclosure for the sliding hatch cover, there was evidence of damage to the gel-coat of the moulding. An example is shown in Figure 10. This damage has occurred during a sanding operation of the teak deck surfaces. It is **RECOMMENDED** (type D recommendation) that these areas of damage are filled with gel-coat.

**Figure 10: Abrasion damage to gel-coat**

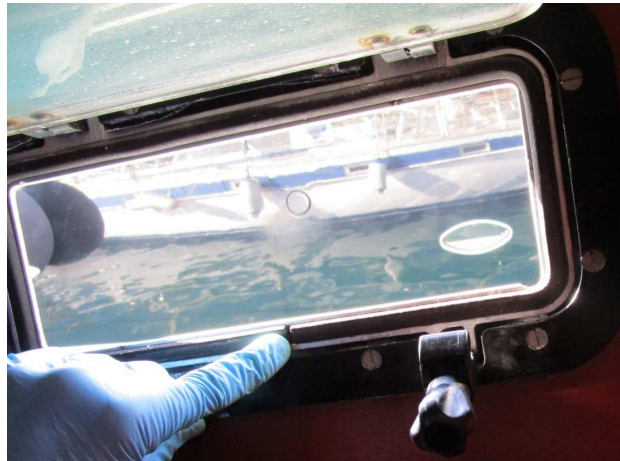
5.3.6.6 A total of ten inward opening, rectangular ports were installed in the hull topsides of JUNO. They were in serviceable condition, but the rubber seals had shrunk. In a number of the ports, the rubber seal had shrunk, revealing a gap between the join of the two ends of the rubber, as shown in Figure 11. Any seals that have shrunk should be replaced.

**Figure 11: Gap in seal of opening port, forward heads compartment**

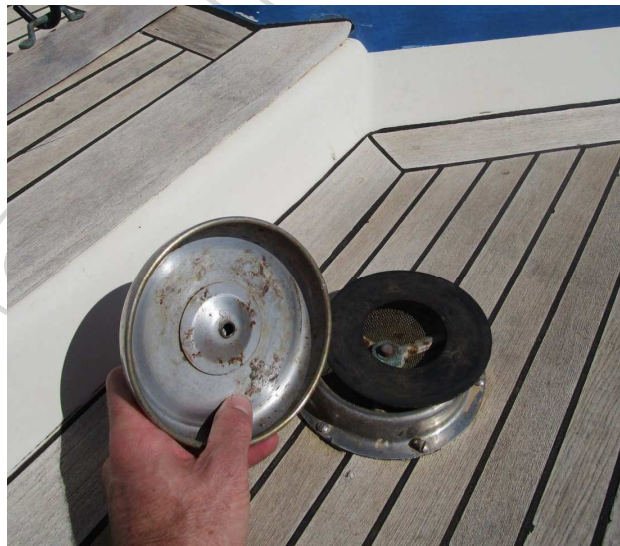
5.3.6.7 A number of closable stainless steel vents were installed on the deck: The cover of the anchor locker, the cover of the locker located on the aft deck, the forward heads and two above the saloon. The vent located on the port side of the saloon was broken, with the external cap loose on the threaded bar (Figure 12). This vent was also found to be allowing moisture to gather on the saloon seating cushions, situated directly below the vent.

**Figure 12: Broken vent, port side of saloon**

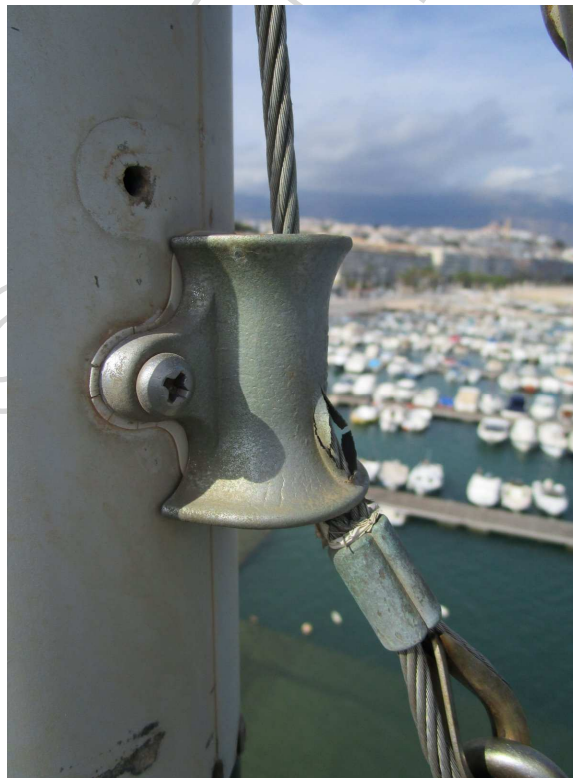
- 5.4.1.7 The sheave at the top of the mast that guides the jib halyard was found to be heavily worn (see Figure 13). It is **RECOMMENDED** (type C recommendation with an implementation time of six months or before an ocean voyage) that the sheave is replaced.

**Figure 13: Worn-out sheave at mast head**

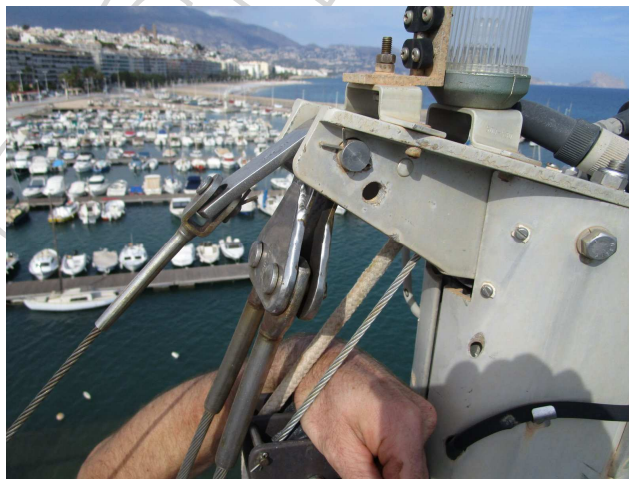
- 5.4.6.5 Figure 14 shows that the line of action of the triatic stay is not in-line with the axis of its tang at the mast head. It is **RECOMMENDED** (type C recommendation with an implementation time of six months or before an ocean voyage) that the mast head fitting is adjusted so that the wire and fitting are in-line.

Figure 14: End fitting of triatic stay on main mast

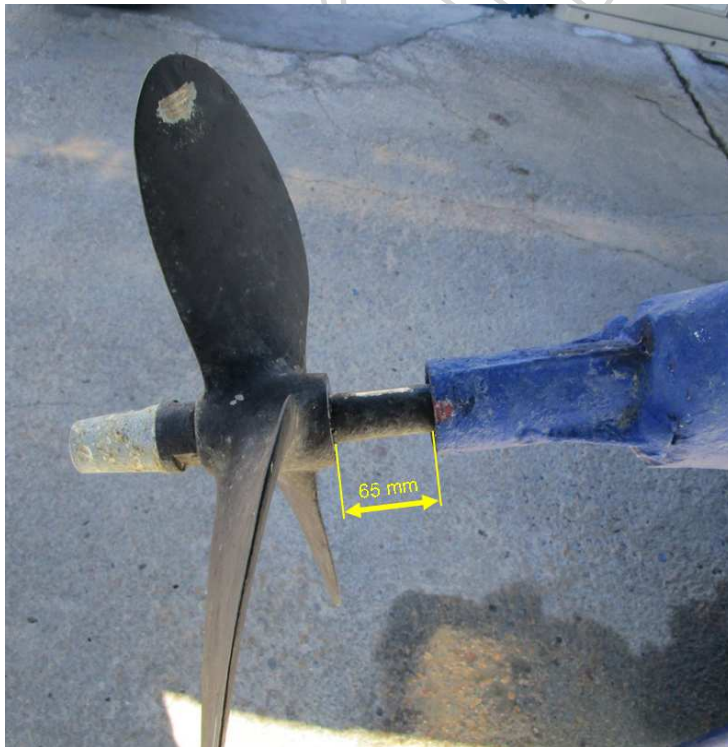
- 5.5.7.4 The length of propeller shaft between the cutlass bearing and the propeller was measured and found to be 65 mm, which is more than twice the diameter of the shaft, as shown in Figure 15. Industry guidelines recommend that the length of shaft between the cutlass bearing and propeller should be equal to one diameter, but this can increase to 1.5 to 2 if a rope cutter is installed. Excessive overhang can lead to shaft vibration. Consideration should be given to reducing the level of overhang at the end of the shaft.

**Figure 15: Excessive overhang in propeller shaft**

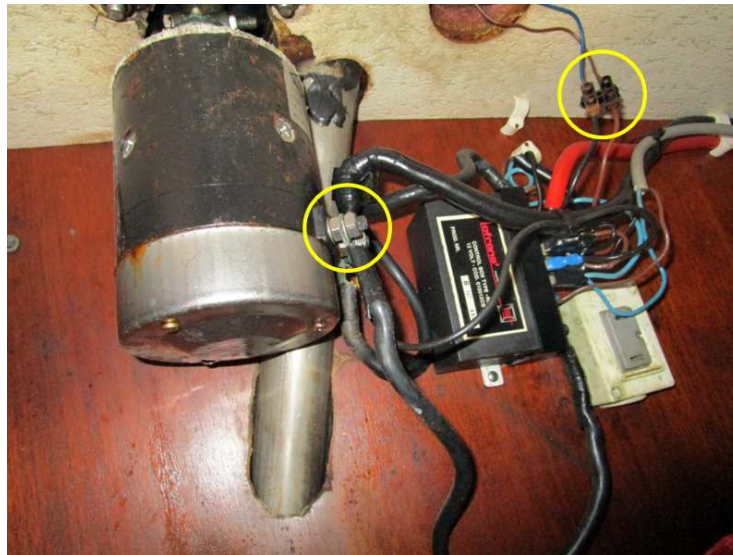
- 5.6.2.3 The electric operation of the windlass was tested from the helm and found to function correctly.
- 5.6.2.4 The external surfaces of the electric motor, mounted under the deck and located inside the forward cupboard of the forepeak, were in satisfactory condition, but the copper terminals of the electrical cables were corroded. These would benefit from being cleaned and protected by a light grease. The blue & brown cables of the 'up' button on the deck were connected to the electrical control box via an electrical connector block. This block was found to be corroding and should be replaced. Figure 16 shows the corroded terminals and connector block.

**Figure 16: Corroded terminals of anchor windlass**

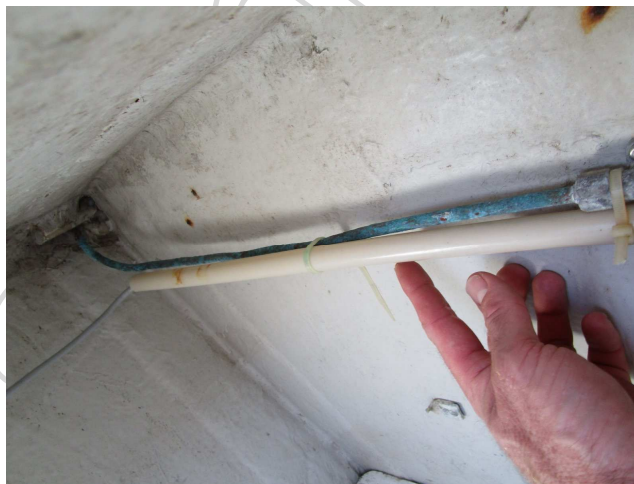
- 5.6.5.4 The copper pipe in the locker was not adequately supported; LPG supply pipe should be supported every 500 mm by plastic P-clips. A length of plastic electrical conduit was attached to the pipe by two cable ties (Figure 17). It is **RECOMMENDED** (type A2 recommendation) that the pipe is given adequate support. The conduit should be detached from the pipe and mounted directly to the locker bulkhead.

**Figure 17: LPG supply pipe in anchor locker**

- 2.4.10 The copper pipe in the locker was not adequately supported; LPG supply pipe should be supported every 500 mm by plastic P-clips. A length of plastic electrical conduit was attached to the pipe by two cable ties (Figure 17). It is **RECOMMENDED** (type A2 recommendation) that the pipe is given adequate support. The conduit should be detached from the pipe and mounted directly to the locker bulkhead (see paragraph 5.6.5.4).
