# CLARA

## Insurance Survey

Completed for  
Anthony Barnes,  
Brown Hill,  
Dorking,  
Surrey,  
GU22 4RF  
On 21/01/2013

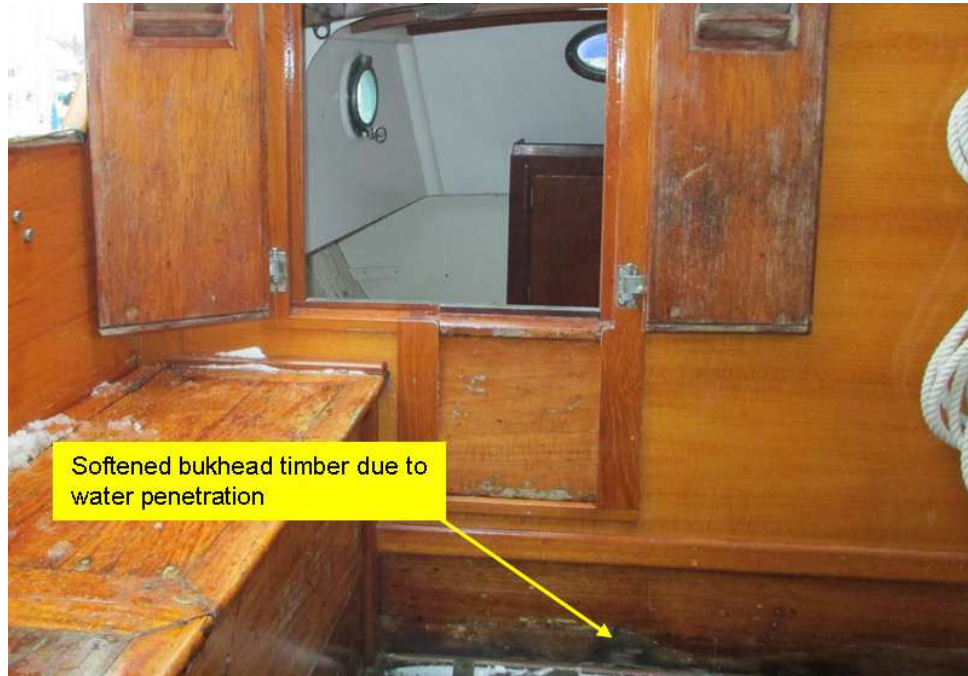
Figure 1: Aft cabin bulkhead

5.2.3.1 The timber bulkheads, including the aft cabin bulkhead, were inspected and found to be generally in satisfactory condition. It was however found that the aft cabin bulkhead timber was softening and discolouring on the exterior surface where it meets the cockpit sole.

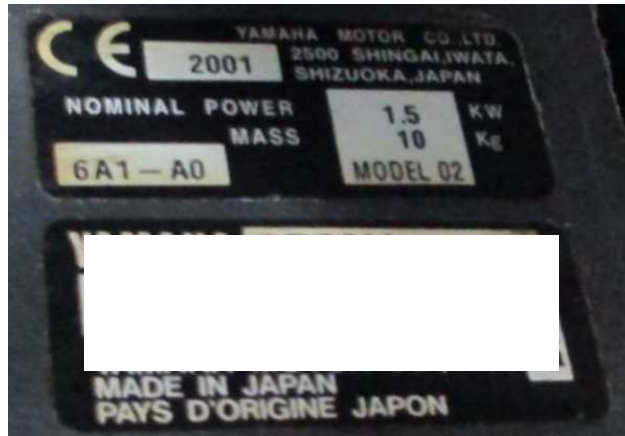
**Figure 2: Outboard motor identification label**

5.3.9.2 A 2-stroke, 2.5HP Yamaha outboard motor was inspected. Year of manufacture labelled as 2001. It was not seen running but was inspected externally and found to be in good condition with only minor evidence of surface corrosion. Figure 2 shows the engine's identification data.

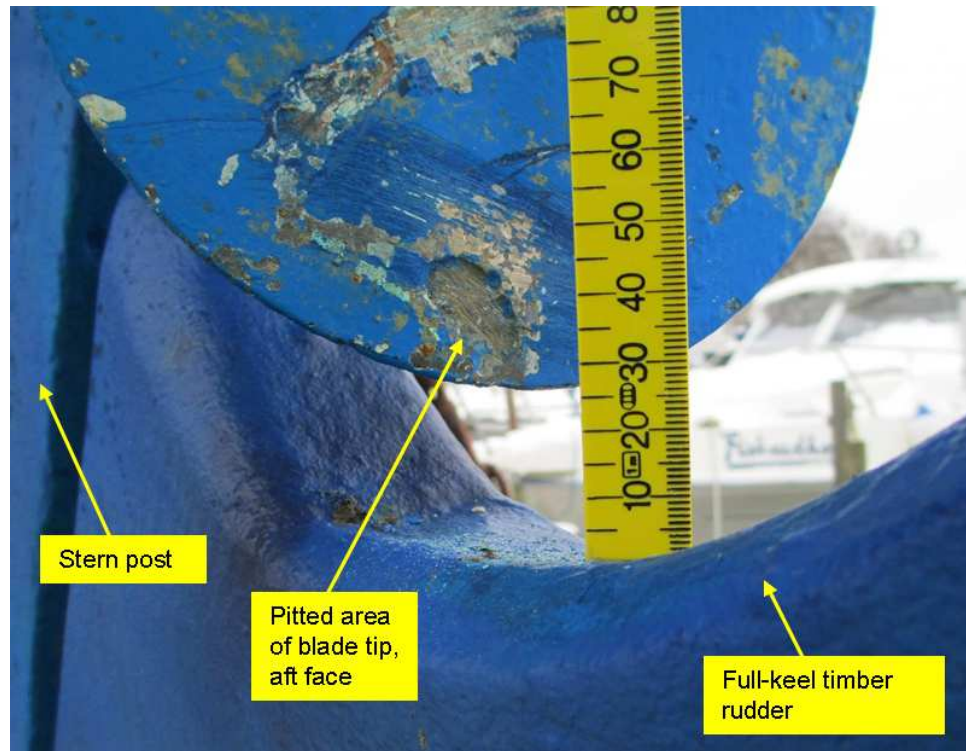
- 5.5.3.1 The 16½" diameter, three-bladed (fixed) bronze propeller was in fair condition, with minor damage to the blade tips. It was noted that two of the blades had an area of corrosion on their aft faces, approximately 10mm in diameter and towards the tip of the blades. Figure 3 shows one such area of pitting.
- 5.5.3.2 As noted in paragraph 5.1.7.1, there was no electrical continuity between the anode and the propeller. It was not established during the survey whether the anode was wired to the engine or gearbox casing, but it is advised that a connection is made between the anode and the propeller shaft in order to minimise any galvanic corrosion that may occur in the propeller.

**Figure 3: Pitting on propeller blade, aft face**
