MELAN

Insurance Survey

Completed for
Client Name,
House,
Tottington Manor,
Edburton Road,
Town,
West Sussex,
POSTCODE

On 07/11/2014

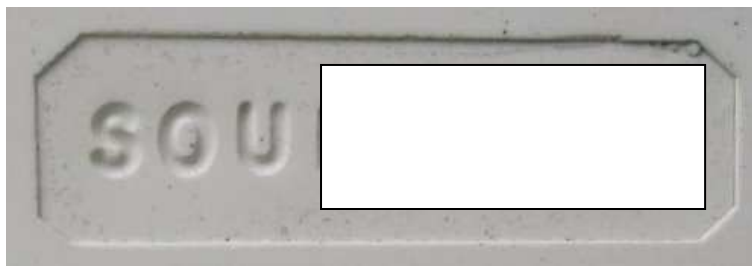
Figure 1: Craft Identification Number of MELAN

4.4.1 The CIN was moulded into to the starboard side of the vessel's transom. The number was SOU xxx, as shown in Figure 1.

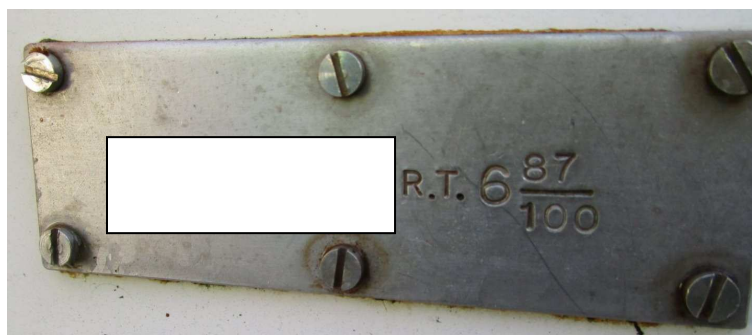
Figure 2: Official Number of MELAN

4.5.1 The Official Number was stamped onto a stainless steel plate, which was secured to the hull moulding at the aft end of the cockpit. The number was xxx, as shown in Figure 2.

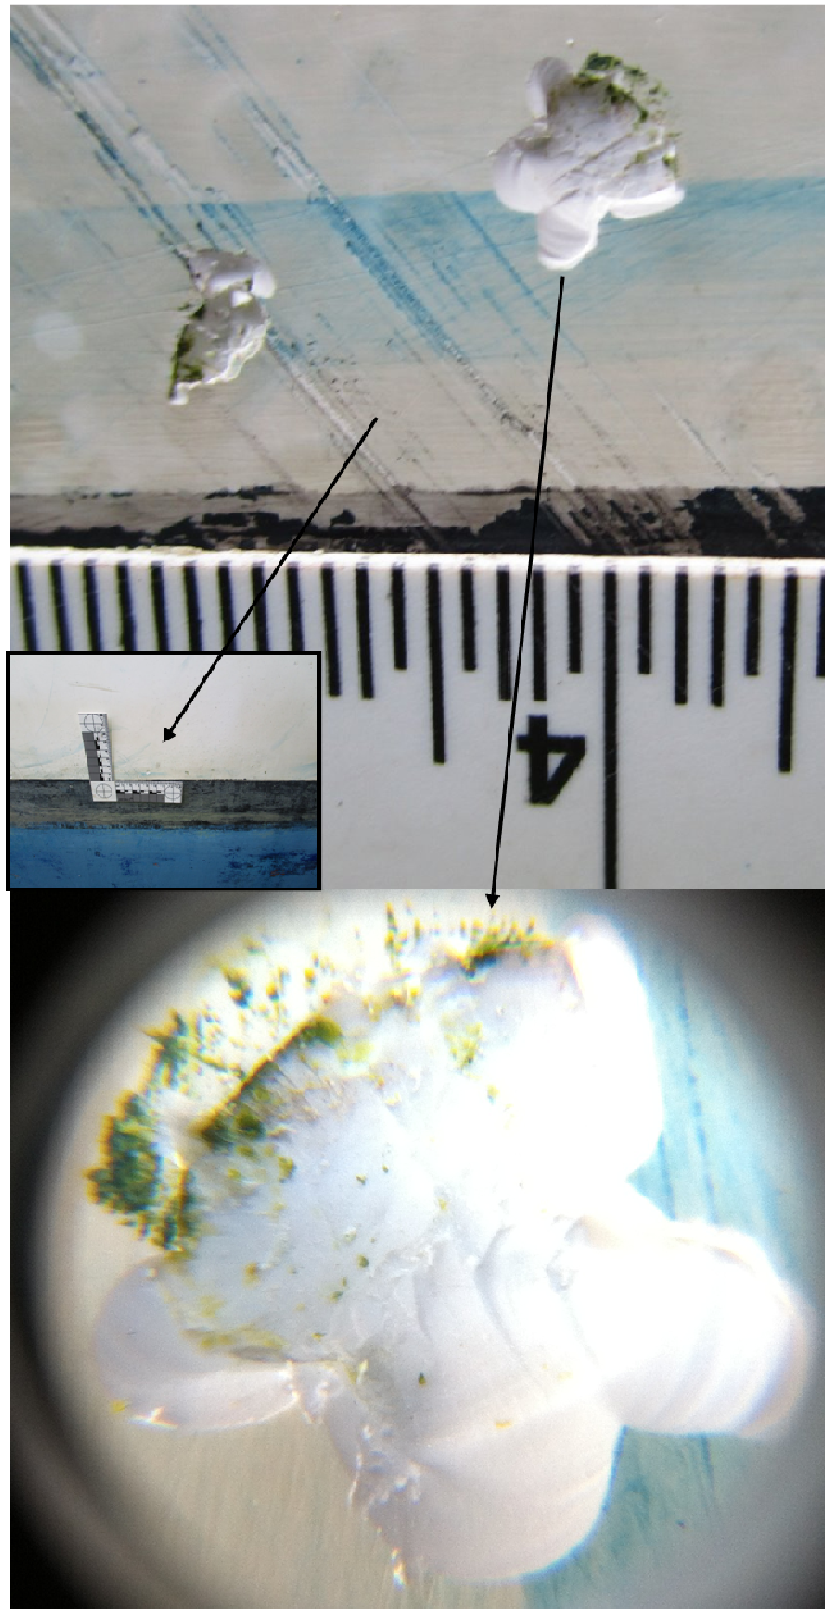
- 2.3.1 There were four **type C recommendations** that do not require immediate attention but are to be dealt with within a specified time period:
- 2.3.2 A number of areas of the gel-coat on the topsides were found to have a large number of small blisters. These blisters were typically about 3 mm in diameter and all were a flattened dome shape. These were generally located close to the waterline but were also found to be located in other areas, particularly below the scuppers of the toe rails. The majority of the blisters located near to the waterline were intact, but a small number were found to be broken, leaving very small 'half-moon' scars on the surface of the gel-coat. A number of the blisters were broken open. Each one contained a very small amount of clear fluid which smelled of vinegar. This evidence suggests that the

blisters have occurred due to hydrolysis within the hull material, commonly termed as 'osmosis'. The material disclosed beneath the surface of the broken blisters was a smooth, white resin surface, with no evidence of glass fibre or fibre pattern. See Figure 3 for an example of two of the blisters. Referring to the publication 'Repairs to Blisters in Glass Fibre Hulls [British Plastics Federation, October 1984], these blisters are of type 3A, which occur in craft with double gel-coats. This condition whilst unsightly is not structurally significant. In the case of broken blisters (including those with 'half-moon' scars), rectification should be undertaken at the earliest opportunity. It is **RECOMMENDED** (type C recommendation with an implementation time of one year) that any blisters that are broken or readily breakable should be thoroughly cleaned out and dried. The shallow cavity should then be filled with epoxy filler (see paragraph 5.1.2.6).

- 5.1.2.6 A number of areas of the gel-coat on the topsides were found to have a large number of small blisters. These blisters were typically about 3 mm in diameter and all were a flattened dome shape. These were generally located close to the waterline but were also found to be located in other areas, particularly below the scuppers of the toe rails. The majority of the blisters located near to the waterline were intact, but a small number were found to be broken, leaving very small 'half-moon' scars on the surface of the gel-coat. A number of the blisters were broken open. Each one contained a very small amount of clear fluid which smelled of vinegar. This evidence suggests that the blisters have occurred due to hydrolysis within the hull material, commonly termed as 'osmosis'. The material disclosed beneath the surface of the broken blisters was a smooth, white resin surface, with no evidence of glass fibre or fibre pattern. See Figure 3 for an example of two of the blisters. Referring to the publication 'Repairs to Blisters in Glass Fibre Hulls [British Plastics Federation, October 1984], these blisters are of type 3A, which occur in craft with double gel-coats. This condition whilst unsightly is not structurally significant. In the case of broken blisters (including those with 'half-moon' scars), rectification should be undertaken at the earliest opportunity. It is **RECOMMENDED** (type C recommendation with an implementation time of one year) that any blisters that are broken or readily breakable should be thoroughly cleaned out and dried. The shallow cavity should then be filled with epoxy filler.

Figure 3: Opened up blisters, located just above the waterline

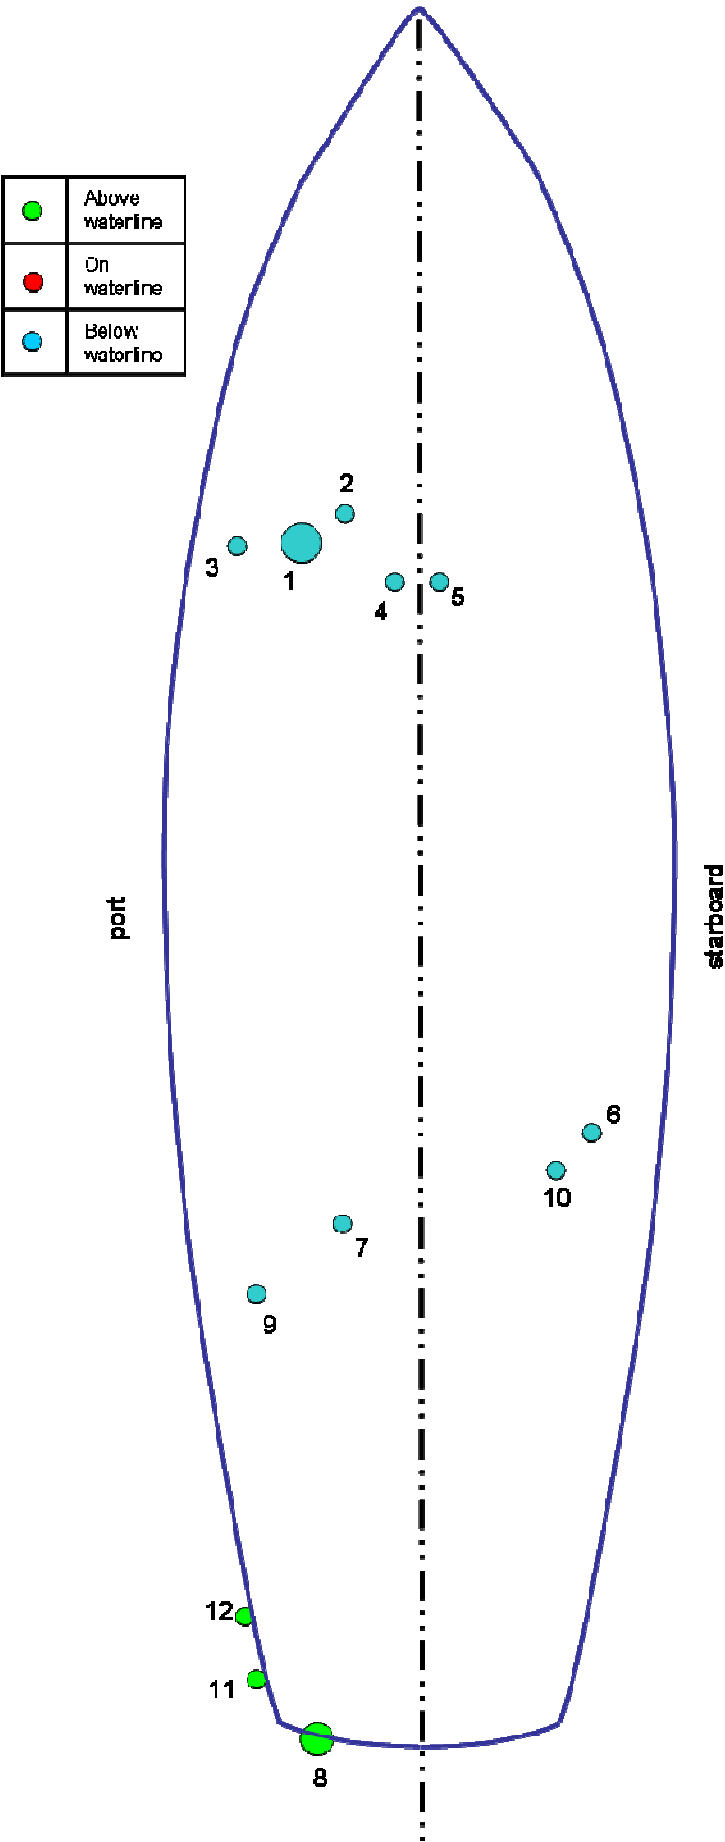
Figure 4: Location of skin fittings (plan view looking from above)

- 5.1.7.3 Figure 4 and Table 3 below show the location and function of the skin fittings, together with the condition of the valves, hoses and clips. The items in **red** text in Table 3 indicate a defect or poor condition of the items and are addressed in the recommendations below.

- 5.1.7.4 There was clear access inside the vessel to all valves.
- 5.1.7.5 Two of the hoses were secured with a single stainless steel screw clip. These hoses included the heads sink outlet and the bilge pump outlet. It is **RECOMMENDED** (type A2 recommendation) that all hoses that have a skin fitting located near to or below the waterline are fitted with two hose clips at each end.

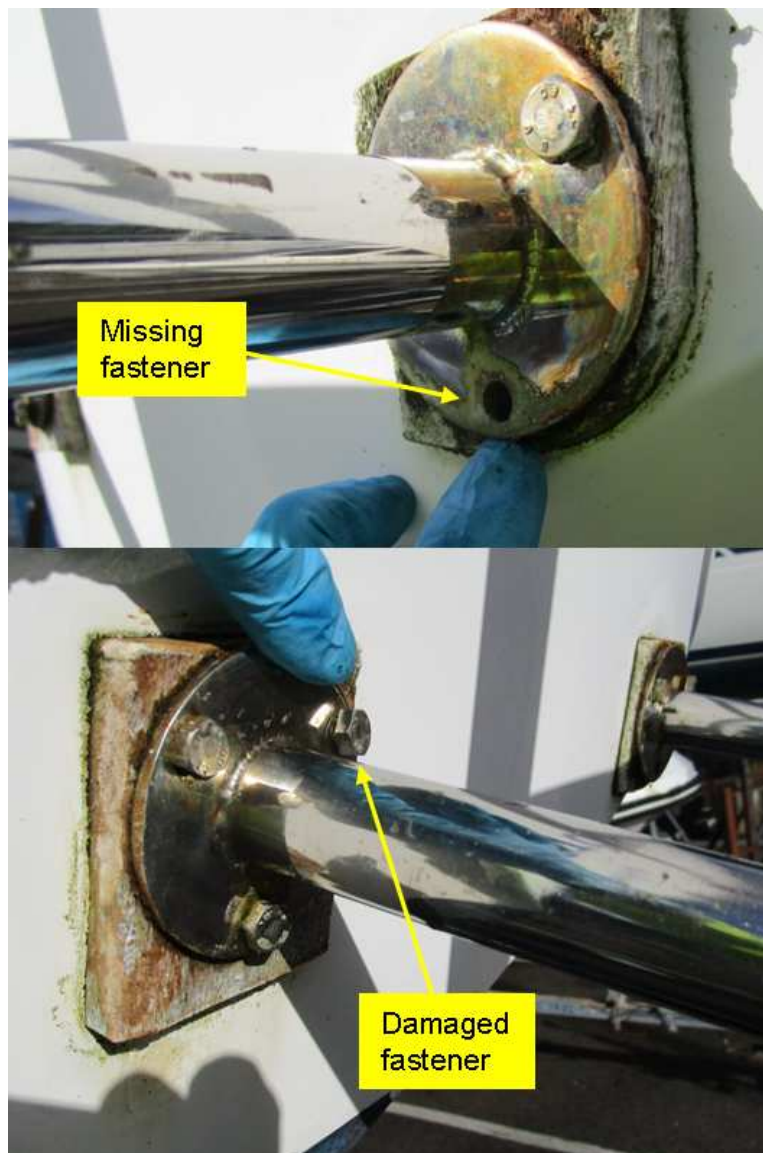
Figure 5: Stern-mounted boarding ladder

- 2.1.2 A four step, hinging, welded stainless steel boarding ladder was secured to the hull moulding on the stern of the vessel. One of the stainless steel fasteners on the lower port mount was distorted. One of the fasteners on the lower starboard mount was missing. It is **RECOMMENDED** (type A1 recommendation) that these two fasteners are replaced with A4-grade stainless steel fasteners. It is likely that the missing fastener had corroded and subsequently sheared off. The other fasteners on the lower mounts of the ladder should therefore be withdrawn and inspected. They should be replaced if they are found to be corroded (see paragraph 5.3.7.1).

- 5.3.7.1 A four step, hinging, welded stainless steel boarding ladder was secured to the hull moulding on the stern of the vessel. This ladder hinged down to and below the waterline in order to assist with man overboard recovery. The ladder was found to be free of cracks or deformation. One of the stainless steel fasteners on the lower port mount was distorted. One of the fasteners on the lower starboard mount was missing. It is **RECOMMENDED** (type A1 recommendation) that these two fasteners are replaced with A4-grade stainless steel fasteners. It is likely that the missing fastener had corroded and subsequently sheared off. The other fasteners on the lower mounts of the ladder should therefore be withdrawn and inspected. They should be replaced if they are found to be corroded.

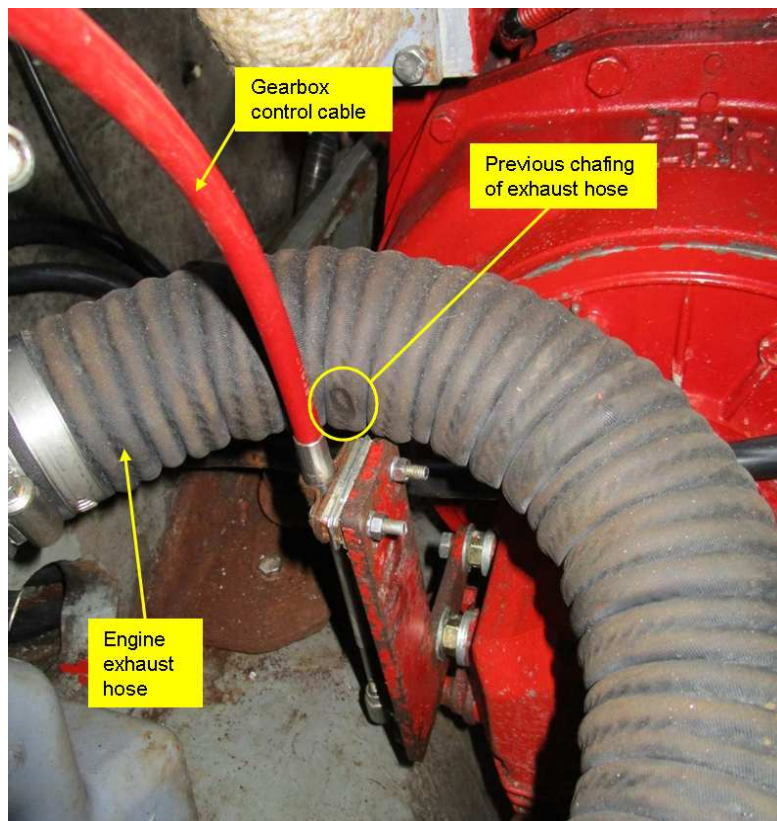
- 2.2.5 There was evidence that the exhaust hose had been very slightly damaged by chafing from the engine gear control cable, as shown in Figure 6. At the time of survey, the hose was still in contact with the gear cable and further wear is likely. It is **RECOMMENDED** (type A2 recommendation) that the exhaust hose is re-routed so that it does not chafe on the cable, or adequately protected by a piece of padding material (see paragraph 5.5.4.14).

- 5.5.4.14 There was evidence that the exhaust hose had been very slightly damaged by chafing from the engine gear control cable, as shown in Figure 6. At the time of survey, the hose was still in contact with the gear cable and further wear is likely. It is **RECOMMENDED** (type A2 recommendation) that the exhaust hose is re-routed so that it does not chafe on the cable, or adequately protected by a piece of padding material.

Figure 6: Chafing of exhaust hose

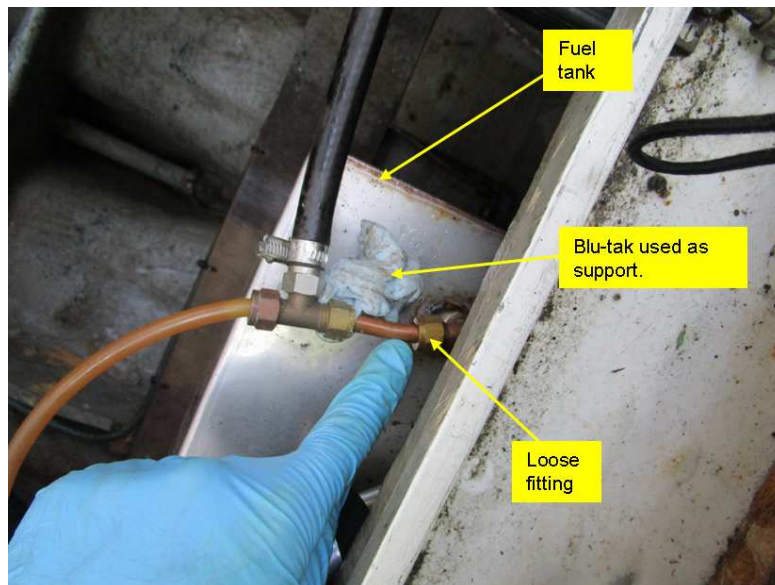
- 2.2.6 The brass fittings of the return feed, located on top of the fuel tank were loose and were supported by a lump of Blu Tack, as shown in Figure 7. It is **RECOMMENDED** (type A2 recommendation) that the pipe fittings are tightened and adequately supported (see paragraph 5.5.5.4).

- 5.5.5.3 The hose that connects the filler cap to the tank was in acceptable condition but was kinked where it was connected to the fuel tank.
- 5.5.5.4 The brass fittings of the return feed, located on top of the fuel tank were loose and were supported by a lump of Blu Tack, as shown in Figure 7. It is **RECOMMENDED** (type A2 recommendation) that the pipe fittings are tightened and adequately supported.

Figure 7: Loose fuel tank pipe fitting

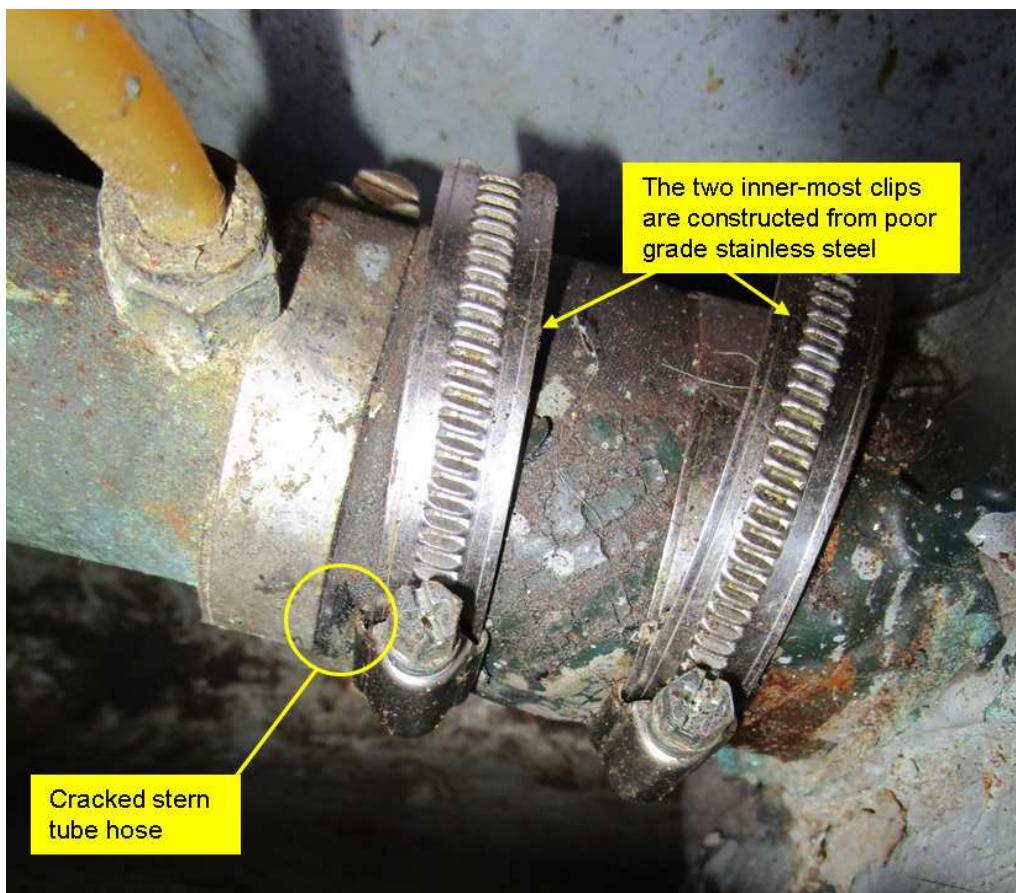
- 2.1.4 The inboard shaft seal was inspected and found to be in poor condition, with cracking of the rubber visible in one area, as shown in Figure 8. It is **RECOMMENDED** (type A1 recommendation) that the rubber hose of the shaft seal is replaced (see paragraph 5.5.6.6).

- 2.1.5 The hose clips that secure the seal were in acceptable condition, but the inner two were found to be constructed from A2-grade stainless steel (Figure 8). It is **RECOMMENDED** (type A1 recommendation) that all of the hose clips are replaced with new A4 grade stainless steel clips when the work described in paragraph 5.5.6.6 is undertaken (see paragraph 5.5.6.7).

- 5.5.6.6 The inboard shaft seal was inspected and found to be in poor condition, with cracking of the rubber visible in one area, as shown in Figure 8. It is **RECOMMENDED** (type A1 recommendation) that the rubber hose of the shaft seal is replaced.

- 5.5.6.7 The hose clips that secure the seal were in acceptable condition, but the inner two were found to be constructed from A2-grade stainless steel (Figure 8). It is **RECOMMENDED** (type A1 recommendation) that all of the hose clips are replaced with new A4 grade stainless steel clips when the work described in paragraph 5.5.6.6 is undertaken.

Figure 8: Damage to shaft seal rubber and poor quality clips
