WHITE EAGLE

Insurance Survey

on Monday 15th January 2018

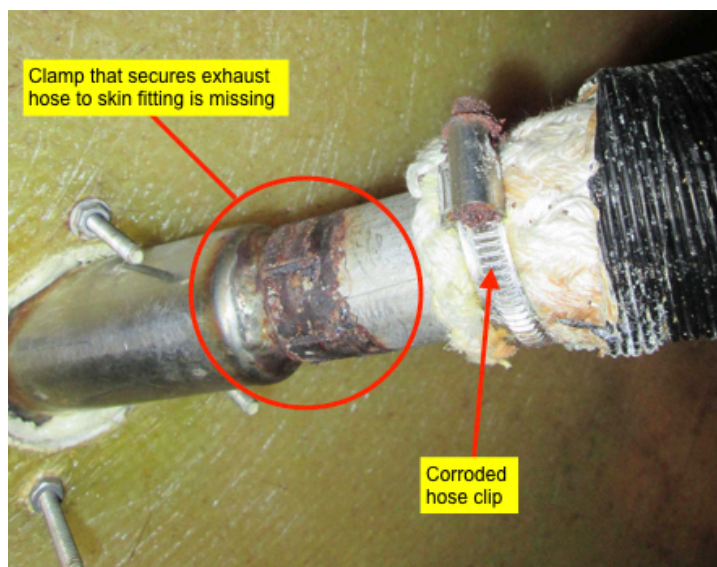
- 5.6.9.1. WHITE EAGLE was fitted with an Eberspächer diesel powered heating system. The unit was installed in the space located at the aft end of the aft cabin. The heater was not powered up during the survey.
- 5.6.9.2. The heater body appeared to be correctly installed. The exhaust ducting was suitably insulated. It was found that the Eberspächer hose clamp that secured the exhaust duct to the skin fitting on the transom was missing. The location of the missing clamp is circled in red in Figure 4. It is **RECOMMENDED** (type C recommendation with an implementation time of one month or before the heater unit is used) that the missing clamp is replaced with an Eberspächer approved exhaust hose clamp. The corroded hose clip shown in Figure 4 should also be replaced.

Figure 4: Corroded clip of space heater exhaust hose

- 2.2.6. The Eberspächer diesel powered heater body appeared to be correctly installed. The exhaust ducting was suitably insulated. It was found that the Eberspächer hose clamp that secured the exhaust duct to the skin fitting on the transom was missing. The location of the missing clamp is circled in red in Figure 4. It is **RECOMMENDED** (type C recommendation with an implementation time of one month or before the heater unit is used) that that the missing clamp is replaced with an Eberspächer approved exhaust hose clamp. The corroded hose clip shown in Figure 4 should also be replaced.
