VOYAGER

Pre-purchase
Survey

Colin Adams,
33 Valley Road,
London,
SW23 4JQ

On 09/12/2015

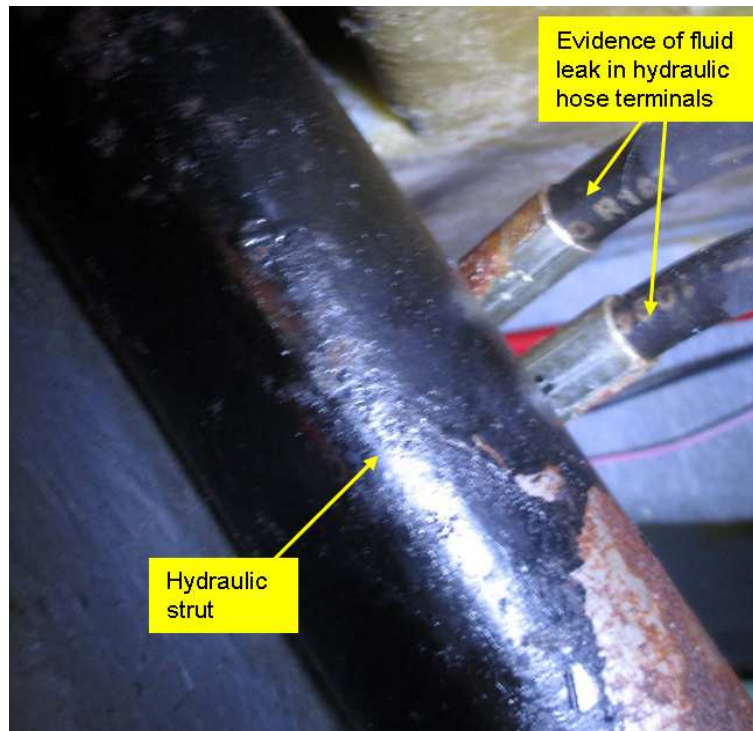
- 2.4.3 The hydraulic keel lifting mechanism was inspected via the lifting sole boards in the galley area. The hydraulic strut had some minor surface corrosion. There was evidence of hydraulic fluid around the end terminals of the hoses attached to the strut, as shown in Figure 4. It is **RECOMMENDED** (type C recommendation with an inspection interval of six months) that the hydraulic system is periodically inspected for evidence of further fluid leakage. If further leaks develop, the system may need to be fully overhauled (see paragraph 5.1.7.4).

- 5.1.7.4 The hydraulic mechanism was inspected via the lifting sole boards in the galley area. The hydraulic strut had some minor surface corrosion. There was evidence of hydraulic fluid around the end terminals of the hoses attached to the strut, as shown in Figure 4. It is **RECOMMENDED** (type C recommendation with an inspection interval of six months) that the hydraulic system is periodically inspected for evidence of further fluid leakage. If further leaks develop, the system may need to be fully overhauled.

Figure 4: Hydraulic strut and hoses

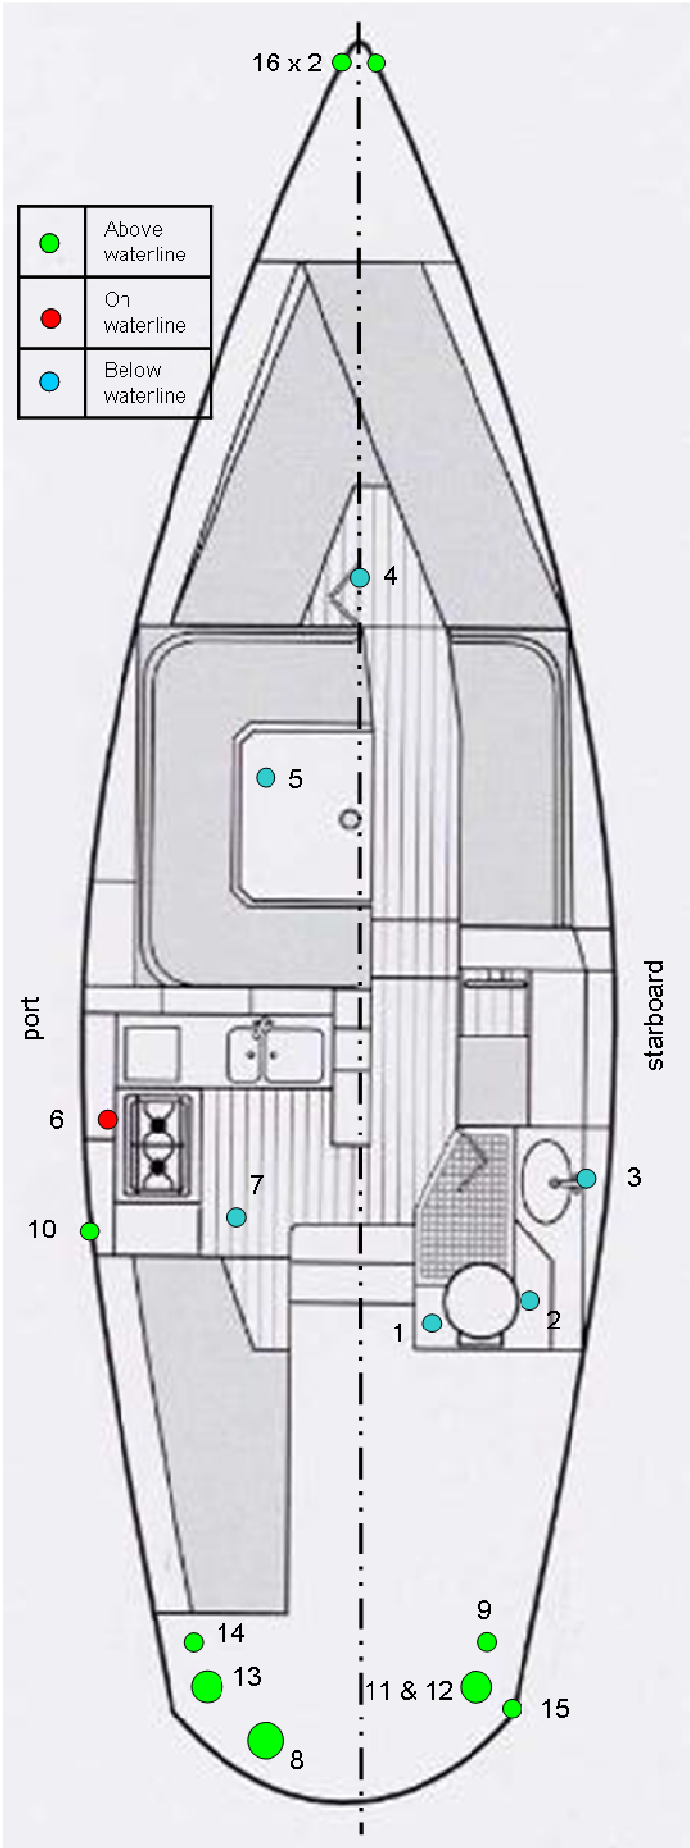
- 2.2.3 The outer skin of the heads outlet hose (item # 1 in Figure 5 and Table 3) was old and degraded. It is **RECOMMENDED** (type A1 recommendation) that this hose is replaced (see paragraph 5.1.9.4).

- 2.2.4 It is **RECOMMENDED** (type A1 recommendation) that the slots of the skin fitting that provide the sea water to the heads toilet (item # 2 in Figure 5 and Table 3) should be cleared of antifouling and internal marine growth that might obstruct the flow of water into the toilet (see paragraph 5.1.9.5).

- 2.2.5 The bronze or dezincification resistant brass spigot that connects the heads sink outlet hose to the valve (item # 3 in Figure 5 and Table 3) was corroding heavily, with evidence of water seeping into the vessel. It is **RECOMMENDED** (type A1 recommendation) that the valve and spigot are replaced with bronze or dezincification resistant brass items (see paragraph 5.1.9.6).

- 2.2.6 The hoses for the electric bilge pump outlet, shower tray pump outlet and gas locker vent (items # 9, 10 & 14 in Figure 5 and Table 3) were secured with a single stainless steel screw clip. It is **RECOMMENDED** (type A1 recommendation) that where the barbed spigot of the skin fitting is long enough to accept two clips, all hoses that have a skin fitting located near to or below the waterline should be fitted with two hose clips at each end (see paragraph 5.1.9.8).

- 5.1.9.1 Figure 5 and Table 3 below show the location and function of the skin fittings, together with the condition of the valves, hoses and clips. The items in **red** text in Table 3 indicate a defect or poor condition of the items and are addressed in the recommendations below.

Figure 5: Location of skin fittings (plan view looking from above)

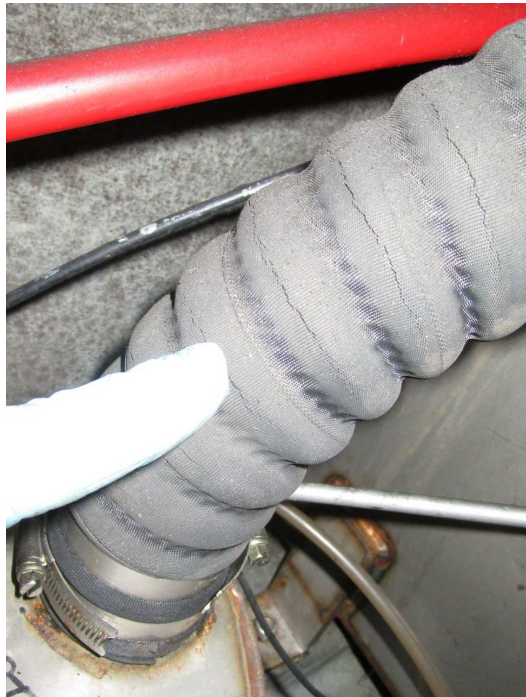
- 2.4.5 The length of engine exhaust hose (item # 8 in Figure 5 and Table 3) that runs between the stainless steel exhaust muffler and the hull fitting was found to be partially degraded on its outer skin, as shown in Figure 6. It is **RECOMMENDED** (type C recommendation with an implementation time of two years) that this length of hose is replaced (see paragraph 5.1.9.7).

- 5.1.9.7 The length of engine exhaust hose (item # 8 in Figure 5 and Table 3) that runs between the stainless steel exhaust muffler and the hull fitting was found to be partially degraded on its outer skin, as shown in Figure 6. It is **RECOMMENDED** (type C recommendation with an implementation time of two years) that this length of hose is replaced.

Figure 6: Cracking on outer skin of exhaust hose

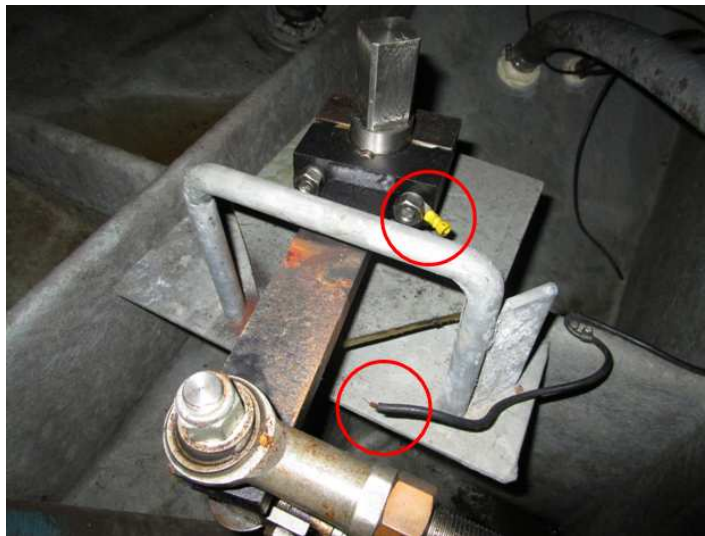
- 2.2.7 The electrical connection between the hull anode and the propeller shaft & propeller was tested with a multimeter and the resistance found to be approximately 42 Ω. The resistance between the anode and bronze stern bearing was found to be 0.6 Ω. There was no electrical continuity between the anode and the upper rudder bearing or rudder stock. Inspection of the anode wiring located in the engine compartment revealed that

the wire that connected the anode to the rudder stock was broken, as shown in Figure 7. The recommended maximum resistance is 1.0 Ω . It is **RECOMMENDED** (type A1 recommendation) that the bonding of the anode to the propeller shaft (via the engine block) and the bonding to the rudder stock is inspected further and the wires & terminals overhauled where necessary (see paragraph 5.1.10.3).

- 5.1.10.3 The electrical connection between the hull anode and the propeller shaft & propeller was tested with a multimeter and the resistance found to be approximately 42 Ω . The resistance between the anode and bronze stern bearing was found to be 0.6 Ω . There was no electrical continuity between the anode and the upper rudder bearing or rudder stock. Inspection of the anode wiring located in the engine compartment revealed that the wire that connected the anode to the rudder stock was broken, as shown in Figure 7. The recommended maximum resistance is 1.0 Ω . It is **RECOMMENDED** (type A1 recommendation) that the bonding of the anode to the propeller shaft (via the engine block) and the bonding to the rudder stock is inspected further and the wires & terminals overhauled where necessary.

Figure 7: Broken wiring of anode to rudder stock connection

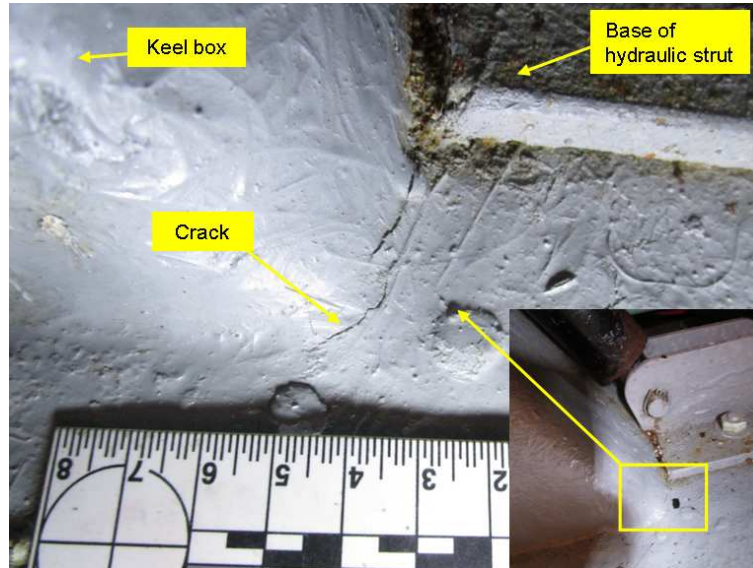
- 2.3.1 There were twenty four **type A2 recommendations** that must be implemented before the vessel is taken cruising:
- 2.3.2 The hull was heavily reinforced around the recess that locates the cast iron grounding plate and also at the lower end of the hydraulic strut that lifts the keel. One small crack was found in the hull moulding, extending from the galvanised steel base plate that secured the hydraulic strut to the hull. This crack is shown in Figure 8. The depth of the crack was not determined, but it was found to be within the outer layer of laminate and possibly deeper. It is **RECOMMENDED** (type A2 recommendation) that the galvanised steel hull bracket of the hydraulic strut is temporarily removed. The sharp corners of the base plate should be modified to form a radius. The laminate around the crack should be cleaned of all paint. The crack should be cut back to sound laminate and thoroughly cleaned. The area should be repaired with layers of GRP cloth and epoxy resin, ensuring that each successive layer of cloth is larger than the previous. When the hull bracket of the hydraulic strut is re-fastened, it should be bedded onto a semi-hardened sealing compound (see paragraph 5.2.1.4).

- 5.2.1.4 The hull was heavily reinforced around the recess that locates the cast iron grounding plate and also at the lower end of the hydraulic strut that lifts the keel. One small crack was found in the hull moulding, extending from the galvanised steel base plate that secured the hydraulic strut to the hull. This crack is shown in Figure 8. The depth of the crack was not determined, but it was found to be within the outer layer of laminate and possibly deeper. It is **RECOMMENDED** (type A2 recommendation) that the galvanised

Figure 8: Crack in hull at base of hydraulic strut

steel hull bracket of the hydraulic strut is temporarily removed. The sharp corners of the base plate should be modified to form a radius. The laminate around the crack should be cleaned of all paint. The crack should be cut back to sound laminate and thoroughly cleaned. The area should be repaired with layers of GRP cloth and epoxy resin, ensuring that each successive layer of cloth is larger than the previous. When the hull bracket of the hydraulic strut is re-fastened, it should be bedded onto a semi-hardened sealing compound.

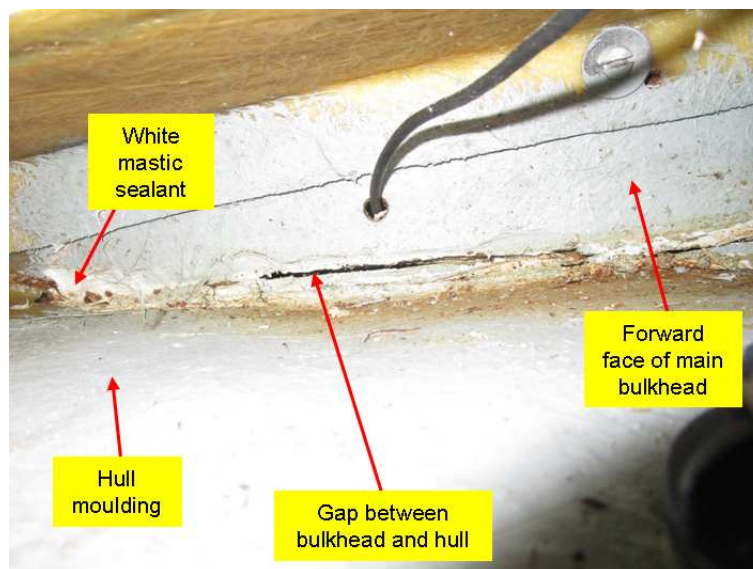
- 2.3.3 It was found that the lower edges of the main bulkhead, positioned beneath the sole boards of the saloon and forepeak, were not connected to the bulkhead by GRP tabbing. The forward face of the bulkhead beneath the forepeak sole can be seen in Figure 9. The 2 mm gap between the hull and the lower edge of the bulkhead was filled with a soft mastic sealant. This sealant was loose and peeling along the majority of the gap. Inspection of the adjacent bulkhead revealed that the adjacent plywood was covered in one or more layers of GRP cloth. This indicates that the lower edge of the bulkhead was originally attached to the hull by GRP tabbing, as was normal build practise with the majority of sailing vessels of this size and era. It is **RECOMMENDED** (type A2 recommendation) that this area is repaired with woven GRP cloth and epoxy resin. The surfaces of the hull and bulkhead either side of the gap should be cleaned of all paint, grease and dirt. Layers of GRP cloth should be applied, ensuring that each successive layer of cloth is larger than the previous. The repair should extend as far up

5.2.4.3 It was found that the lower edges of the main bulkhead, positioned beneath the sole boards of the saloon and forepeak, were not connected to the bulkhead by GRP tabbing. The forward face of the bulkhead beneath the forepeak sole can be seen in Figure 9. The 2 mm gap between the hull and the lower edge of the bulkhead was filled with a soft mastic sealant. This sealant was loose and peeling along the majority of the gap. Inspection of the adjacent bulkhead revealed that the adjacent plywood was covered in one or more layers of GRP cloth. This indicates that the lower edge of the bulkhead was originally attached to the hull by GRP tabbing, as was normal build practise with the majority of sailing vessels of this size and era. It is **RECOMMENDED** (type A2 recommendation) that this area is repaired with woven GRP cloth and epoxy resin. The surfaces of the hull and bulkhead either side of the gap should be cleaned of all paint, grease and dirt. Layers of GRP cloth should be applied, ensuring that each successive layer of cloth is larger than the previous. The repair should extend as far up the bulkhead as possible and at least 150 mm along the hull in the fore-aft direction.

Figure 9: Joint between main bulkhead and hull

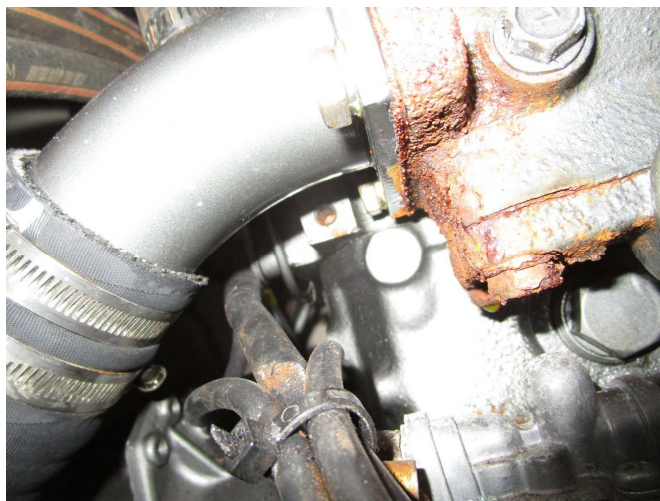
- 5.5.3.3 The exhaust elbow was inspected and found to be in good order and free of corrosion or cracking on its outer surface. There was no evidence of recent leakage, but rust deposits around the exhaust manifold indicated that the joint or elbow has leaked in the past, allowing sea water to drip over the diesel lift pump. When the engine is next run under load and at full working temperature, the elbow should be inspected for any coolant leakage.

Figure 10: Corrosion on exhaust manifold at flange of elbow

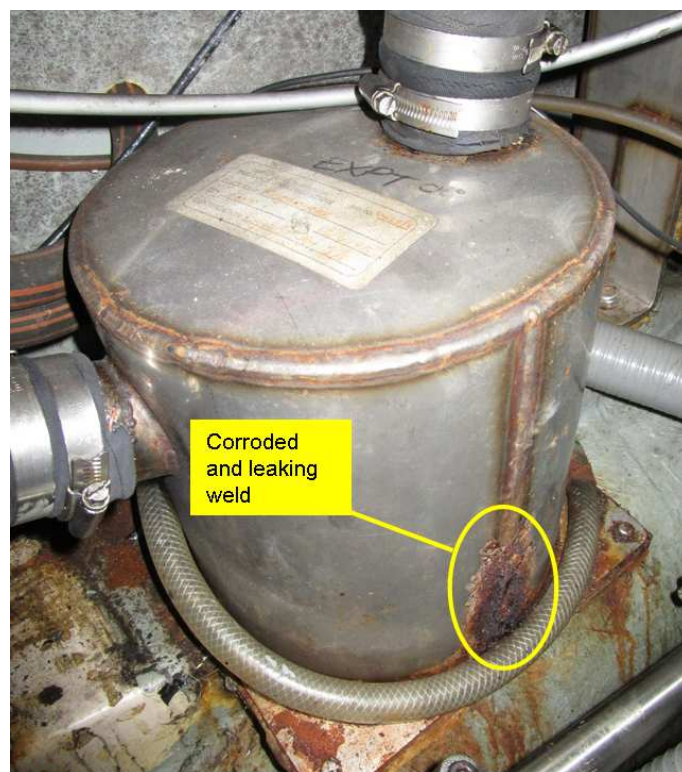
Figure 11: Exhaust muffler

- 2.3.4 When under load no fuming was noted in the engine space. No leaks from the engine cooling water, fuel and exhaust systems were evident, except for a water leak in the side of the stainless steel muffler, as shown in Figure 11. It is **RECOMMENDED** (type A2 recommendation) that the muffler is replaced (see paragraph 5.5.4.5).

5.5.4.5 When under load no fuming was noted in the engine space. No leaks from the engine cooling water, fuel and exhaust systems were evident, except for a water leak in the side of the stainless steel muffler, as shown in Figure 11. It is **RECOMMENDED** (type A2 recommendation) that the muffler is replaced.

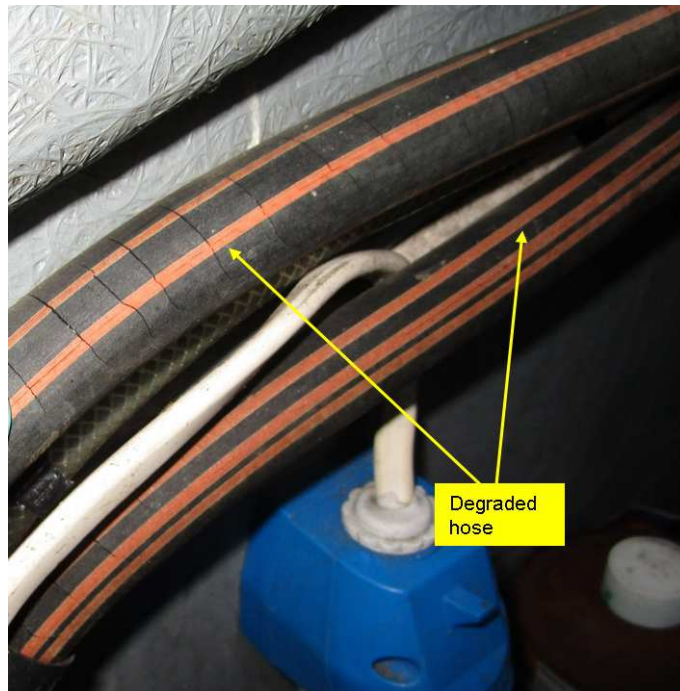
- 2.3.6 The engine cooling feed to the exhaust was suitably fitted with an anti-siphon attachment, with the head of the anti-siphon venting through a skin fitting on the transom, just beneath deck level. The anti-siphon loop was mounted inside the large cockpit locker. The supply & return hoses connected to the anti-siphon loop were cracked and degraded, as shown in Figure 12. It is **RECOMMENDED** (type A2 recommendation) that these hoses are replaced (see paragraph 5.5.4.12).

- 5.5.4.12 The cooling feed to the exhaust was suitably fitted with an anti-siphon attachment, with the head of the anti-siphon venting through a skin fitting on the transom, just beneath deck level. The anti-siphon loop was mounted inside the large cockpit locker. The supply & return hoses connected to the anti-siphon loop were cracked and degraded, as shown in Figure 12. It is **RECOMMENDED** (type A2 recommendation) that these hoses are replaced.

Figure 12: Supply & return hose for engine anti-siphon loop.
