# ATLANTA

## Pre-purchase Survey

On Wednesday 14<sup>th</sup> October 2020

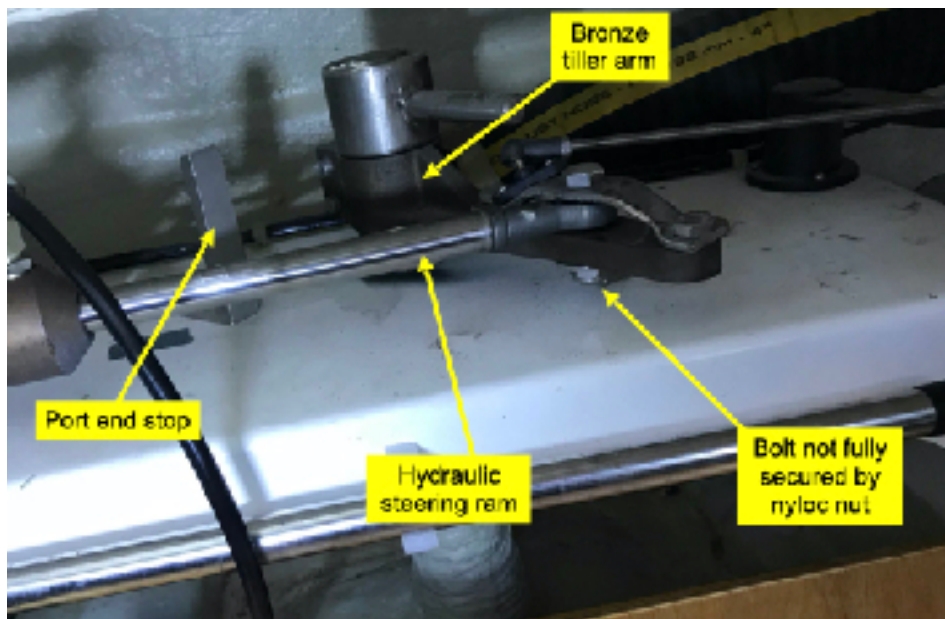
**Figure 4: Steering mechanism in cockpit locker**

- 5.1.7.9. The hydraulic ram of the steering system was secured to the forward end of the bronze tiller arm via a stainless steel bolt, secured by a nyloc nut. It was found that the threaded shank of the bolt did not fully engage with the nyloc nut. This nut is shown in Figure 4. This could allow the nut to work loose. It is **RECOMMENDED** (type A2 recommendation) that the stainless steel bolt is replaced with a longer item or the nut

- 5.1.7.11. The steering was tested by turning the helm wheel from lock to lock. The rudder turned correctly, but it was found that when it was turned fully to port, the tiller arm struck the bronze body of the steering ram before the tiller arm could make contact with the stainless steel fabrication of the port end-stop. The bracket of this end-stop is shown in Figure 4. It was also found that the hydraulic ram reached the end of its travel before the tiller arm makes contact with the port end stop. It is **RECOMMENDED** (type A2 recommendation) that both stainless steel end stop brackets are adjusted so that the tiller arm makes contact with them before the tiller strikes the body of the steering ram or before the ram reaches the end of its travel.

is properly secured with a thread locking compound.

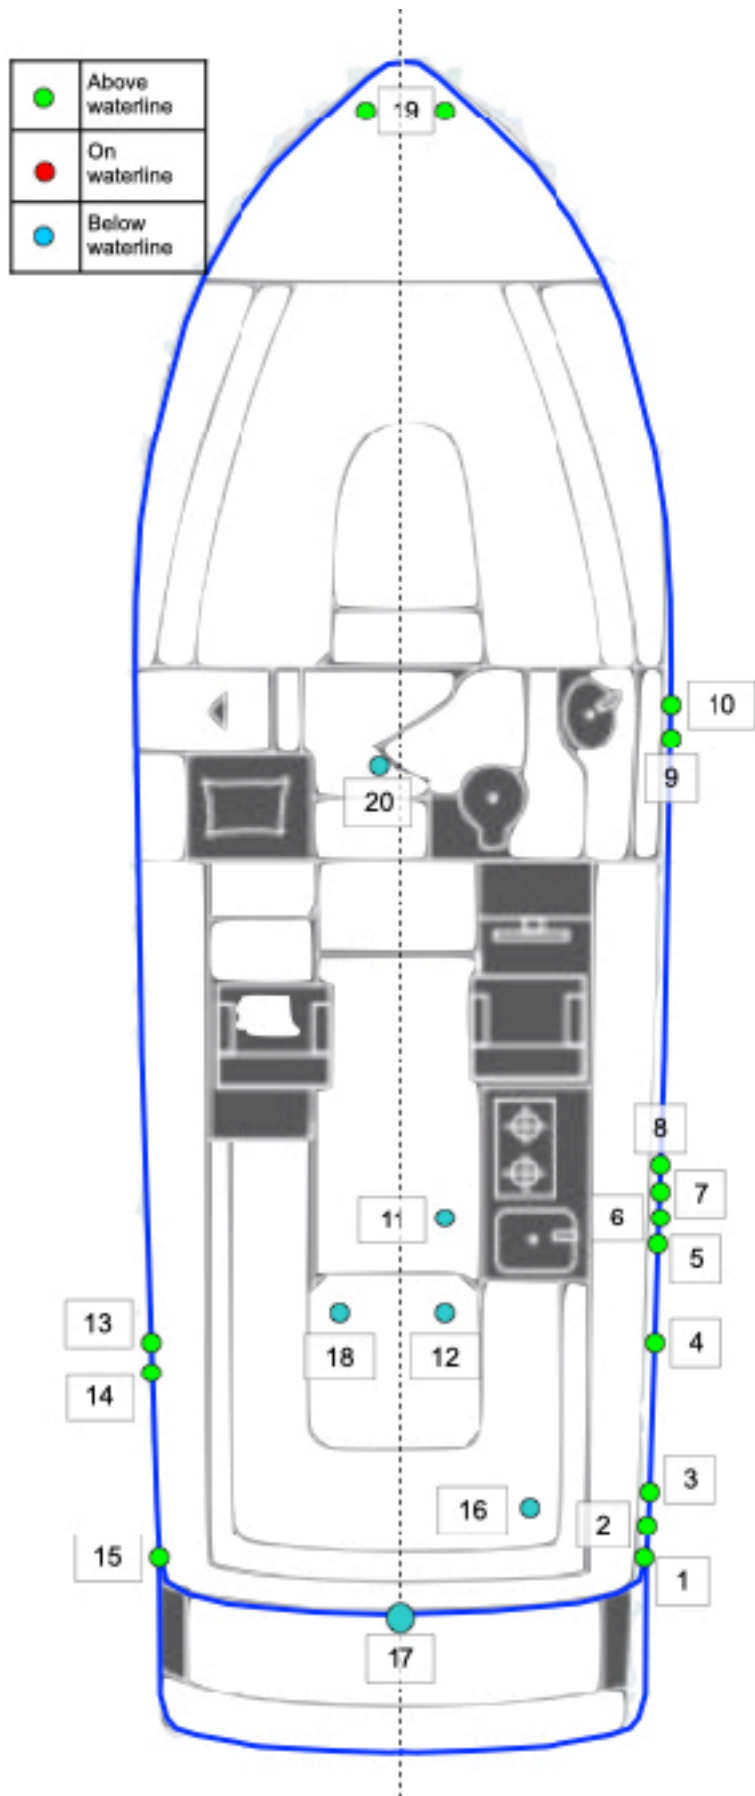
Figure 5: Location of skin fittings (plan view looking from above)

- 5.1.8.1. Figure 5 and Table 3 show the location and function of the skin fittings, together with the condition of the valves, hoses and clips. The items in **red** text in Table 3. indicate a defect or poor condition of the items and are addressed in the recommendations below.
- 5.1.8.2. No skin fittings or valves were dismantled as part of the survey but the following tests were performed:
  - Examination from outside and inside the vessel
  - All valves opened and closed to their full extent
  - The through-hull fittings, hose clips and valve bodies were hammer tested
  - The fittings were aggressively tested to assess their security of attachment to the hull
  - Where accessible, hose clips were inspected and hoses were aggressively tested

- 5.1.8.5. The isolation valve handles of the black water tank vent and the forward, starboard cockpit drain (items 3 and 4 in Figure 5 and Table 3) were found to be very loose. It is **RECOMMENDED** (type A2 recommendation) that these are tightened.

- 5.1.8.6. The isolation valves of the black water tank outlet and the engine cooling intake (items 16 and 18 in Figure 5 and Table 3) were constructed from Tonval. This is a low quality brass with a high zinc content and is susceptible to dezincification in the marine environment. Dezincification leads to the structural degradation of the material. These valves showed significant evidence of internal corrosion, particularly where the valves were connected to the skin fitting or to the barbed brass hose-tail. It is **RECOMMENDED** (type A1 recommendation) that that these two valves and their attached hose tails are replaced with items constructed from bronze or dezincification resistant brass. Whilst this work is being performed, the exposed threads of the skin fittings should be examined for evidence of corrosion.

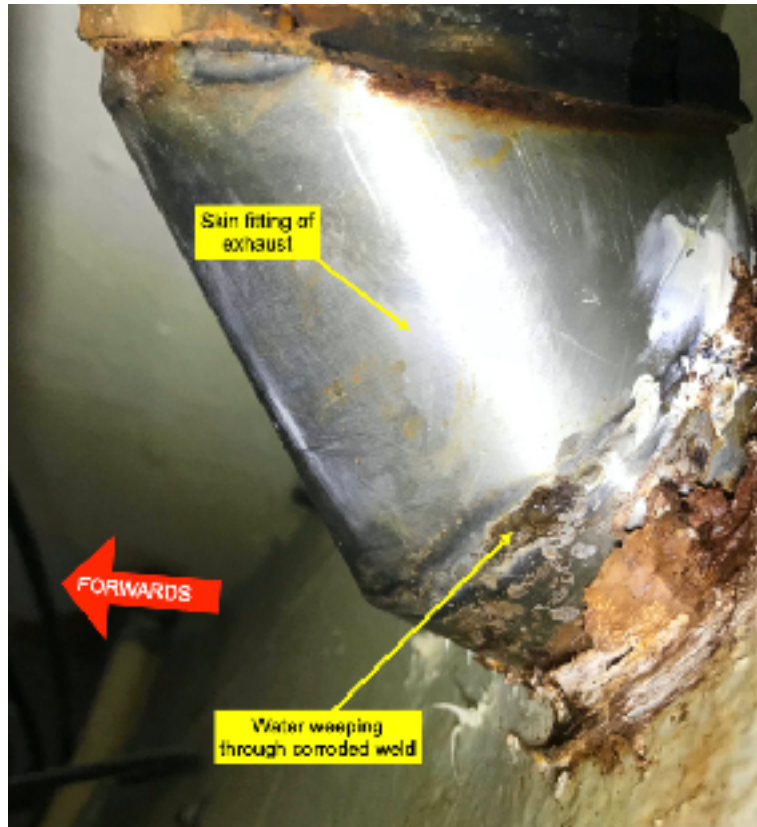
**Figure 6: Corroded skin fitting of engine exhaust**

- 2.1.3. When inspected from the cockpit locker, it was found that the welded stainless steel skin fitting of the engine exhaust outlet (item 17 in Figure 5 and Table 3) was corroded. Exhaust water was found to be weeping through the corroded weld bead. This area of corrosion is shown in Figure 6. It is **RECOMMENDED** (type A1 recommendation) that the skin fitting of the exhaust is replaced (see paragraph 5.1.8.4).

- 5.1.8.3. All fittings on or below the waterline were bronze or brass (apart from the plastic speed impeller & depth transducer) and showed no signs of dezincification. The parts of these fittings that were accessible from outside of the boat were found to be free of dezincification. All skin fittings located close to or below the waterline were fitted with an isolation valve.
- 5.1.8.4. When inspected from the cockpit locker, it was found that the welded stainless steel skin fitting of the engine exhaust outlet (item 17 in Figure 5 and Table 3) was corroded. Exhaust water was found to be weeping through the corroded weld bead. This area of corrosion is shown in Figure 6. It is **RECOMMENDED** (type A1 recommendation) that the skin fitting of the exhaust is replaced.

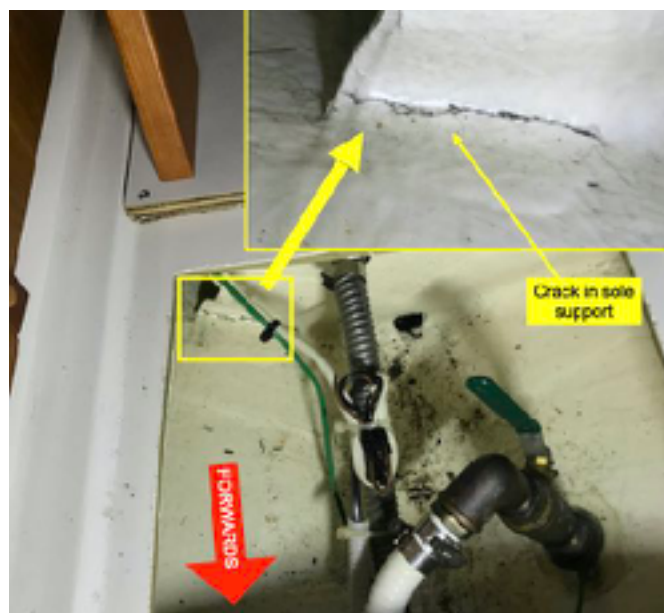
Figure 7: Crack in GRP support of sole in forward living area

- 2.3.1. There were six **type C recommendations** that do not require immediate attention but are to be dealt with within a specified time period:
- 2.3.2. Reinforcing in the forward parts of the hull was provided by a white GRP moulding that formed the sole & bunk frames in the guest cabin & forepeak. This moulding was found to be in good cosmetic condition and free of cracking or de-bonding from the hull, except for one location: As shown in Figure 7, the vertical GRP plate that provided additional support to the white GRP moulding was cracked. This 100 mm long crack was located beneath the steps that lead down to the guest cabin from the wheelhouse. It is likely that this damage has developed as a result of repeated loading when crew step down into the forward living area. It is **RECOMMENDED** (type C recommendation with an implementation time of two years) that this cracked support is repaired with layers of GRP cloth (see paragraph 5.2.2.2).

- 5.2.2.2. Further reinforcing in the forward parts of the hull was provided by a white GRP moulding that formed the sole & bunk frames in the guest cabin & forepeak. This moulding was found to be in good cosmetic condition and free of cracking or de-bonding from the hull, except for one location: As shown in Figure 7, the vertical GRP plate that provided additional support to the white GRP moulding was cracked. This 100 mm long crack was located beneath the steps that lead down to the guest cabin from the wheelhouse. It is likely that this damage has developed as a result of repeated loading when crew step down into the forward living area. It is **RECOMMENDED** (type C recommendation with an implementation time of two years) that this cracked support is repaired with layers of GRP cloth.
