# MAYFLY

## Pre-purchase Survey

On Friday 18<sup>th</sup> November 2019

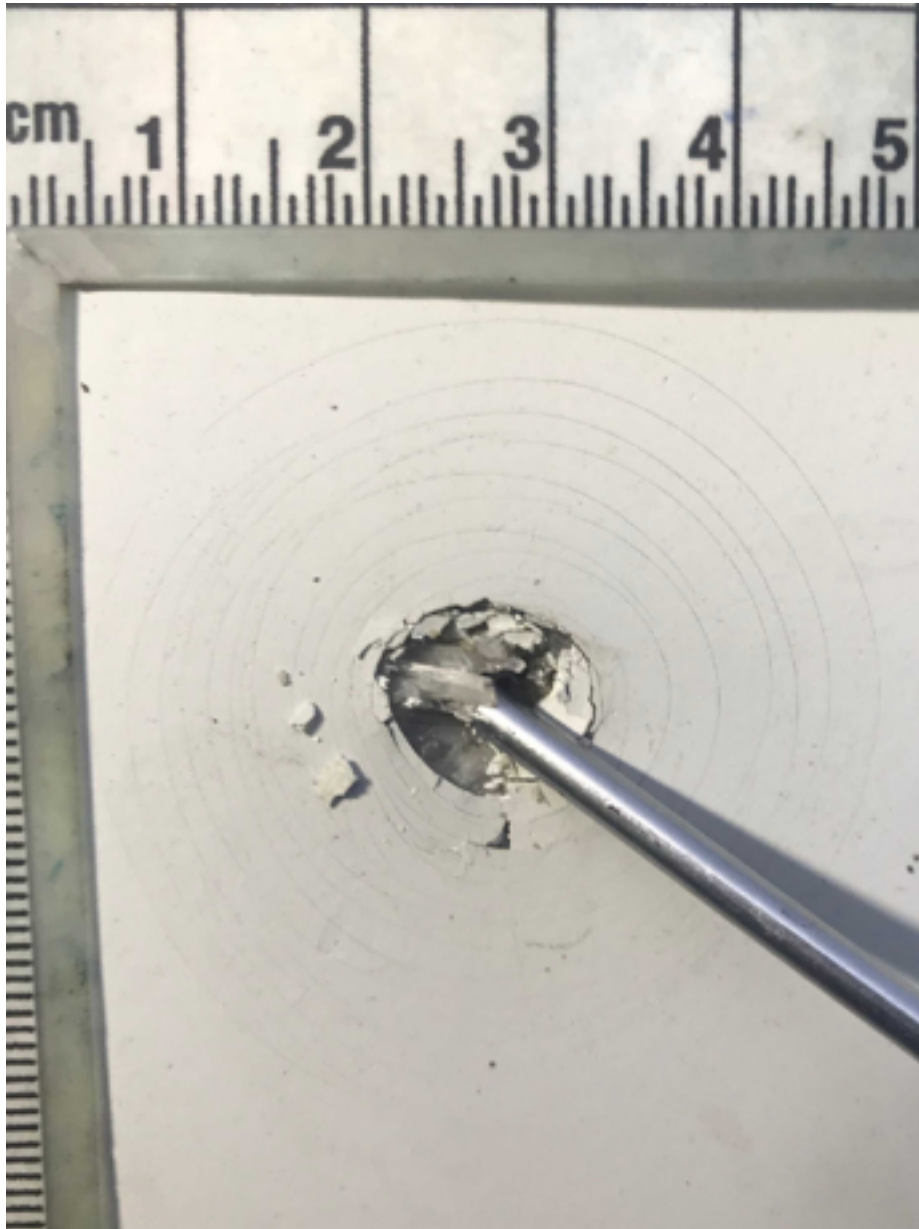
- 5.1.3.3. There were numerous areas of gel-coat repair on both outboard topsides, particularly on the port hull. These were typically 60 mm in diameter. The gel-coat of some of these repairs was cracked and loose. There were numerous small impact cracks and dents, with arc-shaped or circular-shaped rings of cracks around these. An example of one area of impact is shown in Figure 2. This damage was located on the outboard side of the port hull, positioned 2070 mm forward of the stern and 310 mm up from the waterline. With very little force, the surveyor's spike (shown in the photograph) was able to penetrate into the foam core. These areas of impact damage were inspected with a moisture meter. Moisture levels were found to be significantly higher than the un-damaged areas of the topsides, indicating that some moisture has penetrated into the adjacent parts of the foam core. The areas immediately adjacent to the holes and cracks gave a dull return when tested with a small plastic headed hammer, giving further evidence that the foam core around the visible damage has de-bonded from one or both GRP skins. There was one area of the port topside, located just forward of the shroud chain plate, where hammer testing indicated that an area of foam core approximately 500 mm wide and 400 mm high was poorly bonded, due to the numerous cracks and impact holes in this region. It is **RECOMMENDED** (type C recommendation with an implementation time of one year) that on all topsides, all cracks and impact holes, including previously repaired damage, are cut out. Any crushed, rotten or debonded foam core should also be removed. All exposed core material should be thoroughly dried. Any removed core should then be replaced and the outer skin repaired, ensuring that the finished gel-coat surface is fair and smooth. In order to return the same strength to the areas of repair, consideration should be given to using a good quality epoxy resin for these repairs.

**Figure 2: Impact damage of topsides**

- 5.1.5.3. Moisture readings taken on the topsides were typically between 10 and 12, indicating a low moisture level. In the areas of topside damage described in paragraph 5.1.3.3, moisture readings were between 20 and 25, which indicate a high moisture content.

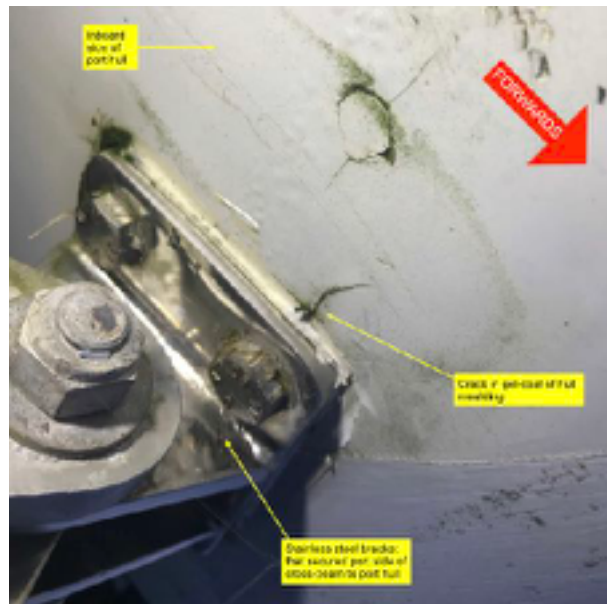
- 5.1.3.6. Figure 3 shows an area of gel-coat cracking on the inboard side of the port hull. The depth of this defect could not be determined. It is **RECOMMENDED** (type C recommendation with an implementation time of one year or before an offshore voyage) that when the recommendation detailed in paragraph 5.3.8.9 is being addressed, the extent of this damage should be investigated from inside the forepeak of the port hull and suitably repaired.

**Figure 3: Crack on port hull, where aluminium cross-beam is mounted to hull**

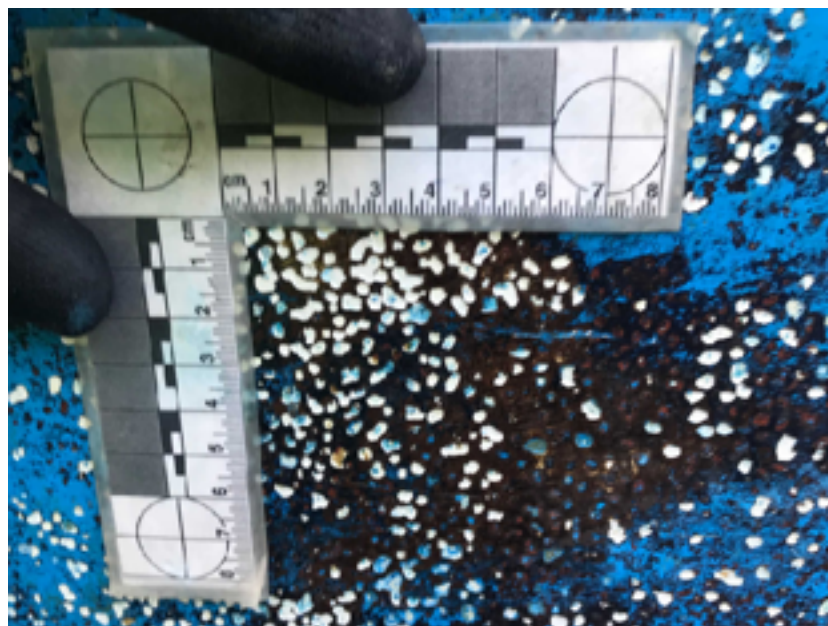
- 5.1.4.3. After pressure washing it was found that the majority of the port & starboard hull surfaces, located below the waterline, were found to be covered with the remains of blisters. The majority of these were not visible before power washing, indicating that the pressure of the water jet had forced off the heads of the blisters, leaving numerous shallow blister pits. Some of the pits were coated in antifouling, indicating that some of the pits have existed for some time and certainly prior to the most recent application of antifouling. A typical area of the hull surface is shown in Figure 4.

**Figure 4: Remains of blisters in hull gel-coat**

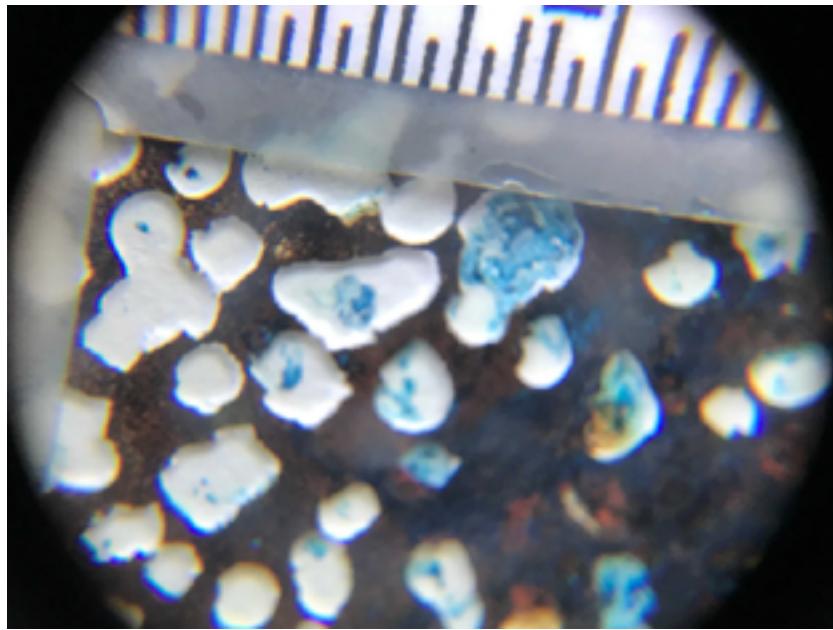
- 5.1.4.4. The pits of the hull blisters were typically 2 to 3 mm in diameter. The material in the base of each blister pit was a smooth, white resin, with no evidence of glass fibre or fibre pattern. See Figure 5 for a magnified view of some of the blister pits. The evidence gathered suggested that these pits were the remains of blisters that have developed due to hydrolysis within the gel-coat. Referring to the publication 'Repairs to Blisters in Glass Fibre Hulls [British Plastics Federation, November 1984], these blisters are of type 3A, which occur in craft with double gel-coats. This condition whilst unsightly is not structurally significant. In the case of broken blisters, rectification should be undertaken at the earliest opportunity. It is **RECOMMENDED** (type C recommendation with an implementation time of one year) that any broken blisters or blisters that are readily breakable should be thoroughly cleaned out and dried. The shallow cavity should then be filled with epoxy filler. All hull surfaces below the waterline should then be suitably cleaned, dried and then treated with a number of coats of epoxy gel-coat.

**Figure 5: Close-up view of typical blisters**

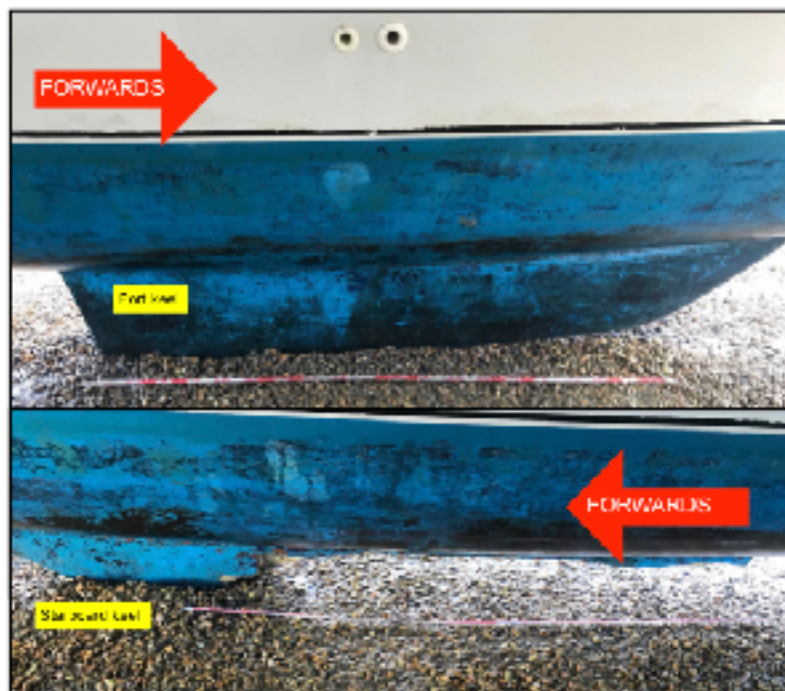
- 5.1.7.2. The majority of the starboard keel moulding was missing, with only  $\frac{1}{3}$  of the moulding still bonded to the underside of the starboard hull. Figure 6 shows the extent of the damage. Note that the red & white tape measure in the images is 2 metres long. Where the keel moulding was missing, the exposed parts of the hull moulding were found to be in sound condition and free of evidence of significant damage. It is **RECOMMENDED** (type C recommendation with an implementation time of one month) that the starboard keel is replaced. If this repair is delayed for any significant length of time, damage of the surrounding hull moulding or the starboard rudder assembly may occur, where the starboard hull and rudder rest on the mud of her drying berth.

Figure 6: Port & starboard keels

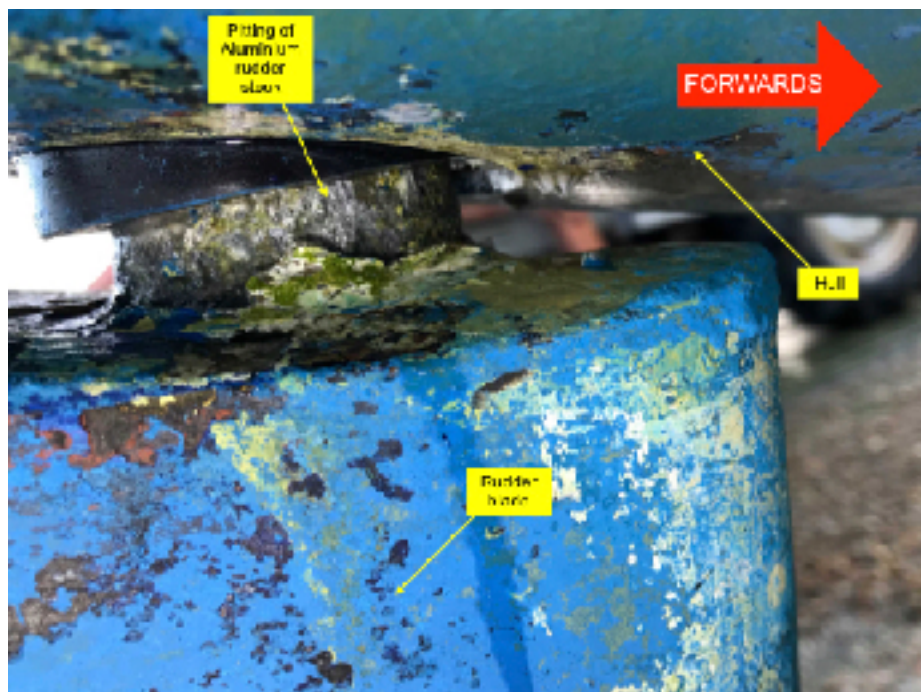
- 5.1.8.3. The 50 mm diameter aluminium rudder stocks were inspected where access allowed. The visible portions of the stock were found to be heavily pitted, with some loss of strength of each stock. This pitting corrosion was located located at the point where the stock emerges from the blade, just beneath the lower rudder bearing (see Figure 7). It is **RECOMMENDED** (type C recommendation with an implementation time of six months or before an offshore voyage) that both rudder assemblies are removed from the vessel. The exposed parts of each stock should be thoroughly cleaned and inspected for evidence of cracking or significant corrosion. The depth of any corrosion pits should be measured. If the diameter of either stock has been reduced by more than 10% in any one location, both rudder assemblies should be replaced before undertaking an offshore voyage. It should be noted that the portions of the rudder stocks within the rudder tubes and within the blades could not be accessed for inspection; therefore the condition of the hidden parts of the stocks cannot be guaranteed.

**Figure 7 : Pitting corrosion of aluminium rudder stock**

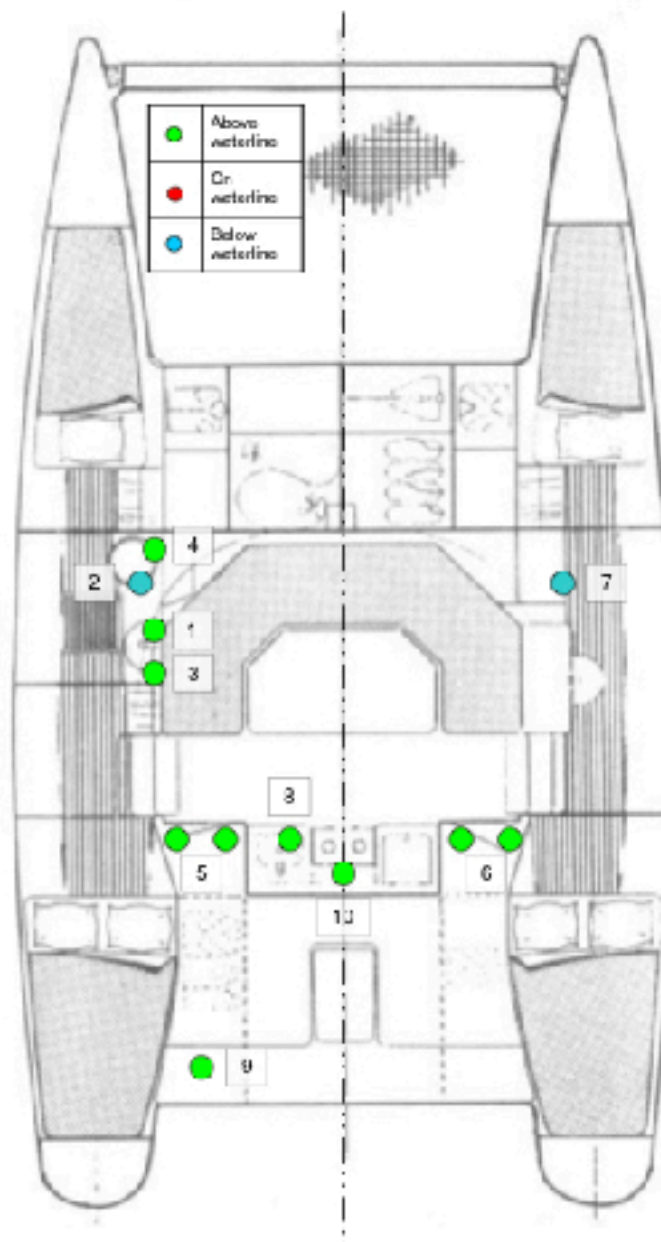
**Figure 8: Location of skin fittings (plan view looking from above)**

- 2.5.2. The hose of the heads toilet inlet (item 2 in Figure 8 and Table 3) was secured with a single stainless steel screw clip. It is **RECOMMENDED** (type A2 recommendation) that because this fitting was located below the vessel's waterline, the hose should be secured at both ends with two stainless steel hose clips.

- 2.6.8. The isolation valves of the heads toilet inlet and heads bilge pump outlet (items 2 and 4 in Figure 8 and Table 3) were found to be partially corroded and were stiff. These valves were constructed from Tonval. This is a low quality brass with a high zinc content and is susceptible to dezincification in the marine environment. The heads toilet inlet valve showed evidence of external corrosion, particularly where the valve was connected to the skin fitting and the barbed hose tail. In consideration of the age of the vessel and the developing corrosion of the two valves & fittings, it is **RECOMMENDED** (type C recommendation with an implementation time of six months) that both quarter-turn valves, skin fittings and hose tails are replaced with items constructed from dezincification resistant brass.

- 5.1.9.1. Figure 8 and Table 3 below show the location and function of the skin fittings, together with the condition of the valves, hoses and clips. The items in **red** text in Table 3 indicate a defect or poor condition of the items and are addressed in the recommendations below.
