PUFFIN II

Pre-purchase Survey

Mike Chapman,
27 Hyde Road,
Bognor Regis,
West Sussex,
PO20 4PQ

On Friday 17th August 2020 and Friday 24th August 2020

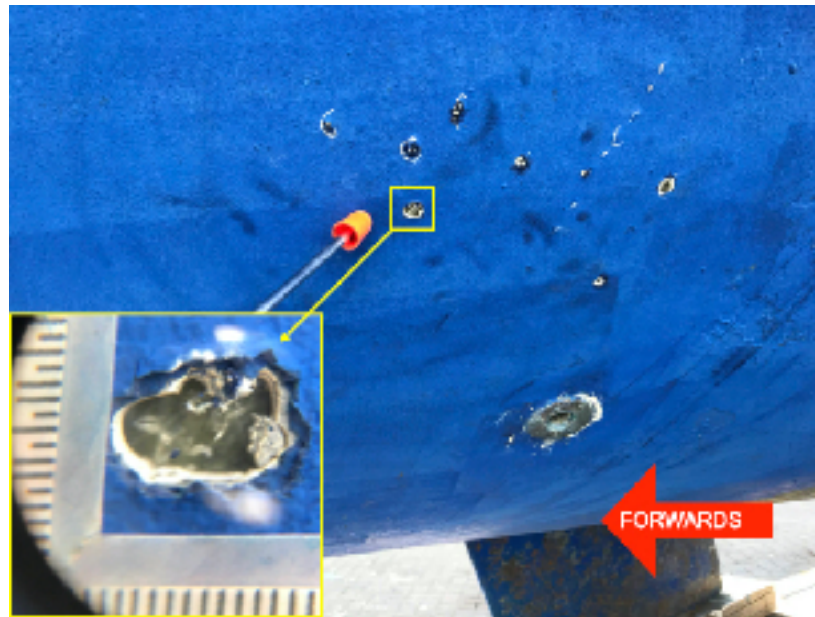
2.5.2. Small, very shallow, domed shaped blisters in the gel-coat were found to be distributed over much of the hull below the waterline, with approximately 5 to 10 blisters per 200 mm square of hull area. These blisters were approximately 2 to 10 mm in diameter, but the majority were less than 5 mm in diameter. It is likely that these blisters were more pronounced when the vessel was freshly lifted. A number of the blisters were broken and opened up by the surveyor. These blisters contained a very small amount of fluid that had a foul smell but also with a faint smell of vinegar. This evidence suggests that the blisters have occurred due to hydrolysis within the hull moulding, commonly termed as 'osmosis'. The glass fibres within the inspected blisters were well coated with resin. Figure 5 shows an example of one of the larger blisters. None of the opened up blister cavities were deep, indicating that the blisters had developed just beneath the gel-coat. Referring to the publication 'Repairs to Blisters in Glass Fibre Hulls [British Plastics Federation, October 1984], these blisters are of type 3B. This type of blister leaves the laminate more susceptible to the ingress of moisture. Whilst not of immediate significance to the integrity of the hull, to leave blisters of this type to develop over a number of years could lead to a localised weak area in the hull. Development of more blisters of this kind can not be ruled out and the size of the existing blisters may increase in size. It is **RECOMMENDED** (type C recommendation with an implementation time of one year) that all blisters greater than 5 mm in diameter are

- 5.1.3.3. Small, very shallow, domed shaped blisters in the gel-coat were found to be distributed over much of the hull, with approximately 5 to 10 blisters per 200 mm square of hull area. These blisters were approximately 2 to 10 mm in diameter, but the majority were less than 5 mm in diameter. It is likely that these blisters were more pronounced when the vessel was freshly lifted. A number of the blisters were broken and opened up by the surveyor. These blisters contained a very small amount of fluid that had a foul smell but also with a faint smell of vinegar. This evidence suggests that the blisters have occurred due to hydrolysis within the hull moulding, commonly termed as 'osmosis'. The glass fibres within the inspected blisters were well coated with resin. Figure 5 shows an example of one of the larger blisters. None of the opened up blister

cavities were deep, indicating that the blisters had developed just beneath the gel-coat. Referring to the publication 'Repairs to Blisters in Glass Fibre Hulls [British Plastics Federation, October 1984], these blisters are of type 3B. This type of blister leaves the laminate more susceptible to the ingress of moisture. Whilst not of immediate significance to the integrity of the hull, to leave blisters of this type to develop over a number of years could lead to a localised weak area in the hull. Development of more blisters of this kind can not be ruled out and the size of the existing blisters may increase in size. It is **RECOMMENDED** (type C recommendation with an implementation time of one year) that all blisters greater than 5 mm in diameter are broken open and the cavity cut back to sound laminate. The laminate should then be thoroughly cleaned & dried. If the cavities are deep, the exposed surfaces should then be repaired layers of GRP cloth and finished with a gel-coat. If the cavities are shallow they can be filled with epoxy filler.

Figure 5: One of the larger blisters found on the port beam, opened up by the Surveyor.

broken open and the cavity cut back to sound laminate. The laminate should then be thoroughly cleaned & dried. If the cavities are deep, the exposed surfaces should then be repaired layers of GRP cloth and finished with a gel-coat. If the cavities are shallow they can be filled with epoxy filler (see paragraph 5.1.3.3).

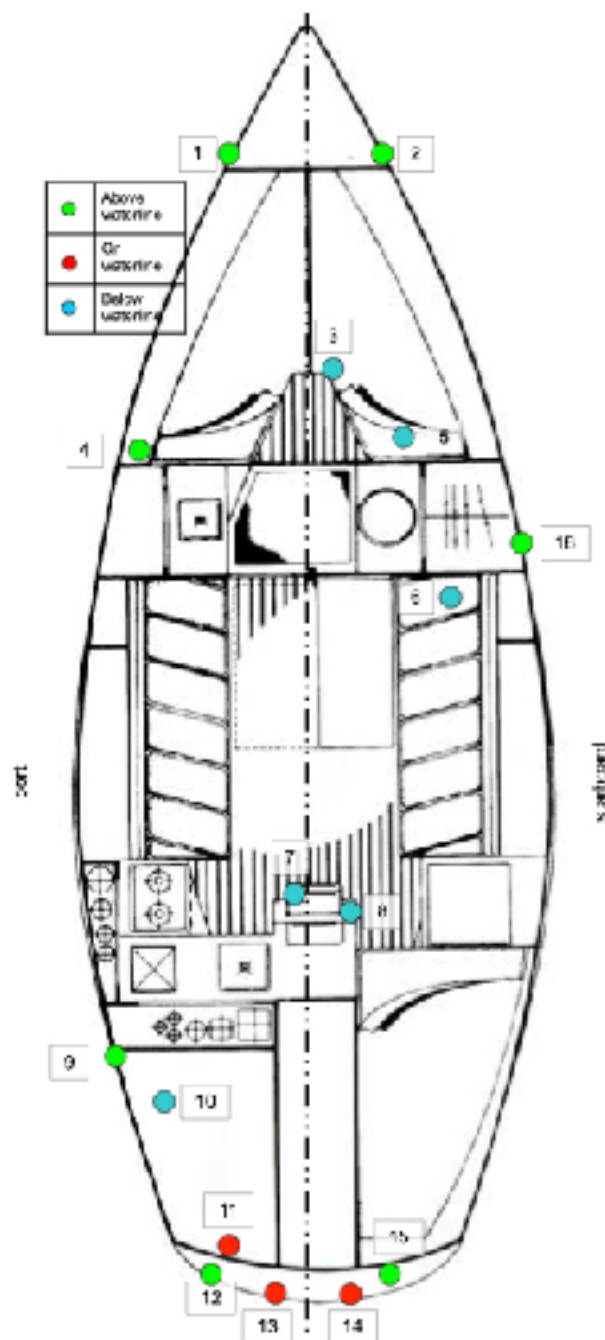
Figure 6: Location of skin fittings (plan view looking from above)

- 5.1.8.1. Figure 6 and Table 3 below show the location and function of the skin fittings, together with the condition of the valves, hoses and clips. The items in **red** text in Table 3 indicate a defect or poor condition of the items and are addressed in the recommendations below.

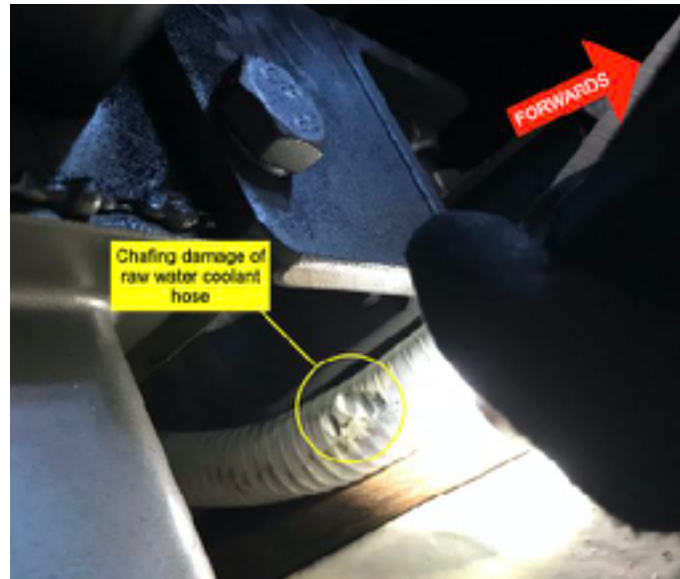
- 2.4.4. The hose of the engine cooling intake (item 7 in Figure 6 and Table 3) was found to be heavily chafed at one location. This area of damage was beneath the engine and can be seen in Figure 7. The level of damage was such that the reinforcing material in the hose had almost worn through. It is **RECOMMENDED** (type A2 recommendation) that this hose is replaced (see paragraph 5.1.8.11).

- 5.1.8.10. All other valves were in good working order and operated normally. The visible parts of the valves were free of significant corrosion.
- 5.1.8.11. The hose of the engine cooling intake (item 7 in Figure 6 and Table 3) was found to be heavily chafed at one location. This area of damage was beneath the engine and can be seen in Figure 7. The level of damage was such that the reinforcing material in the hose had almost worn through. It is **RECOMMENDED** (type A2 recommendation) that this hose is replaced.

Figure 7: Chafing damage of engine cooling intake hose

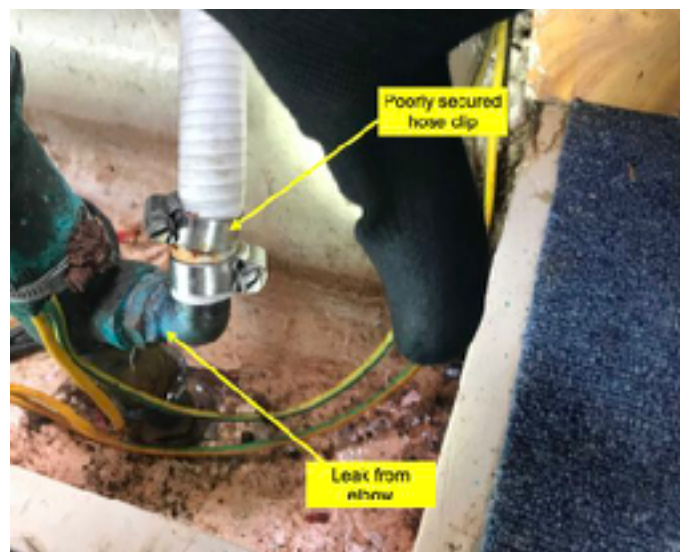
- 2.4.5. The hose of the engine cooling intake (item 7 in Figure 6 and Table 3) was secured to the isolation valve with two stainless steel hose clips. One of these clips was poorly secured and was not gripping on the hose tail of the isolation valve. This hose clip can be seen in Figure 8. It is **RECOMMENDED** (type A2 recommendation) that both hose clips are correctly secured (see paragraph 5.1.8.12).

- 5.1.8.12. The hose of the engine cooling intake (item 7 in Figure 6 and Table 3) was secured to the isolation valve with two stainless steel hose clips. One of these clips was poorly secured and was not gripping on the hose tail of the isolation valve. This hose clip can be seen in Figure 8 It is **RECOMMENDED** (type A2 recommendation) that both hose clips are correctly secured.

Figure 8: Isolation valve & hose of engine cooling intake

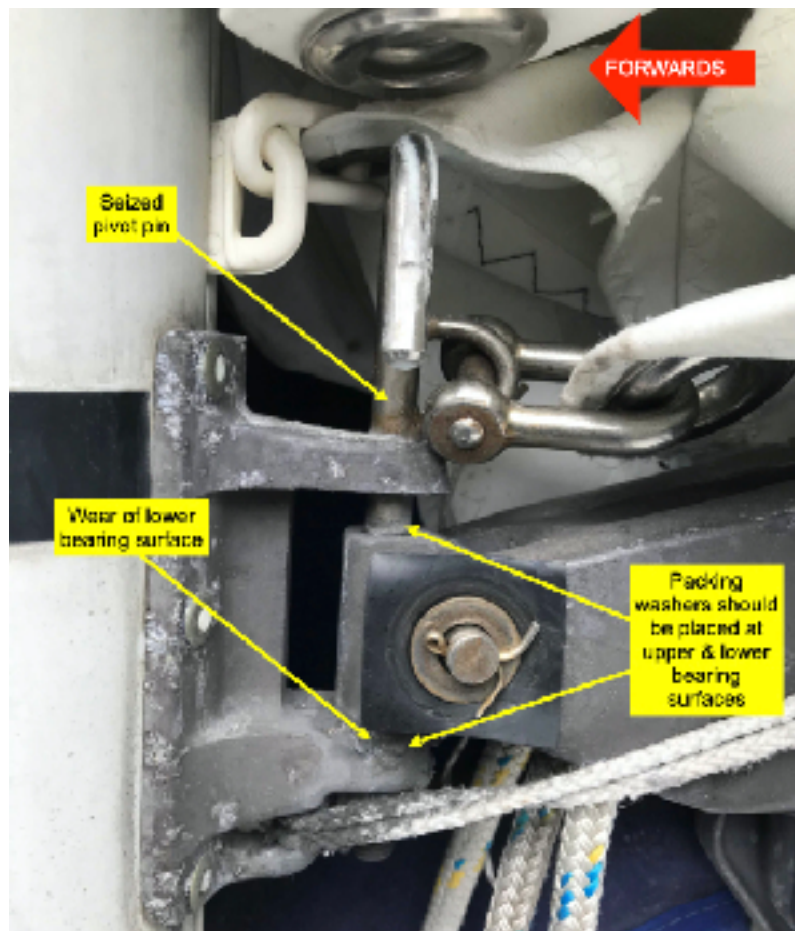
- 5.4.1.3. The Proctor boom was in good condition, with no significant wear of the anodised coating. The cast aluminium gooseneck was in poor condition. The rivets that secured the castings to the mast and to the boom were secure and free of damage. The vertical stainless steel pivot pin was seized. There was a large gap between the bearing surfaces of this vertical pivot, with significant wear of the lower bearing surface. These defects are shown in Figure 9. It is **RECOMMENDED** (type C recommendation with an implementation time of six months) that the seized pivot pin is released. The gooseneck should be disassembled and all parts cleaned & lubricated. The excessive play in the pivots should be taken up by a combination of nylon and stainless steel washers.

- 5.4.1.4. An invoice was found on the vessel which showed that the rigging of PUFFIN II had been inspected in April 2012 by Holman Rigging, Chichester. The brief report noted that the gooseneck bracket was very worn. It is likely that no attempt has been made to address the wear noted during the inspection of 2012.

Figure 9: Worn bearing surfaces of gooseneck

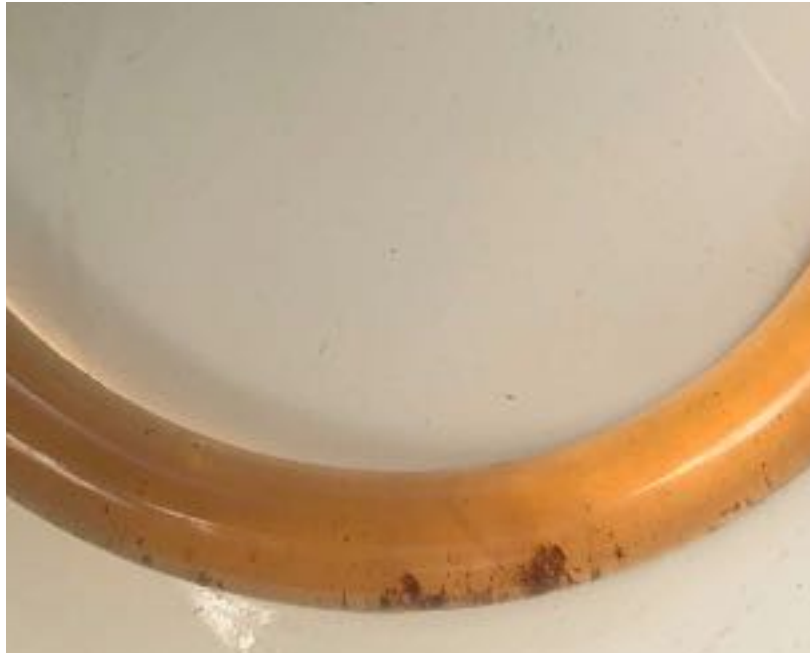
- 2.4.14. The diesel fuel was tested by taking three small samples from the tank, accessed via the fuel tank filler cap. All samples were found to contain particles of brown debris. One of these samples can be seen in Figure 10. A layer of sediment was also found lying in the bottom of the glass bowl of the primary fuel filter. In consideration of the possible age of the diesel fuel and the dirt deposits, it is **RECOMMENDED** (type A2 recommendation) that the fuel tank and fuel lines are emptied of all fuel. Both fuel filters should be replaced. The new fuel should be treated with a diesel additive, such as Soltron. See <https://www.force4.co.uk/soltron-enzyme-fuel-treatment-m.html> for further information on this product (see paragraph 5.5.2.2).

- 5.5.2.2. The diesel fuel was tested by taking three small samples from the tank, accessed via the fuel tank filler cap. All samples were found to contain particles of brown debris. One of these samples can be seen in Figure 10. A layer of sediment was also found lying in the bottom of the glass bowl of the primary fuel filter. In consideration of the possible age of the diesel fuel and the dirt deposits, it is **RECOMMENDED** (type A2 recommendation) that the fuel tank and fuel lines are emptied of all fuel. Both fuel filters should be replaced. The new fuel should be treated with a diesel additive, such as Soltron. See <https://www.force4.co.uk/soltron-enzyme-fuel-treatment-m.html> for further information on this product.

Figure 10: Brown debris in sample taken from fuel tank
