ORCA

Damage Inspection

Insurance Company Reference Number: ABC1234 - Mr Smith "ORCA"

On Monday 8th June 2018

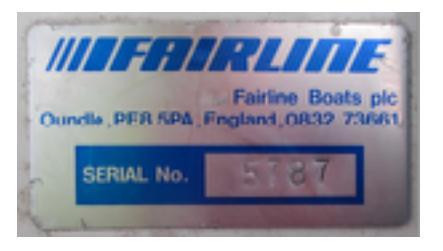
2.2.1. The vessel's Serial Number was stamped onto a small aluminium plate. This plate was bonded to the inside of a small locker in the cockpit and is shown in Figure 1. The vessel's Serial Number was xxx.

Figure 1: Vessel's Serial Number

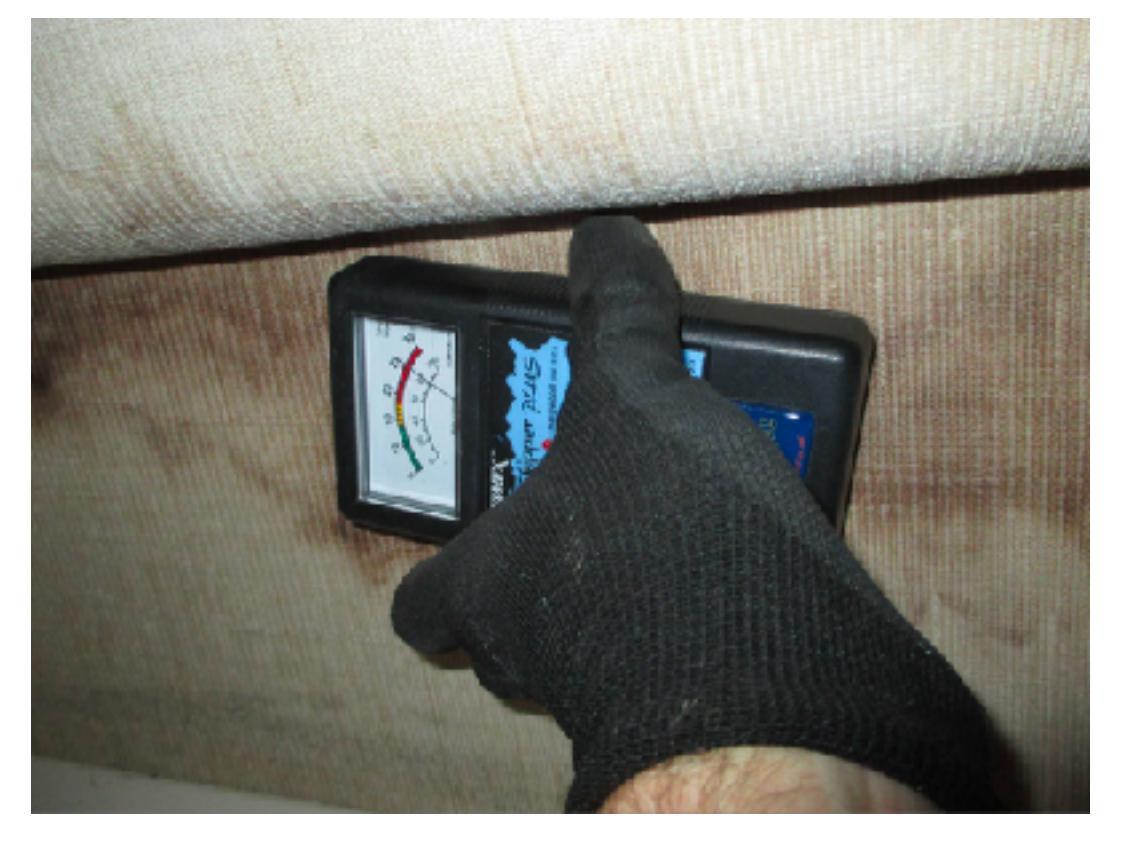
- 3.3.1. The soft bulkhead linings of the aft bulkhead of the second cabin were heavily stained from moisture ingress. These can be seen in Figure 4. It could not be confirmed, but the 'tide marks' on the woven fabric material suggested that the damage had been developing over a period of months, rather than over a shorter space of time. The foreaft plywood bulkhead panel of the second cabin, positioned towards the centreline of the vessel showed evidence of water damage. This area of damage was positioned next to the bunk cushions, suggesting that the cushion material would have held on to a certain amount of moisture. When pushed with a metal spike, the outer layer of the plywood in the discoloured area was found to be slightly soft.

Figure 4: High moisture in stained woven cloth of aft bulkhead, second cabin

- 6.3. The damaged lining of the second cabin (aft bulkhead only) should be removed and the area fully dried. This includes the removal of all of the woven cloth material and the foam-backed vinyl above the woven cloth. These linings should be replaced. Although slightly damp, the vinyl cloth on the hull side of the second cabin was not found to be damaged and therefore does not need to be removed.

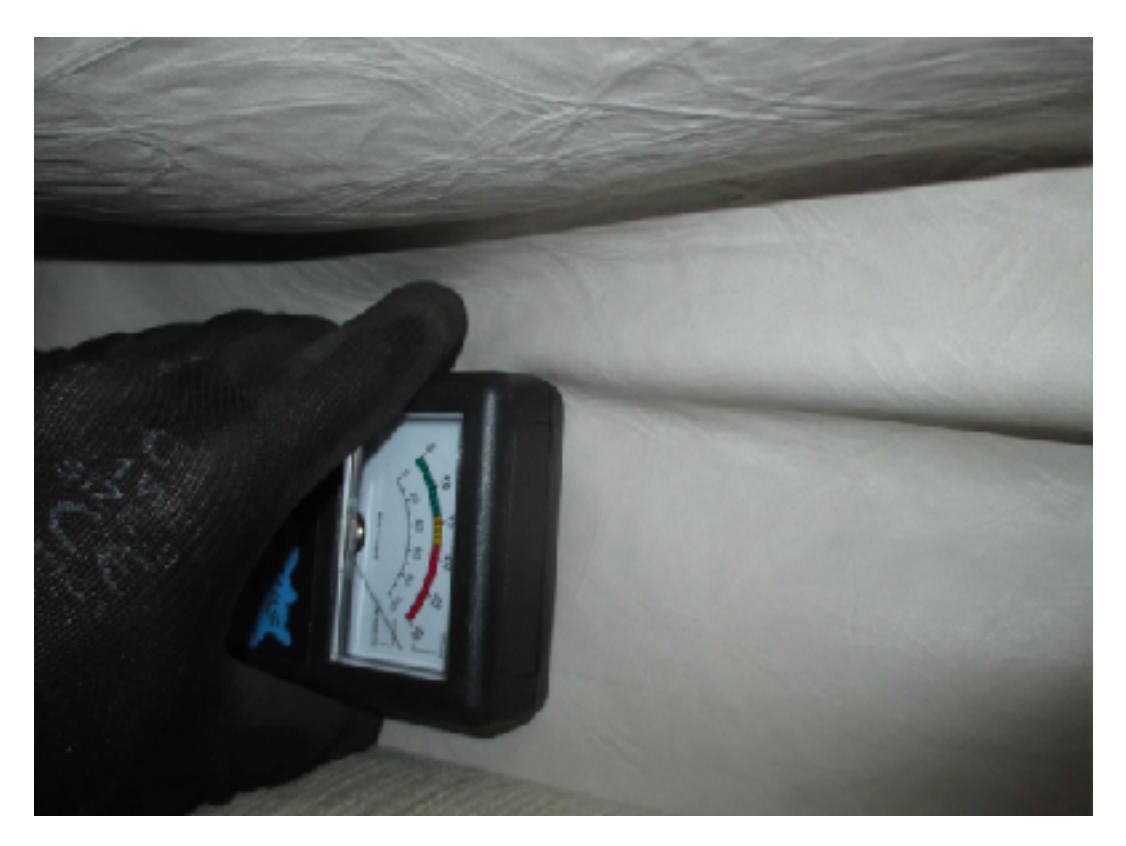
- 3.3.3. Moisture readings of the plywood and soft linings of the aft cabin were taken. The plywood was generally found to have medium to high levels of moisture, which is to be expected in an area that has recently suffered from a leak, even after several weeks of drying with a dehumidifier. Moisture levels in the woven fabric were also medium to high, as shown in Figure 4. The moisture levels in the sagging vinyl were very high and often 'off the scale' (Figure 5). The hull side in the second cabin was found to be also lined with a soft vinyl. This was well bonded to the hull side and free of visible degradation. Moisture levels at the aft end of this hull lining, located near to the damaged woven fabric, were found to be high. Readings in this vinyl reduced to low in areas well away from the damaged fabric & vinyl.

Figure 5: High moisture in PVC lining of aft bulkhead, second cabin

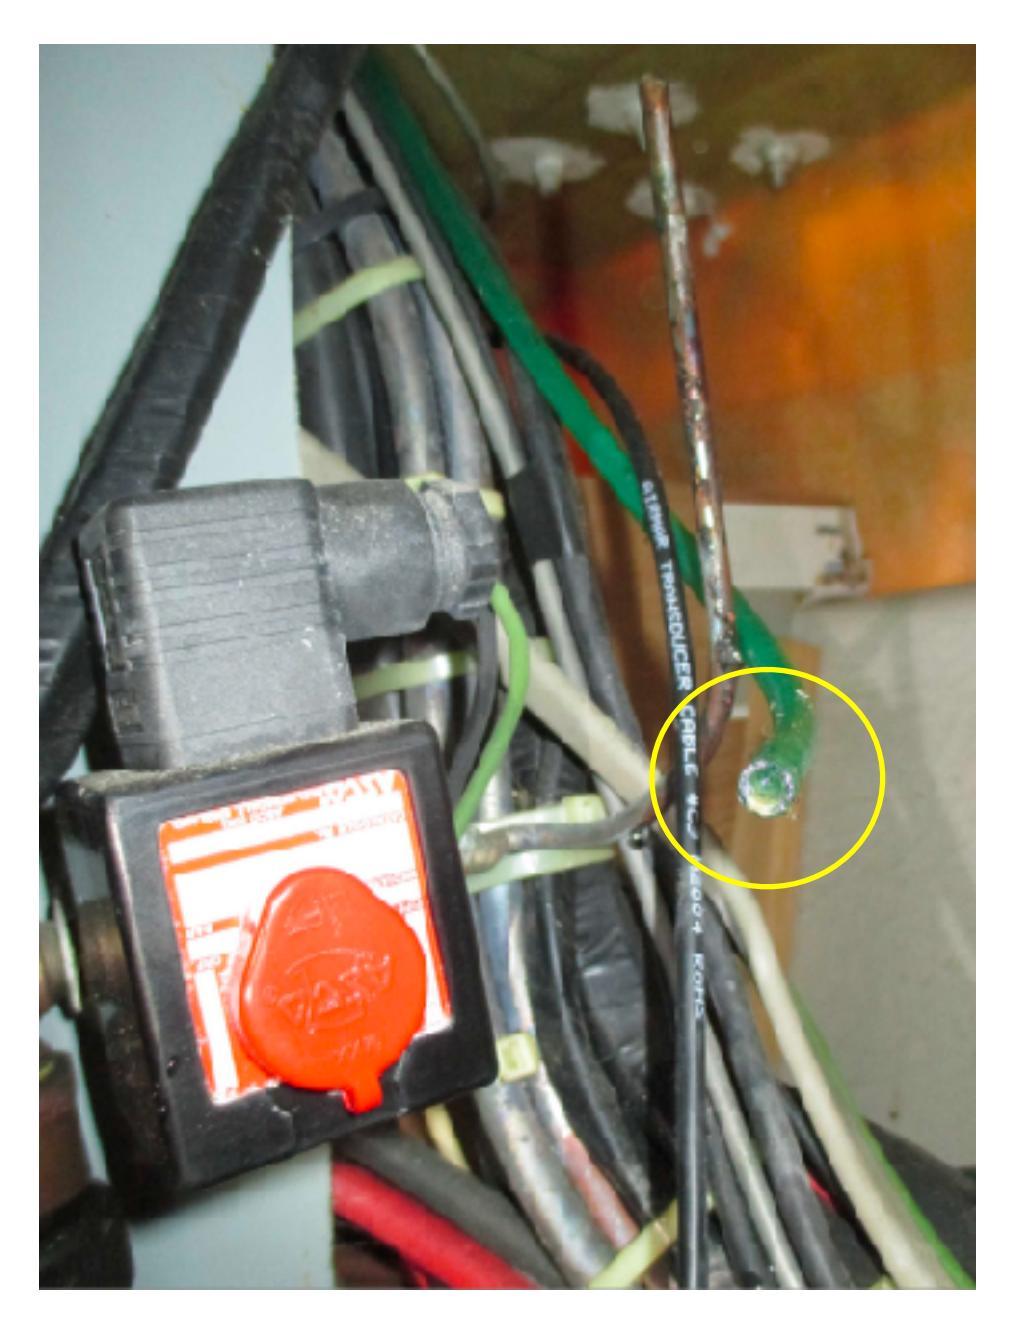
- 4.1.5. The forward, starboard section of the engine compartment, located forwards of the starboard fuel tank, was reinspected for evidence of water. Drops of water were found to be dripping down onto the plywood supporting base of the starboard fuel tank and also onto the hull surface. Further visual inspection found that these drops of water were originating from the enclosed space that was immediately behind the backrest of the helm seat. The seating cushions on the starboard side of the saloon were lifted to reveal a number of screwed down plywood access panels, in the backrests of the saloon seating. The panel located immediately above the area of water leakage was removed by the surveyor. This is shown in Figure 6. The removal of this panel revealed an open space behind the backrest of the helm seat. The solenoid control valve of the vessel's fresh water system was mounted within this space. This valve was connected to one of the vessel's fresh water hoses (Figure 7). A small diameter (< 5mm) copper pipe was fitted to the outlet of this valve. The length of this copper pipe was approximately 150 mm. When the galley or heads tap was turned on, it was found that water leaked out of this small pipe at a rate of approximately one drop every two seconds. The water drops were observed and were found to drip onto part of the vessel's 12 volts d.c. wiring loom and then down into the engine compartment, just in front of the starboard fuel tank. In addition to dripping onto the wiring loom, some of this water was seen to be leaking onto a grey coloured GRP moulding, which formed part of the saloon seating support structure. The water then drained off the shelf and onto the GRP moulding that formed the athwartships bulkhead of the second cabin, which is identified in Figure 3.

- 4.1.7. Inspection of the small diameter copper pipe of the solenoid control valve revealed that a small diameter, green-coloured hose was installed next to the control valve. It could not be confirmed, but it is very likely that this green hose was originally attached to the end of the small diameter copper pipe. This hose was re-attached to the end of the surveyor.

- 5.1. The evidence gathered by the surveyor indicated that the water damage reported by Mr Smith had most likely been developing for some months. The water leak originated from the solenoid control valve and was due to a detached hose on the outlet end of this valve. Water was only found to leak from this valve when the taps were running, making it likely that the leak had been in existence for some time and was leaking water into the engine compartment and second cabin at a very slow rate.

Figure 7: Detached hose on solenoid control valve

- 6.1. Although the green plastic outlet hose of the solenoid control valve was re-fitted by the surveyor, this was not intended to be a long-term fix. A suitably qualified marine plumber should be tasked with servicing the solenoid control valve in order to prevent further leakage. The work should include the cleaning of all corrosion deposits on the copper pipe. Once it has been confirmed that the green hose is meant to be fitted to the copper pipe, the green hose should be blown-through with air to ensure that the hose is not blocked along its length. The green hose should then be firmly secured to the copper pipe, ideally with two hose clips constructed from stainless steel or other non-corroding material.
