fieldhouse yacht surveys

BIRD SONG

Pre-purchase Survey

On Friday 12th April 2018

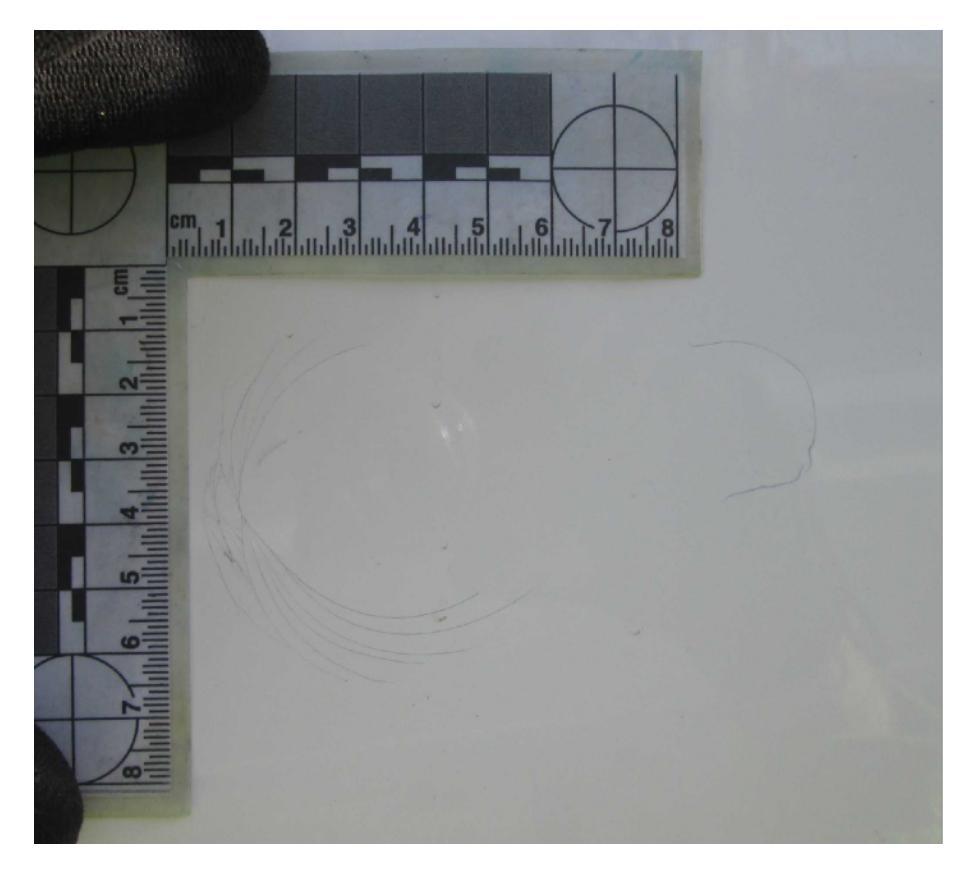
- 5.1.3.2. The topsides were inspected visually. The gel-coat was found to be in very good condition with no signs of major trauma. There was one localised area of gel-coat cracking on the starboard topside, positioned 320 mm below the deck edge and aligned with the second stanchion post aft from the bow. This area of cracking consisted of two arc-shaped cracks, with one arc approximately approximately 50 mm in diameter and the other 20 mm in diameter. These cracks can be seen in Figure 5. Hammer testing of the laminate around these cracks was performed. The dullsounding return of the hammer indicated that there may be some impact damage of the underlying laminate immediately beneath the cracks. The dull hammer sound may also be due to a localised area of poor laminate construction, where the glass fibres have been poorly wetted by the resin during construction of the hull. The moisture of the laminate around these cracks was measured and was found to be higher than the adjacent topsides, indicating that some moisture has been absorbed into the laminate via these cracks. The internal linings of the living quarters prevented access to the internal surfaces of the hull in the region of this damage. It is **RECOMMENDED** (type C recommendation with an implementation time of one to two years) that the cracks are cut back to sound material and suitably repaired. If any laminate is cut out during this work, it should be replaced with fibreglass cloth and epoxy resin or good quality polvester resin.

Figure 5: Two arc-shaped cracks in starboard topside

- 2.2.1. There were six **type C recommendations** that do not require immediate attention but are to be dealt with within a specified time period:
- 2.2.2. The topsides were inspected visually. The gel-coat was found to be in very good condition with no signs of major trauma. There was one localised area of gel-coat cracking on the starboard topside, positioned 320 mm below the deck edge and aligned with the second stanchion post aft from the bow. This area of cracking consisted of two arc-shaped cracks, with one arc approximately approximately 50 mm in diameter and the other 20 mm in diameter. These cracks can be seen in Figure 5. Hammer testing of the laminate around these cracks was performed. The dullsounding return of the hammer indicated that there may be some impact damage of the underlying laminate immediately beneath the cracks. The dull hammer sound may also be due to a localised area of poor laminate construction, where the glass fibres have been poorly wetted by the resin during construction of the hull. The moisture of the laminate around these cracks was measured and was found to be higher than the adjacent topsides, indicating that some moisture has been absorbed into the laminate via these cracks. The internal linings of the living quarters prevented access to the internal surfaces of the hull in the region of this damage. It is RECOMMENDED (type C recommendation with an implementation time of one to two years) that the cracks are cut back to sound material and suitably repaired. If any laminate is cut out during this work, it should be replaced with fibreglass cloth and epoxy resin or good quality polyester resin (see paragraph 5.1.3.2).

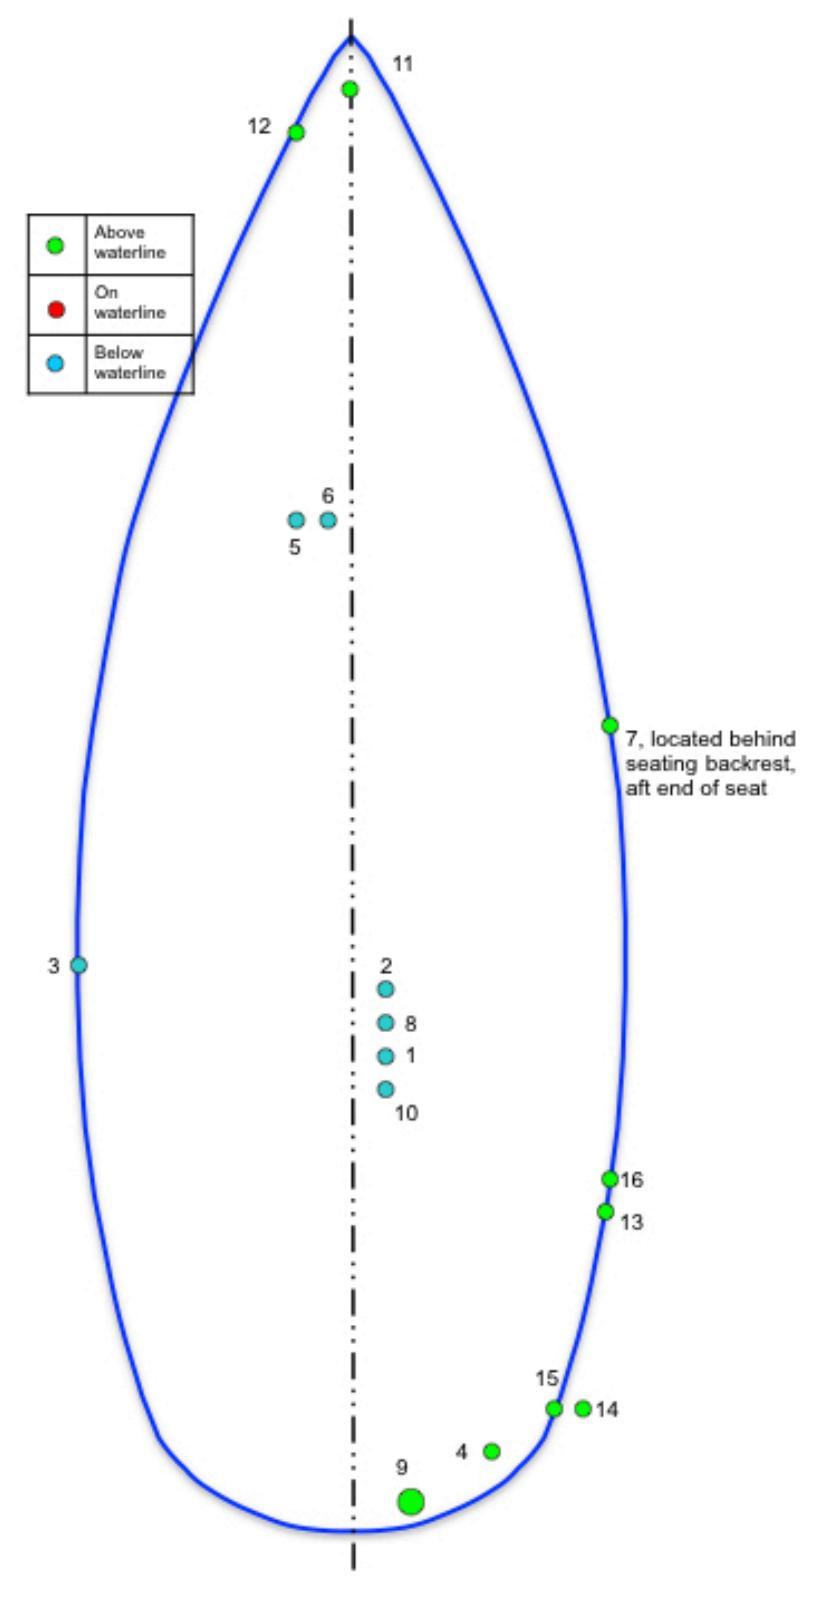
5.1.9.1. Figure 6 and Table 3 below show the location and function of the skin fittings, together with the condition of the valves, hoses and clips. The items in red text in Table 3 indicate a defect or poor condition of the items and are addressed in the recommendations below.

Figure 6: Location of skin fittings (plan view looking from above)

- 5.1.9.3. The skin fittings were all in serviceable condition. All fittings on or below the waterline were bronze or dezincification resistant brass (apart from the plastic speed impeller & depth transducer) and showed no signs of dezincification. All skin fittings located below the waterline were fitted with an isolation valve.
- 5.1.9.4. During the out-of-water part of the survey, the aft lifting sling of the travel hoist

obscured the skin fitting of the heads toilet inlet (item 2 in Figure 6 and Table 3), therefore the condition of the external parts of this fitting could not be assessed.

- 2.2.4. The electrical connection between the pear anode and the skin fittings of the heads outlet, heads inlet, engine cooling intake, cockpit drains (items 1, 2, 8 and 10 in Figure 6 and Table 3), the propeller shaft, the bronze P-bracket, the rudder stock and the engine casing was tested with a multimeter. The continuity between the hull anode and these items of equipment is summarised in Table 4. The recommended maximum resistance is 1.0 Ω . It was found that the wire between the anode and the rudder stock was broken. It is **RECOMMENDED** (type C recommendation with an implementation time of two months) that the bonding of the anode to the skin fittings, propeller shaft, rudder stock and engine casing is inspected further and the wires & terminals overhauled if necessary (see paragraph 5.1.12.3).

- 5.1.9.6. Refer to paragraph 5.1.12.3 for the recommendation relating to the bonding of the skin fittings of the heads outlet, heads inlet, engine cooling intake and cockpit drains (items 1, 2, 8 and 10 in Figure 6 and Table 3) to the hull anode.

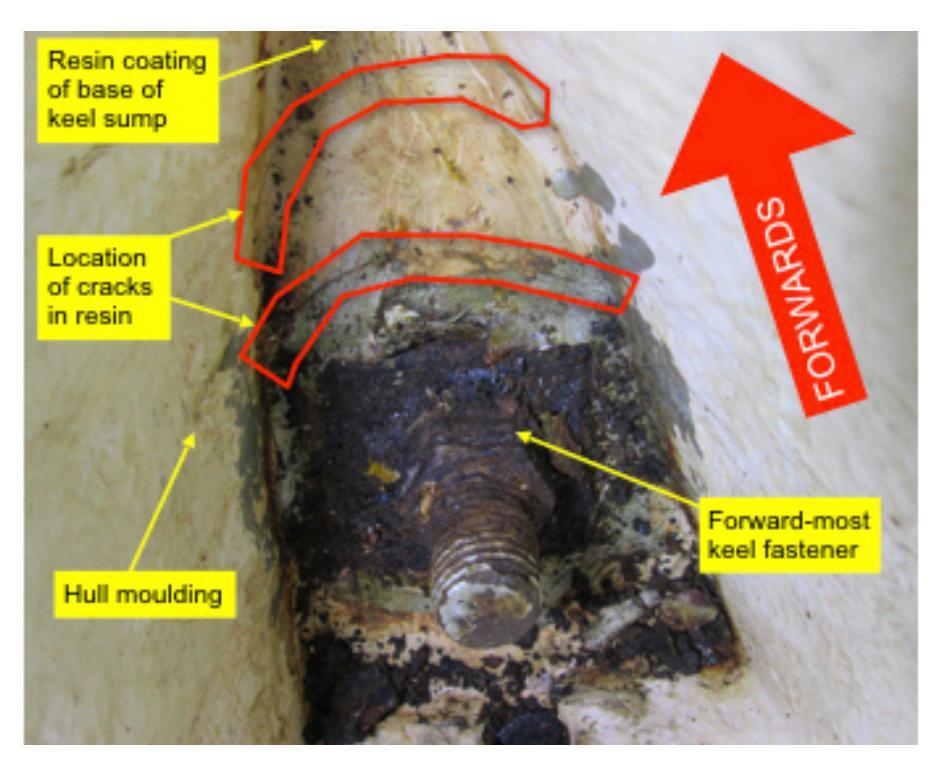
- 5.2.3.2. There were two short cracks in the resin coating of the hull, located just forwards of the forward-most keel stud. There was no evidence to indicate the origin of these cracks, but they may have been caused by the over-tightening of the fastening stud, by a minor grounding impact or by normal flexing of the hull moulding in this region. The two cracks are shown in Figure 7. The exposed parts of the two cracks ran along the surface of the resinous coating, but did not extend athwartships and into the hull laminate. It could not be determined if the cracks extended deep into the resin or if

Figure 7: Cracks in resin of keel sump, located at forward-most keel stud.

- 2.1.2. There were two short cracks in the resin coating of the hull, located just forwards of the forward-most keel stud. There was no evidence to indicate the origin of these cracks, but they may have been caused by the over-tightening of the fastening stud, by a minor grounding impact or by normal flexing of the hull moulding in this region. The two cracks are shown in Figure 7. The exposed parts of the two cracks ran along the surface of the resinous coating, but did not extend athwartships and into the hull laminate. It could not be determined if the cracks extended deep into the resin or if they extended into the laminate beneath the resin. It is **RECOMMENDED** (type A2 recommendation) that the two cracks are investigated further to determine if they extend into the structural laminate beneath this keel stud (see paragraph 5.2.3.2).

they extended into the laminate beneath the resin. It is **RECOMMENDED** (type A2 recommendation) that the two cracks are investigated further to determine if they extend into the structural laminate beneath this keel stud.
