# fieldhouse yacht surveys

# TRAILBLAZER

# Keel Damage Survey

On Thursday 4th March and Wednesday 24th March 2021

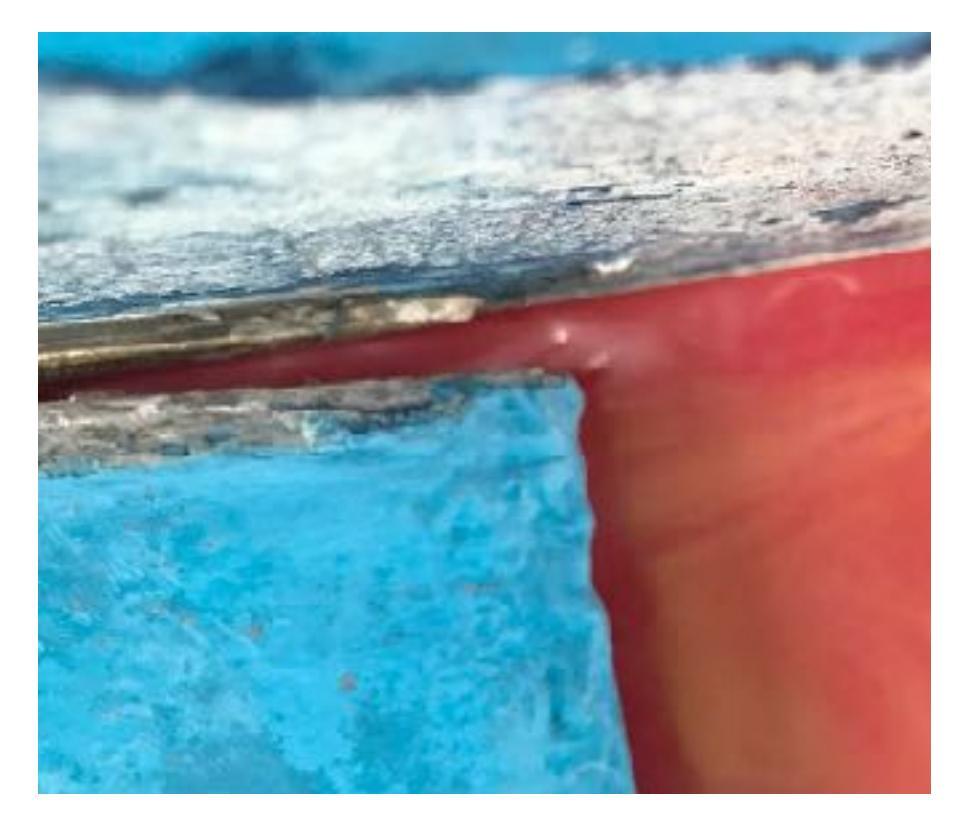
- 5.1.1. During the inspection of 24<sup>th</sup> March, the boat was initially supported by its steel cradle. When the boat was lifted off the cradle using the boat hoist, a gap appeared in the hullto-keel-join at the aft end of the keel. Paragraph 1.2 describes that [Name removed] noted a gap at the forward end of the keel when the boat was lifted on or around 2<sup>nd</sup> March. The reason for the gap appearing at the forward end and then at the aft end could not be determined, but this may have been due a slight difference in pitch of the vessel during the two lift dates. A difference in boat pitch would change the relative loadings on the forward and aft keel studs, thus opening up the gap at one end more than the other.

- 5.1.2. The gap at the aft end of the keel (seen on 24th March) was a maximum of 5mm, tapering to zero over a distance of 130mm when measured in the fore-aft direction. A smaller gap at the forward end of the keel was noted. This gap was maximum 2mm, tapering to zero over a 100 mm distance. The 5mm gap at the aft end of the keel is shown in Figure 1.

Figure 1: 5mm gap at aft end of keel when vessel suspended in slings

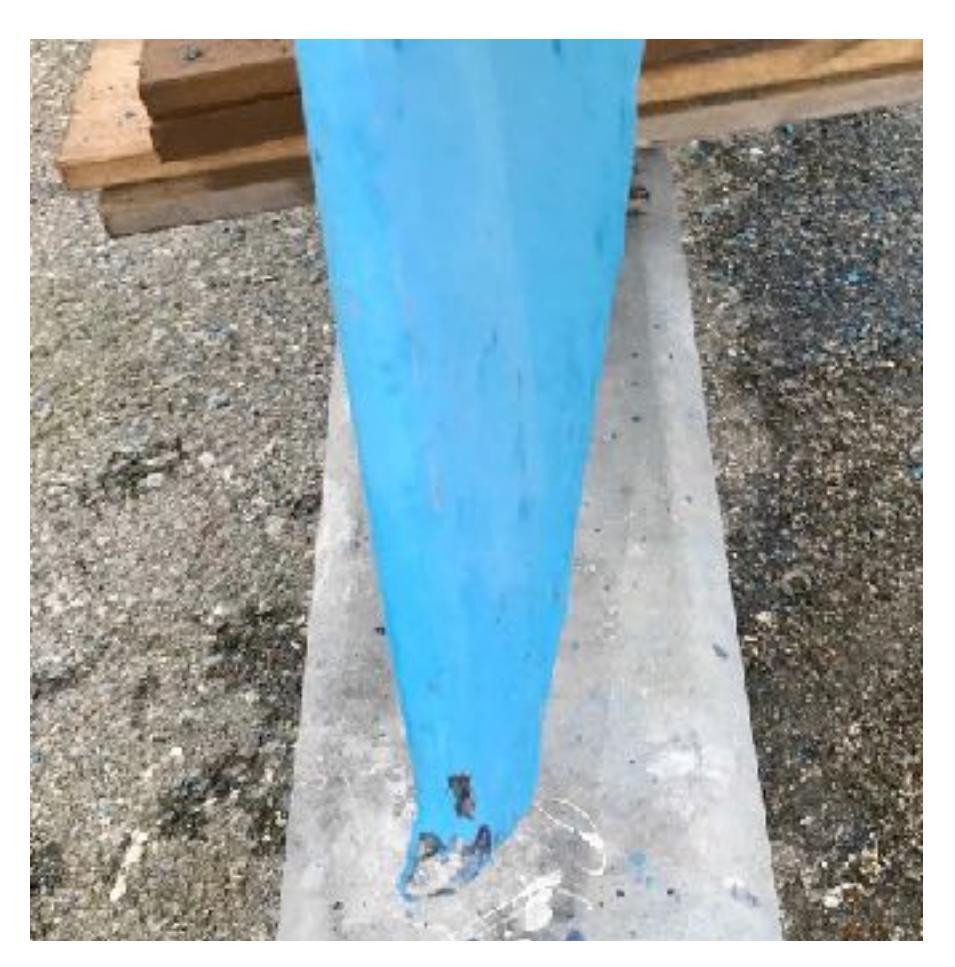
- 5.3.1. The keel was inspected, except where the bottom of the keel was hidden by the two timber blocks and the base of the cradle. Evidence of impact damage was noted along the lower edge, particularly near to the forward end and on the port side. These areas of damage were all coated in antifouling paint, indicating that these had existed for some time.
- 5.3.2. The aft, lower corner of the keel was found to be bent to port. The antifouling paint around this deformation was found to be missing and parts of the exposed lead material were exposed. This area of damage is shown in Figure 2.

Figure 2: Bent keel at lower, aft corner

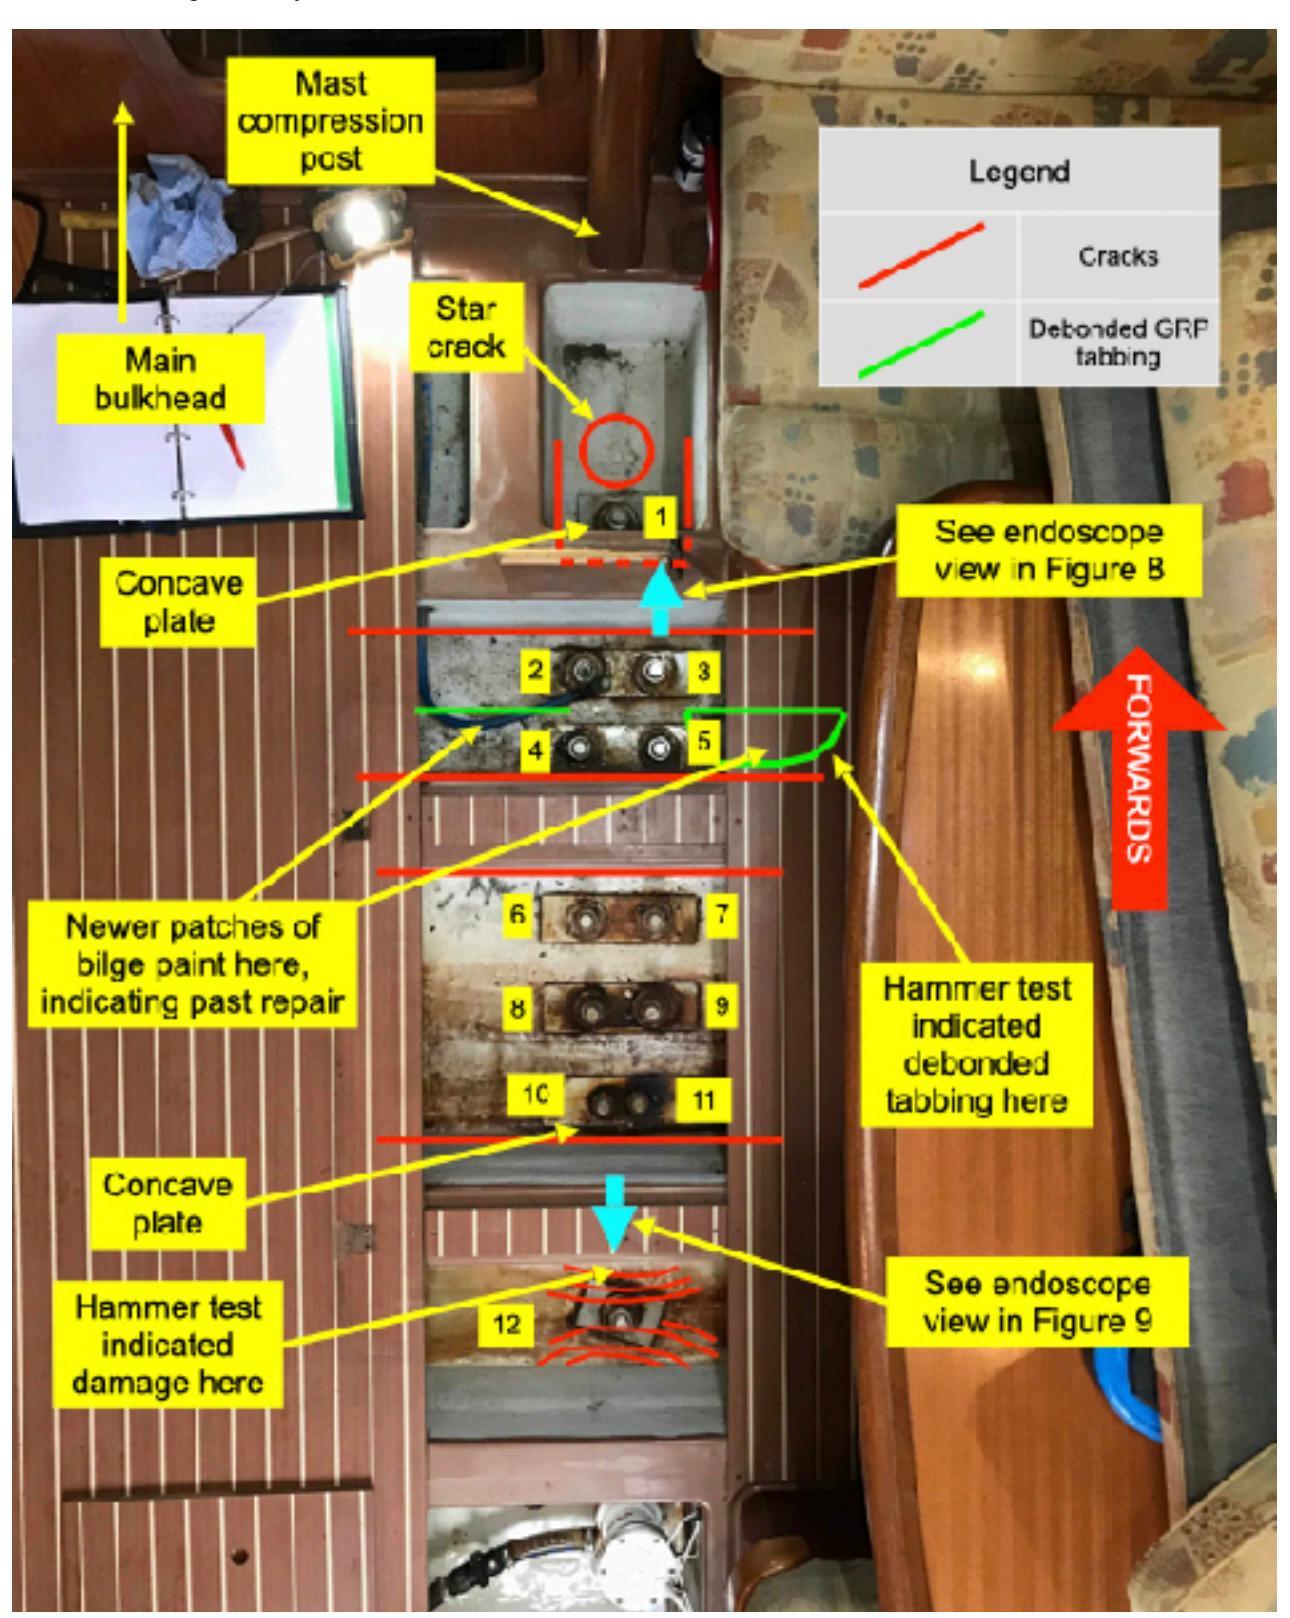
- 5.4.1. Figure 3 shows a plan view of the part of the Hull Internal Moulding that was located aft of the main bulkhead and forwards of the engine bed.
- 5.4.2. Where accessible for inspection, visual inspection and hammer testing revealed a number of areas of cracking and debonded tabbing. These are shown by the red and green lines in Figure 3. It was also found that the stainless steel backing plates beneath keel studs numbered #1, #10 and #11 were found to be bent into a concave shape.
- 5.4.3. There was evidence of a relatively recent application of bilde paint around keel studs #2 to #5. This indicates that the hull & stiffening structure in this region may have been repaired in the past.

Figure 3: Plan view of Hull Internal Moulding around keel studs

- 6.5. All damaged GRP tabbing and laminate in the areas described in section 5.4 should be cut out. All bilge paint should be removed from the areas surrounding the repairs. A common method of repairing the debonded joints between the Hull Internal Moulding and hull moulding is to cut away the bottom flanges of the Hull Internal Moulding. As mentioned in paragraph 4.2.5, it could not be determined if flanges exist at the lower end of each web on TRAILBLAZER. This will become evident when the damaged GRP tabbing is removed from the hull. The vertical webs of the Hull Internal Moulding should then be joined to the hull with layers of GRP, alternating between layers of mat and woven cloth. Ensure that the repairs extend all of the way up the vertical webs of the top hat sections of the Hull Internal Moulding. The layers of repair should be tapered in order to prevent stress concentrations due to sudden changes in laminate thickness. Ensure that as many layers as possible run beneath the stud backing plates, but taking into account the length of the keel studs, to ensure that the locking nuts will fully engage on the threads of the studs. The new repairs should be thicker and stronger than the removed laminate.

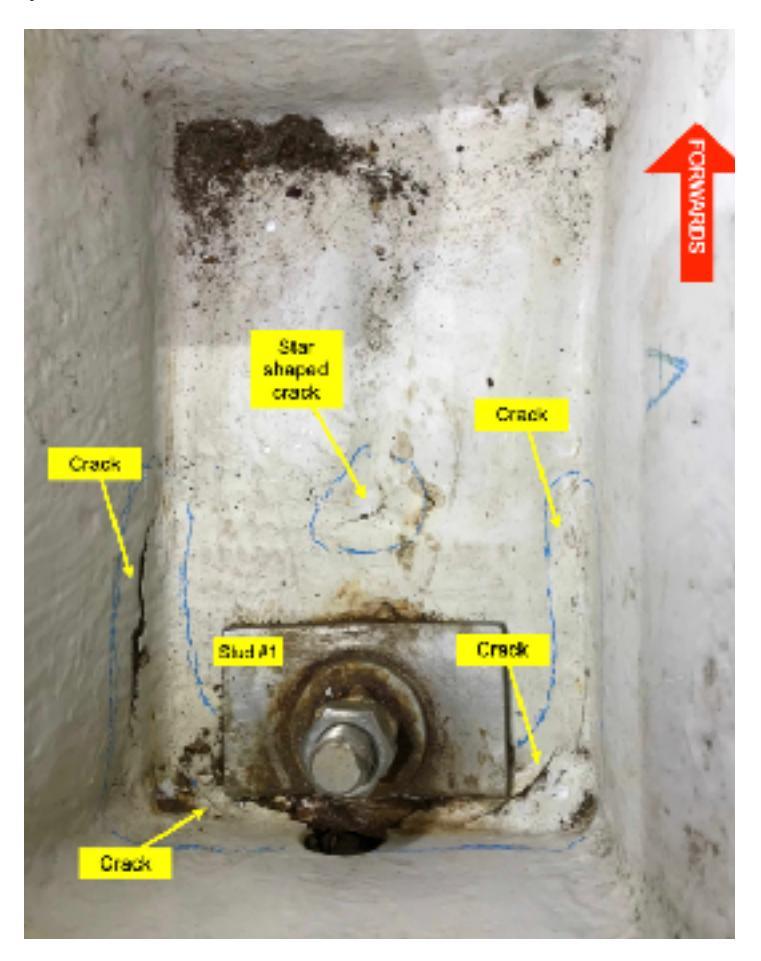
- 5.4.4. A star-shaped crack was found in the hull moulding, located immediately forwards of the forward-most stud (stud #1). The location of this crack was approximately in the same region as the forward end of the keel (Figure 4). This crack indicated that the internal stiffening structure may have been damaged as a result of an upward load on the forward end of the keel. Figure 4 also shows linear cracking around the top hat sections surrounding stud #1.

Figure 4: View of damage at forward-most keel stud (stud #1)

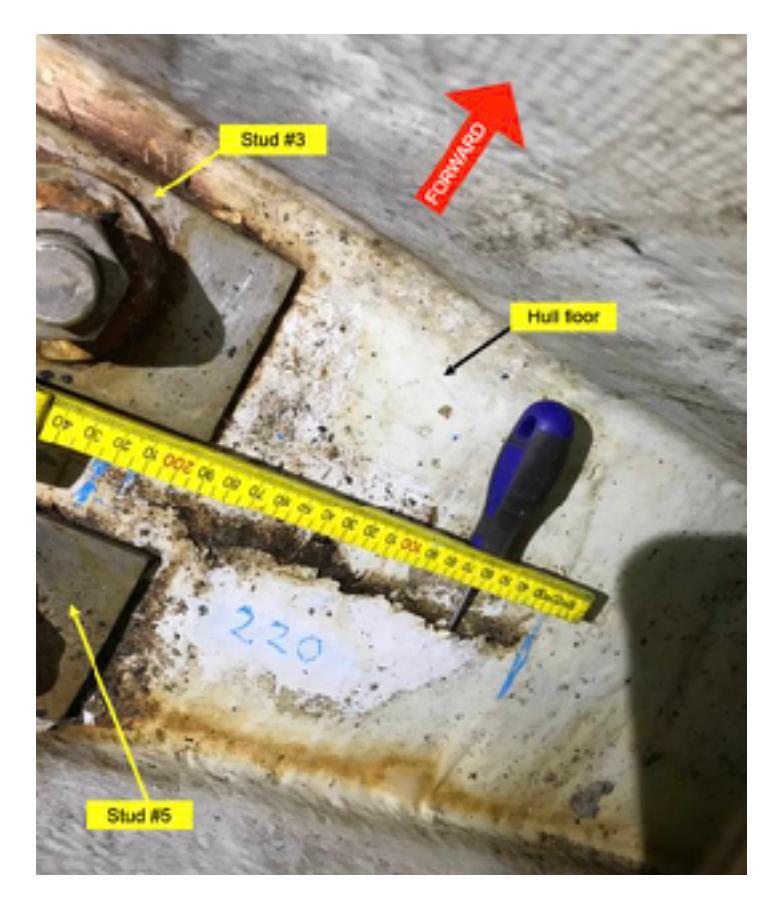
- 5.4.5. Figure 5 shows a 220mm long section of debonded GRP tabbing around studs #2 to #5.
- 5.4.6. The top hat sections of the Hull Internal Moulding were fitted with limber holes, to allow bilge water to drain between compartments. In order to assess the condition of the GRP tabbing between the webs of the top hat sections and the hull, an endoscope was inserted into a number of these limber holes. Figure 6 shows a view looking forwards, towards stud #1. This view shows that a crack exists between the web of the Hull Internal Moulding and the GRP tabbing or bonding paste that secured the top hat section to the hull.

Figure 5: Debonded GRP tabbing at keel studs #3 & #5

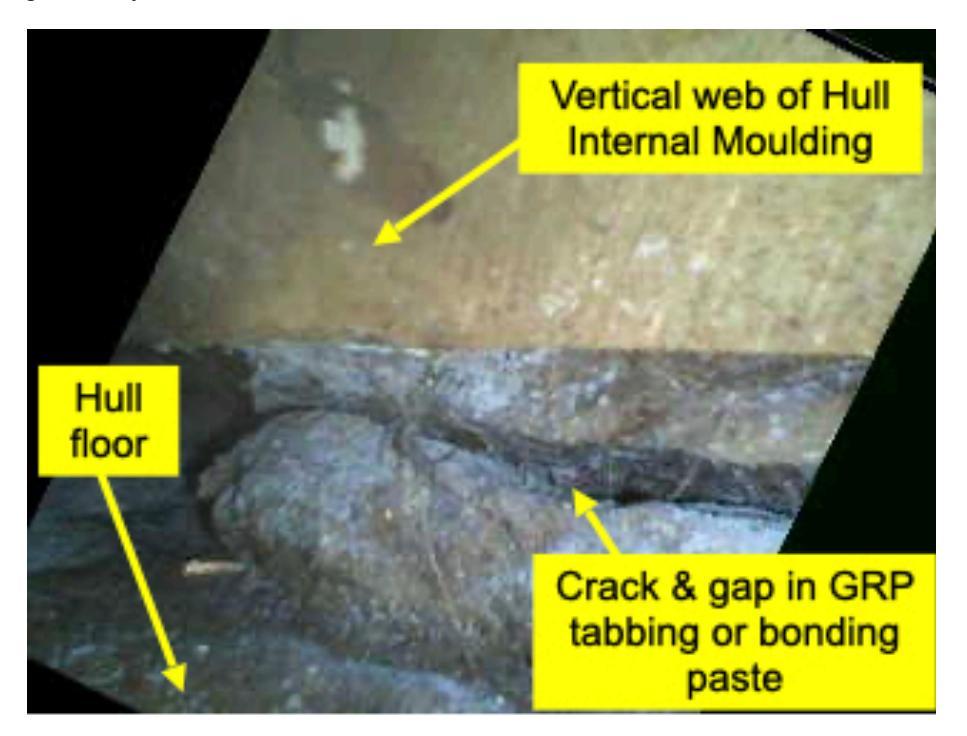
Figure 6: Endoscope view looking forwards towards stud #1, inside top hat section

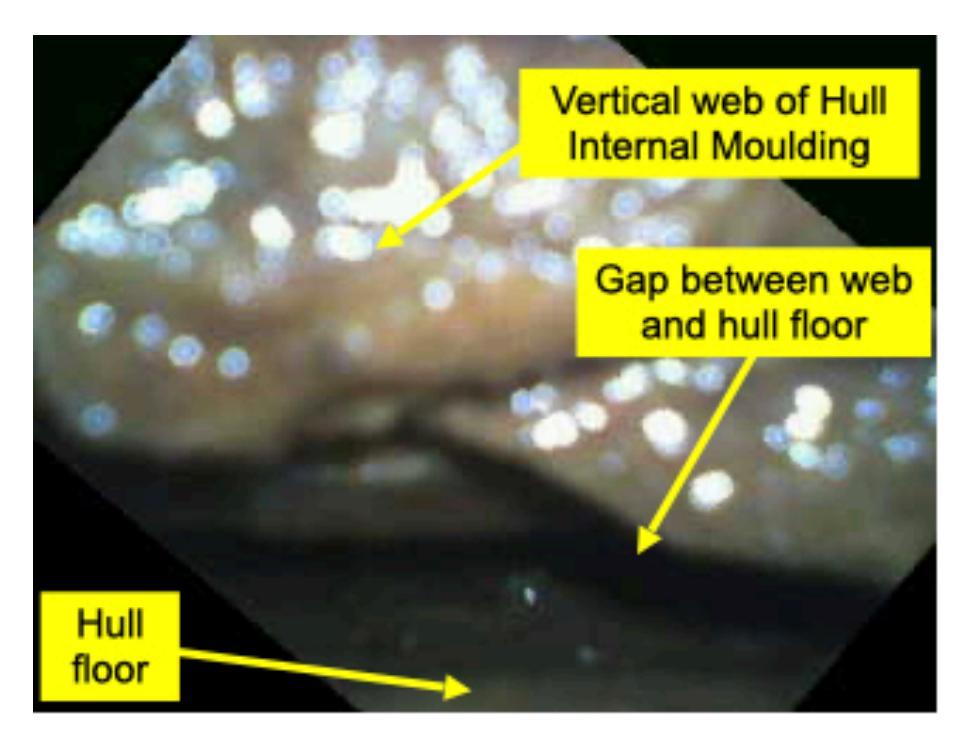
- 5.4.7. Figure 7 shows an endoscope view looking aft, towards stud #12. Although this image is of poor quality, it clearly shows a dark gap between the Hull Internal Moulding and the floor of the hull. With the endoscope pointing to the same location, this device was set to record on video mode. The vessel was then lowered down onto its cradle. The video was then played to determine if the gap shown in Figure 7 closed. The video recording confirmed that the vertical web of the Hull Internal Moulding at stud #12 moved downwards, closing the gap. This video can be seen through the following link:

5.4.8. This video provides evidence that in the region of stud #12, there is a break in the bonded joint between the Hull Internal Moulding and the hull. When the vessel is held in the lifting slings (or when afloat), the weight of the keel pulls the hull downwards, opening up the gap between the Hull Internal Moulding and the hull. This is seen on the outside of the vessel as a gap between the aft end of the keel and the hull.

Figure 7: Endoscope view looking aft towards stud #12, inside top hat section. See <u>video</u> showing gap closing when vessel lowered onto keels
