fieldhouse yacht surveys

MARY BELL

Damage Inspection

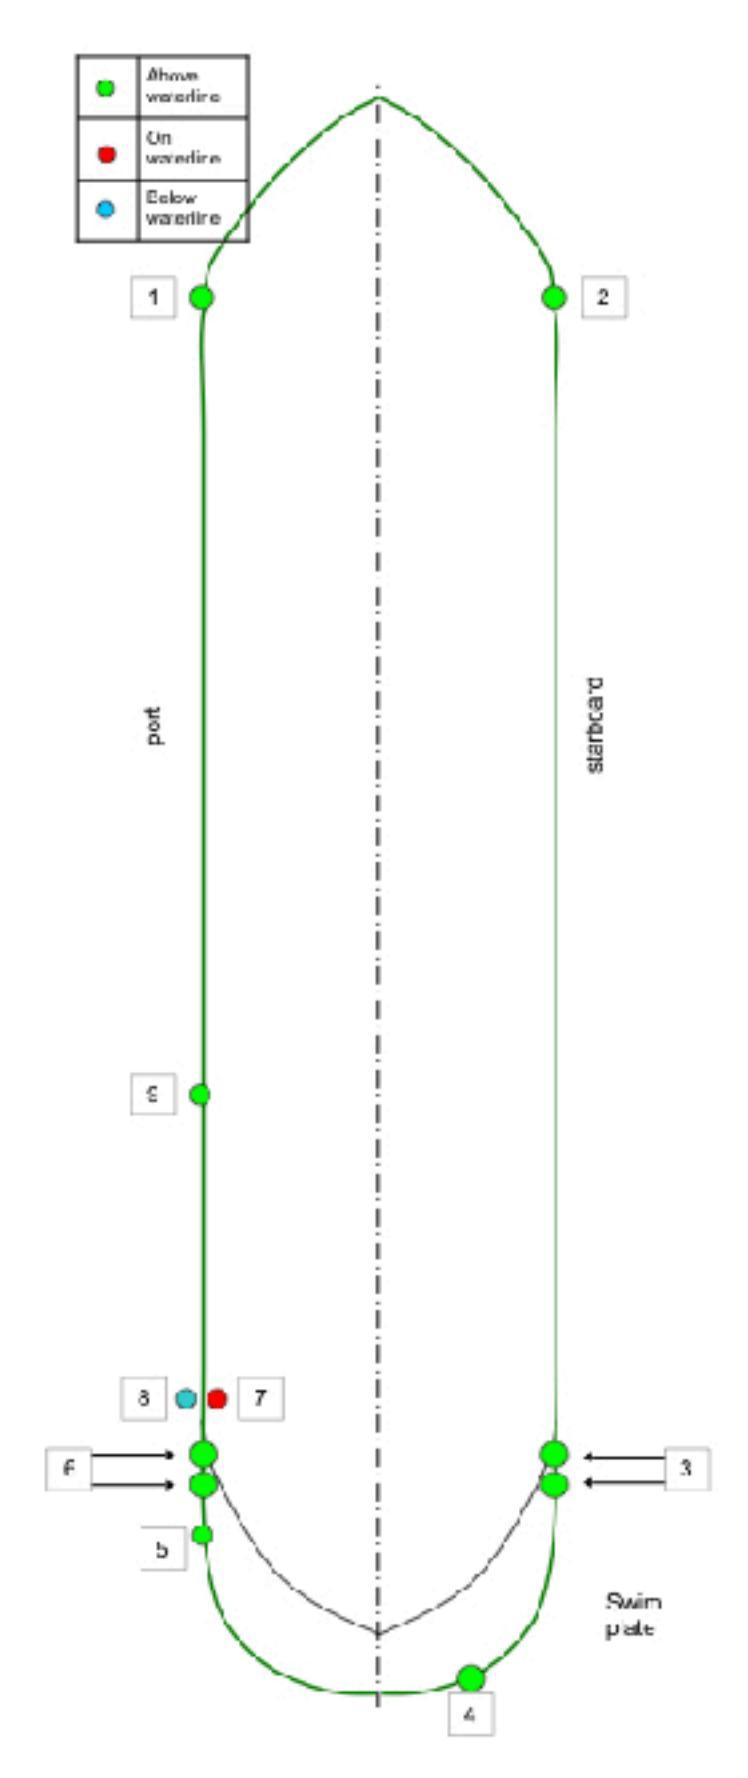
4.1.1. Table 2 and Figure 1 summarise the through-hull penetrations found on MARY BELL.

- 4.1.2.1. The through-hull fittings of the engine exhaust outlet, the un-used bilge pump hose and the heads waste water pump-out (items 4, 5 & 9 in Table 2 and Figure 1) were all located below the minimum recommended clearance height of 250 mm above the vessel's static waterline and were not fitted with isolation valves. Boat Safety Scheme guidelines state that where it is necessary to have the through-hull fitting below the 250 mm height, the through-hull should be permanently and securely connected to ducts or hoses that are watertight up to the 250 mm level. In practise, this means that the attached hoses should be secured to the skin fitting with two stainless steel hose clips, if possible. Additionally, the attached hose should be looped upwards to form a swan neck, where the top of the loop is at least 250 mm above the waterline. This swan neck should be securely held in place to prevent it from falling below 250 mm.

- 4.1.2.2. Table 2 above shows that the through hull openings of the un-used bilge pump outlet and the heads waste water pump outlet (items 5 & 9 in Table 2 and Figure 1) were very close to the waterline. Note that the attached hose of the un-used bilge pump was not connected to any pump and the gradient of the hose sloped downwards.

- 6. After the stern of vessel had dropped by 30 to 40 mm (the height of the rust holes in the side of the LPG cylinder locker above the vessel's original waterline, discussed in paragraph 4.1.3.2), the vessel would have taken on water more rapidly. Soon after, the hose of the un-used bilge pump (item 5 in Table 2 and Figure 1) would have reached the waterline and then taken on water through the hose.

- 7. Finally, when the waterline reached the four air vents of the engine compartment (items 3 & 6 in Table 2 and Figure 1), these large openings would have allowed water into the vessel at a very high rate, sinking the boat within minutes.

Figure 1: Plan view of MARY BELL showing locations of through-hull penetrations

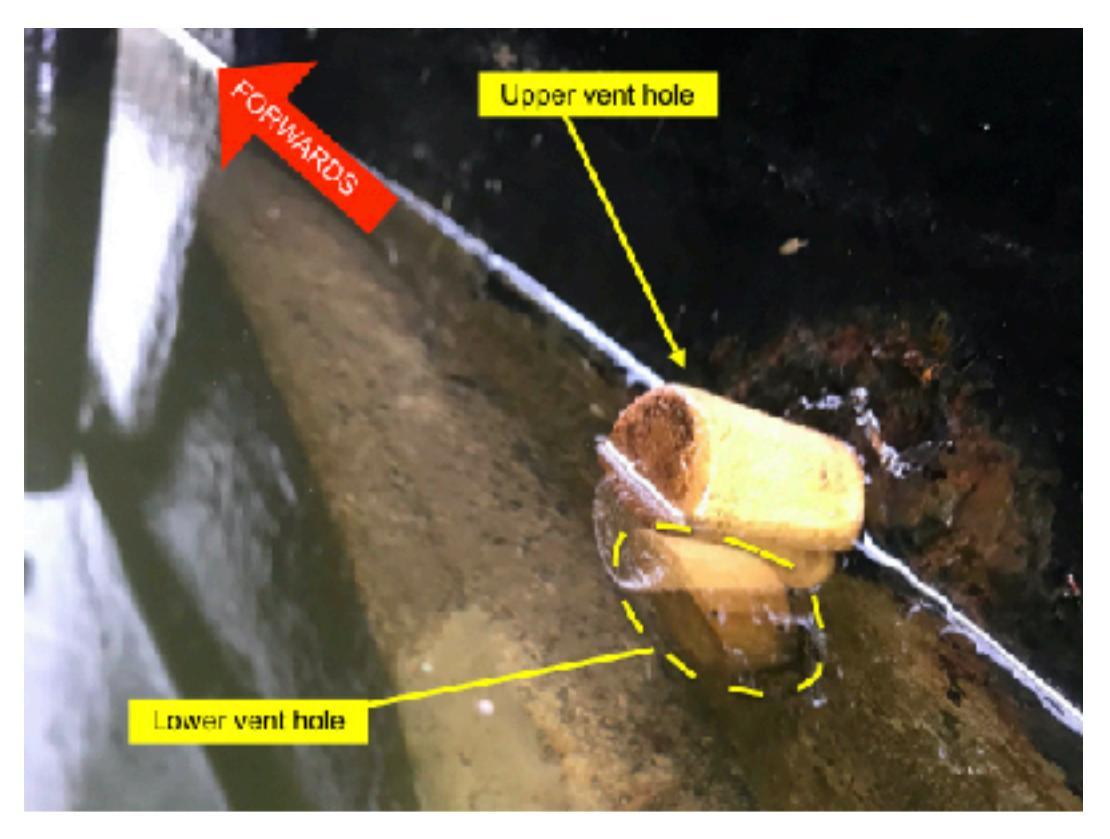
- 4.1.3.1. The gas cylinder storage locker was fabricated from steel plate, with continuously welded seams. The port side of the locker was formed by the topside plating and was fitted with two vent holes to allow any leaking gas to escape out of the vessel. The upper vent hole (item 7 in Table 2 and Figure 1) was located approximately 10 mm below the waterline. At the time of the survey, this hole was blocked off with an old rubber glove. A second vent hole was located immediately below the first (item 8 in Table 2 and Figure 1) and was positioned approximately 30 mm below the waterline. During the survey, both vent holes were blocked by the Surveyor with softwood bungs, to minimise the risk of further flooding via these vents. The outside position of these vent holes are shown in Figure 2.

Figure 2: Exterior view of LPG cylinder locker vent holes (wooden plugs fitted by Surveyor)

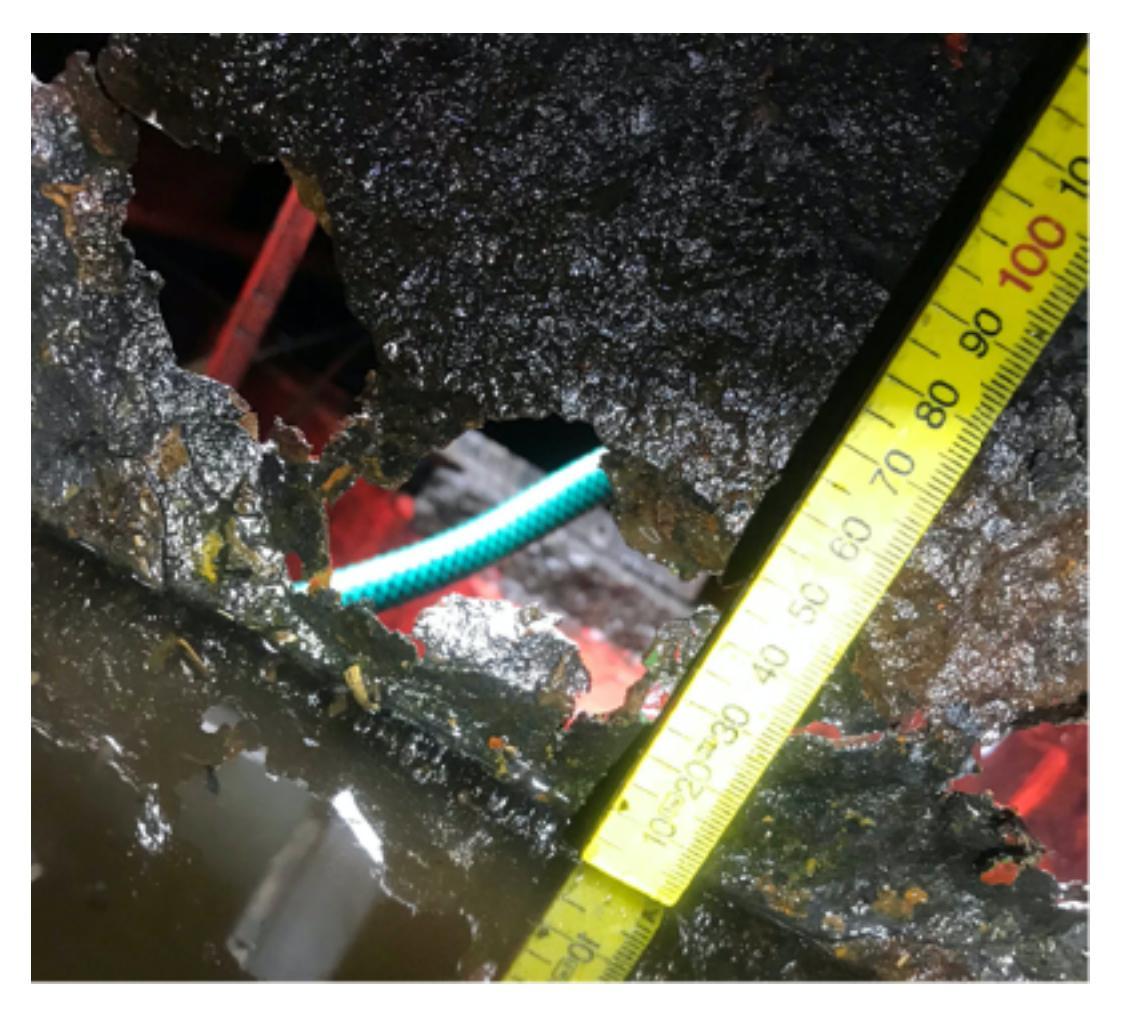
- 4.1.3.2. The lower vent hole of this locker would have allowed river water to enter this locker. In normal operation, the welded base and sides of the locker would have prevented water ingress into the engine compartment & vessel interior. Visual inspection of the locker base and sides found that all steel plating was in fair condition, except for the aft steel panel of this locker. Rust holes through this panel were noted. One of these holes was approximately 50 mm diameter. When lightly kicked with a rubber wellington boot (no steel toe-cap), further holes were created to port & starboard of the original holes. An image of these holes can be seen in Figure 3, shown from inside the gas cylinder storage locker. Note that the water height inside this locker was the same as the water level outside of the vessel. In the photograph, the minimum height between the edges of these holes and the waterline was 15 to 20 mm. Note that this height was measured whilst the Surveyor was on board, standing on the port side of the engine compartment. With the vessel free of people, these holes would have been approximately 30 to 40 mm above the waterline.

Figure 3: Corroded plating on inside panel of LPG cylinder storage locker

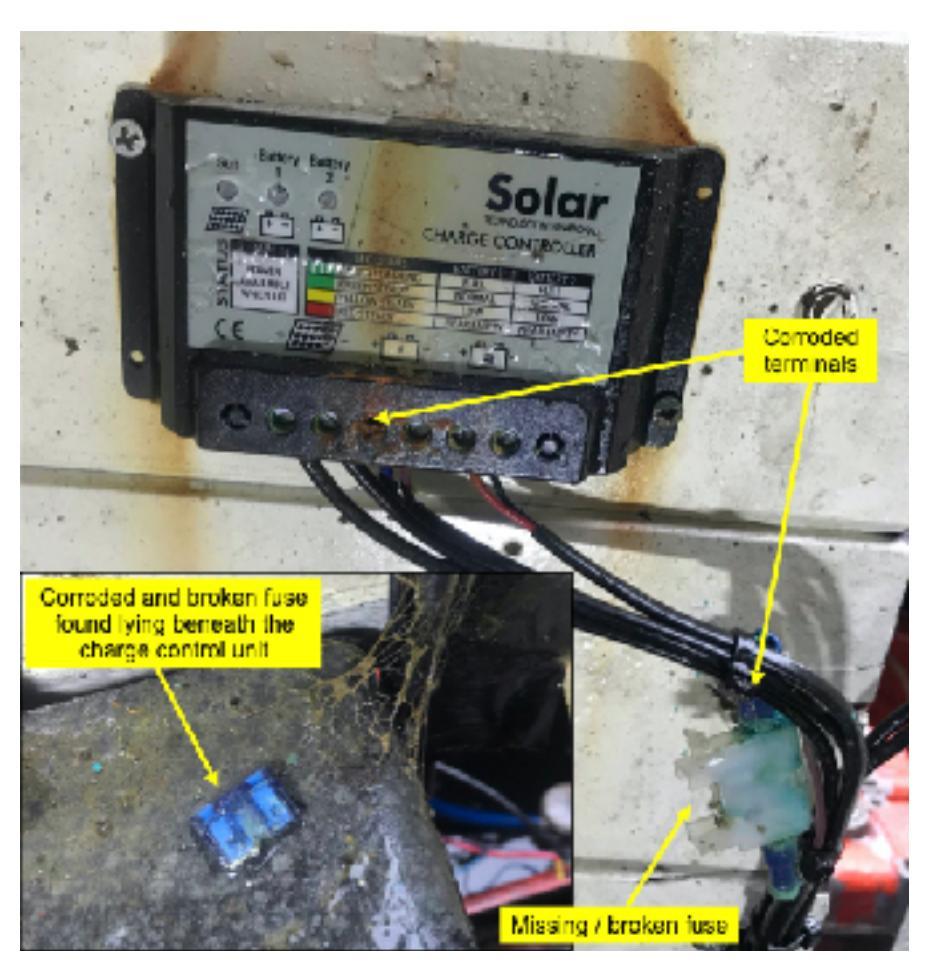
- 4.4.1.1. A large, rigid solar panel was mounted on the cabin roof. This was connected to the vessel's 12 volts d.c. electrical system via a Solar Technology International charge controller unit, mounted inside the cabin, secured to the starboard side of the aft bulkhead.
- 4.4.1.2. Figure 4 shows the condition of the charge controller unit. At the time of survey, the corroded and broken in-line fuse of this unit was lying on the galley worktop, positioned directly below the unit. It was determined that due to the heavy corrosion of the terminals and the broken condition of the fuse, the solar panel had been out of operation for a non-determinable length of time.

Figure 4: Condition of solar panel charge control unit

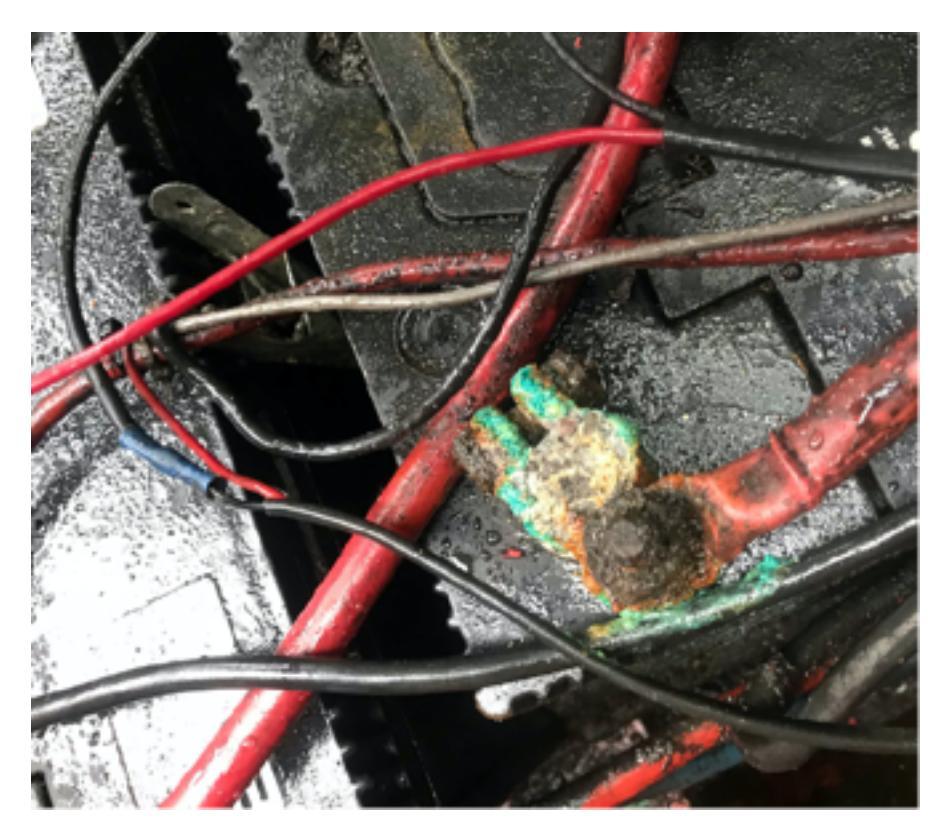
- 4.4.2.1. Four deep-cycling, 12 volts d.c. leisure batteries were installed inside the engine compartment, positioned immediately to starboard of the engine. These were resting on a rubber mat, supported by the uxter plating of the hull.
- 4.4.2.2. The negative posts of all batteries were in good condition and free of significant corrosion. Figure 5 shows the poor condition of one of the positive posts. All four positive posts were in a similar condition. The heavy corrosion on these posts would have significantly affected the efficiency of the batteries and their ability to provide power to the single electric bilge pump.

Figure 5: Typical condition of battery terminal posts
