# **JUNO**

## **Pre-Purchase Survey**

Completed for  
John Smith,  
5, South Road,  
London,  
E22 1QQ  
On 29/10/2011

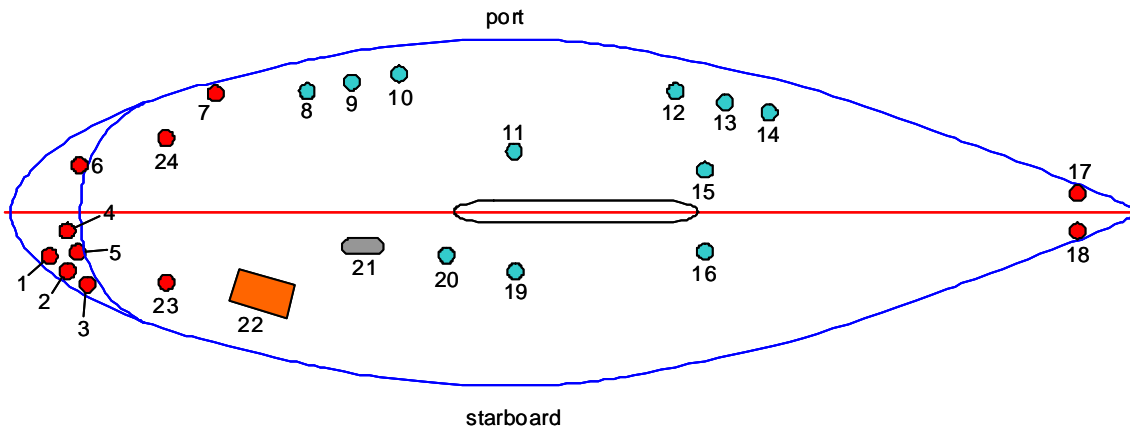
**Figure 5: Location of through-hull fittings**

5.1.9.1 The through-hull skin fittings were all in serviceable condition. All fittings on or below the waterline were bronze (apart from the plastic speed impellor and depth transducer) and showed no signs of dezincification.

5.1.9.2 Figure 5 and Table 3 below show the location and function of the through-hull penetrations.

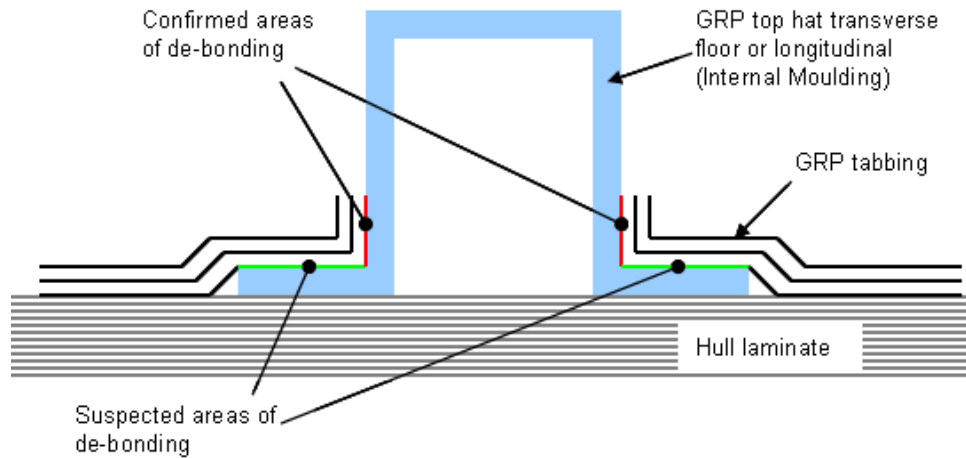
**Figure 9: Schematic cross-section of typical transverse floor**

- 5.2.2.5 Figure 9 shows a schematic cross section of the top hat section and the method of bonding to the hull laminate. It was confirmed by inspection that the red-coloured bond lines had failed. Without destructive testing it was not possible to confirm that the green-coloured bond lines were intact. It is likely that the observed bond failure has occurred as a result of high stresses in the hull and Internal Moulding, combined with the fact that the tabbing was bonded to the gel-coat surface of the Internal Moulding. For this reason it is likely that the green-coloured bond lines have also failed.

- 5.2.2.6 It is **RECOMMENDED** (type A2) that for ALL de-bonded areas of the Internal Moulding, the de-bonded tabbing is cut back entirely until the bonded interface is found. Surfaces of the Internal Moulding that are to receive over-laminating shall be cut back to remove the gel-coat surface. This is to ensure that the new laminate is bonded to existing laminate rather than gel-coat, which is a very poor substrate for bonding. All prepared areas shall then be thoroughly cleaned and dried. Multiple layers of fibreglass cloth and epoxy resin should then be applied, with the edges of the cloth layered so as to give a gradual tapering to the existing structure. The thickness of the layup should be in excess of the laminate removed during the repair. This will ensure that strength of the repair is similar or greater than the original layup.
