# QUICKSILVER

## Pre-purchase Survey

Completed for  
Dave Wakelin,  
Hill View,  
Dorking,  
Surrey,  
DK14 0PQ  
On 24/08/2013

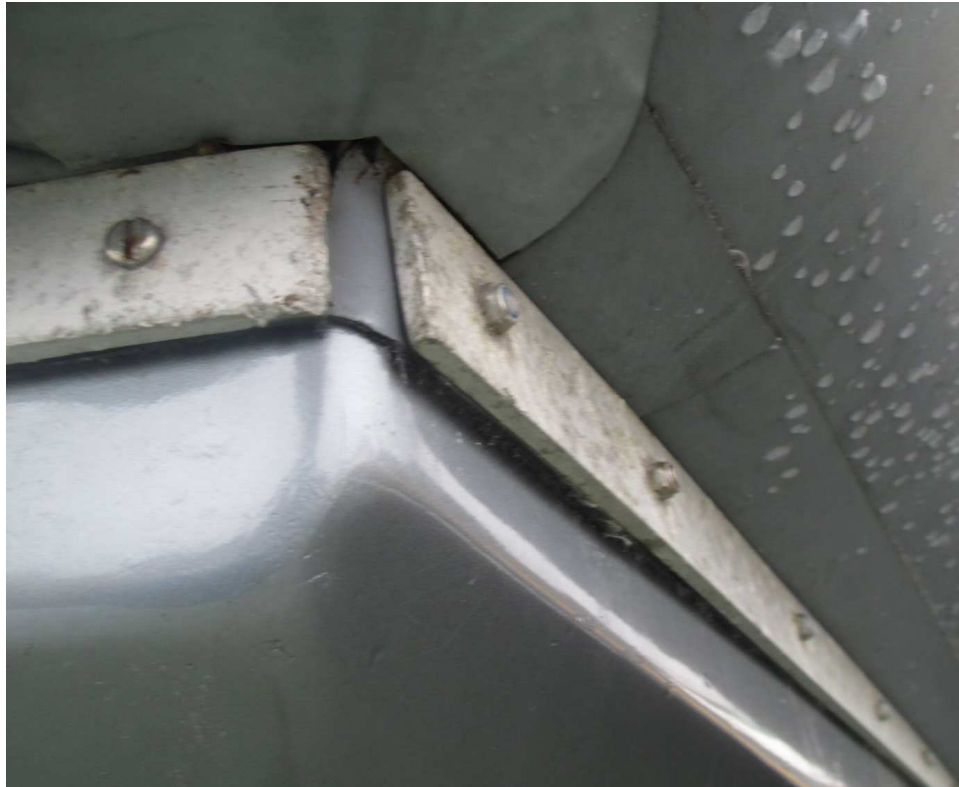
5.2.4 The sponsons were secured onto the hull moulding and foredeck moulding by lengths of hypalon / PVC that were bonded along the length of the sponsons. The flanges of the hypalon / PVC were then clamped onto the hull and foredeck moulding by lengths of aluminium that were through-bolted with stainless steel fasteners, as shown in Figure 3. The aluminium strip and fasteners were found to be in serviceable condition.

5.2.5 The aluminium plates will galvanically corrode where they are in contact with the stainless steel fasteners. The plate and fasteners should be regularly inspected and replaced if found to be corroding significantly.

**Figure 3: Port bow view of sponson to show hull joining method**
