## JUNO

### Pre- purchase Survey

Completed for  
Client Name,  
House Name,  
Town,  
Country

On 15/09/2014

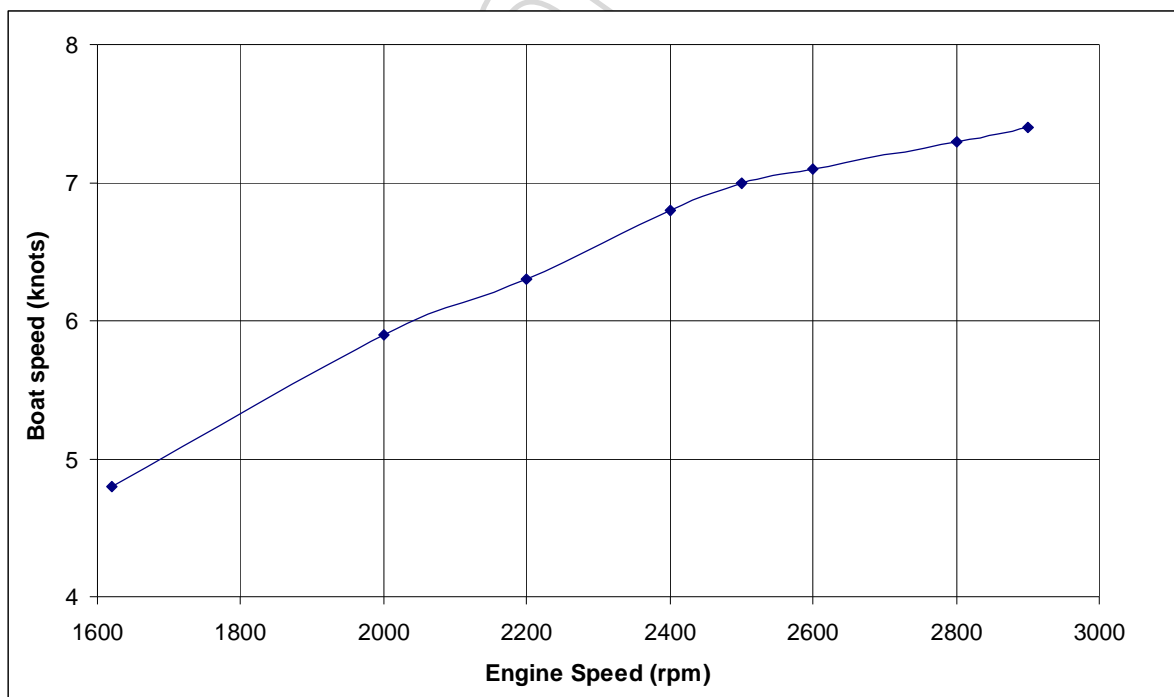
**Table 4: Vessel speed / engine speed in slight sea conditions**

- 5.5.5.3 Ahead and reverse gears engaged normally.
- 5.5.5.4 During the sea trial, the sea conditions were slight. The engine was run in forward gear at various speeds and the vessel speed noted. The engine / boat speed is plotted in Table 4.
