fieldhouse yacht surveys

BIRD SONG

Pre-purchase Survey

On Friday 12th April 2018

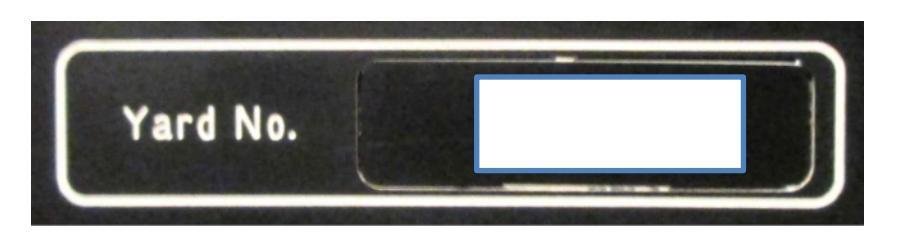
Figure 1: Yard Number

4.4.1. The vessel's Yard Number was Gxxx. This number was applied to the cover plate of the electrical switch panel, located at the chart table in the saloon. This number is shown in Figure 1.
