PUFFIN II

Pre-purchase Survey

Mike Chapman,
27 Hyde Road,
Bognor Regis,
West Sussex,
PO20 4PQ

On Friday 17th August 2020 and Friday 24th August 2020

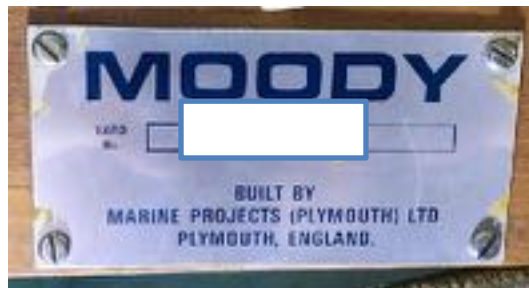
Figure 1: Yard Number on Builder's Plate

- 4.4.1. The vessel's Yard Number was xxx. This number was stamped into an aluminium plate, which was fastened to the side of the starboard quarterberth, next to the chart table. This plate is shown in Figure 1.

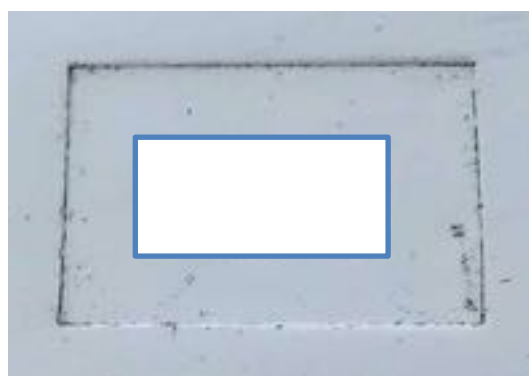
Figure 2: Mould Number on hull & deck mouldings

- 4.5.1. The vessel's Mould Number was xxx. This number was moulded into the upper, port corner of the transom and also on the deck moulding, located at the aft end of the cockpit sole. The number of the transom is shown in Figure 2.

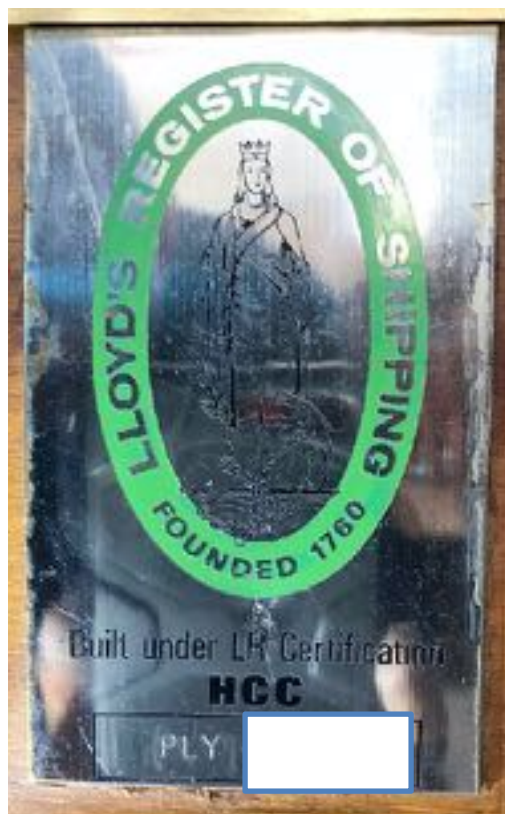
Figure 4: Lloyd's Register of Shipping plaque

- 4.8.1. This number was PLY xxx and was stamped onto a metal plaque, which was fastened to the side of the starboard quarterberth, next to the chart table. This plate is shown in Figure 4.
